Re: Violation Notice, JVIS Manufacturing LLC (JVIS)
Berrien County
Site Identification Number MIR 000 013 623

Attachment – Photographic Log

JVIS Violation Notice Response – Water Curtain Photographic Log

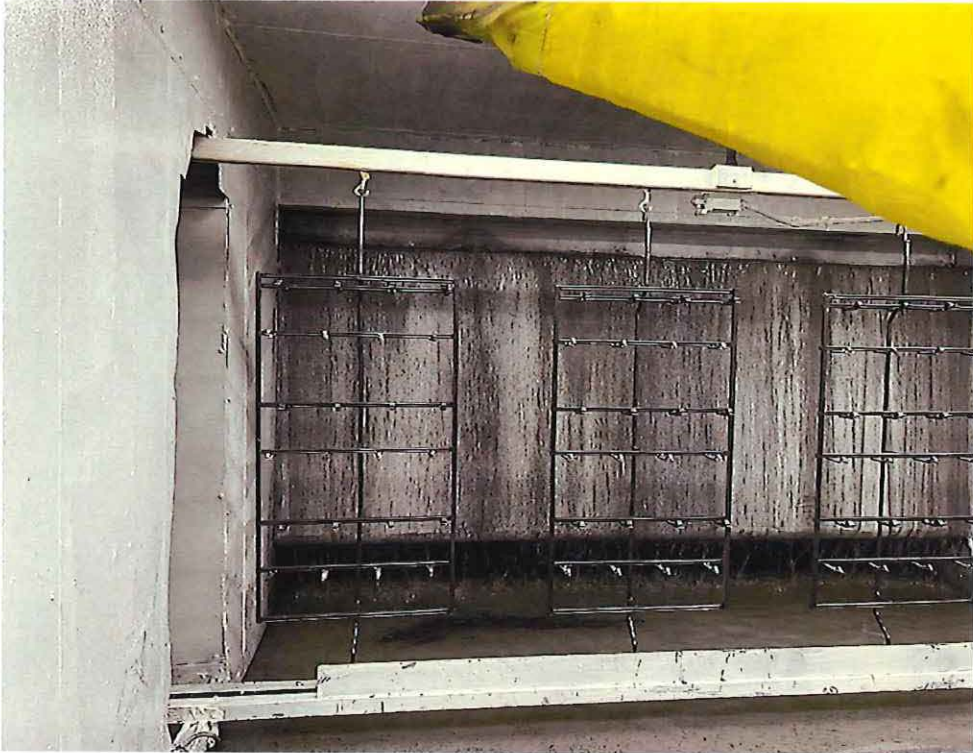
<p>Photo 1 03/21/2023</p> <p>Area: EUPLASTICPARTS</p> <p>Description: Operational water curtain</p>

Comment 1: Although the facility has installed the water curtain control system in each spray booth of EUPLASTICPARTS, it doesn't appear that they've been maintaining and operating them properly. They were not in use during the inspection due to piping being plugged and parts to repair the issue are supposedly on order.

Response: The water curtains in the EUPLASTICPARTS spray booths were repaired and are operating as of March 18, 2023. JVIS Crystal took three photos and one video as documentation of the repaired water curtain. See Attachment for photographic documentation of the repair. A video (.MOV format) of the water curtain in operation is attached to the email for which this letter is attached.

JVIS Crystal investigated the plugged paint line to determine the root cause. Synergy, the paint system specialist in charge of maintaining the water curtain, is required to drain water tanks, remove debris, and clean the tanks on a weekly basis, as determined by a maintenance calendar provided to the vendor by JVIS Crystal. JVIS Crystal believes that Synergy was not conducting the required weekly maintenance, which caused buildup that plugged the water lines and pump. Moving forward, JVIS Crystal will uphold the maintenance calendar and improve the maintenance process by validating the scope of work during a meeting with Synergy and implementing an internal inspection where an employee of JVIS Crystal is to sign off that the items on the maintenance calendar are completed as required. Additionally, JVIS Crystal will review its Malfunction Abatement Plan (MAP) for opportunities for improvement based on its water curtain findings.

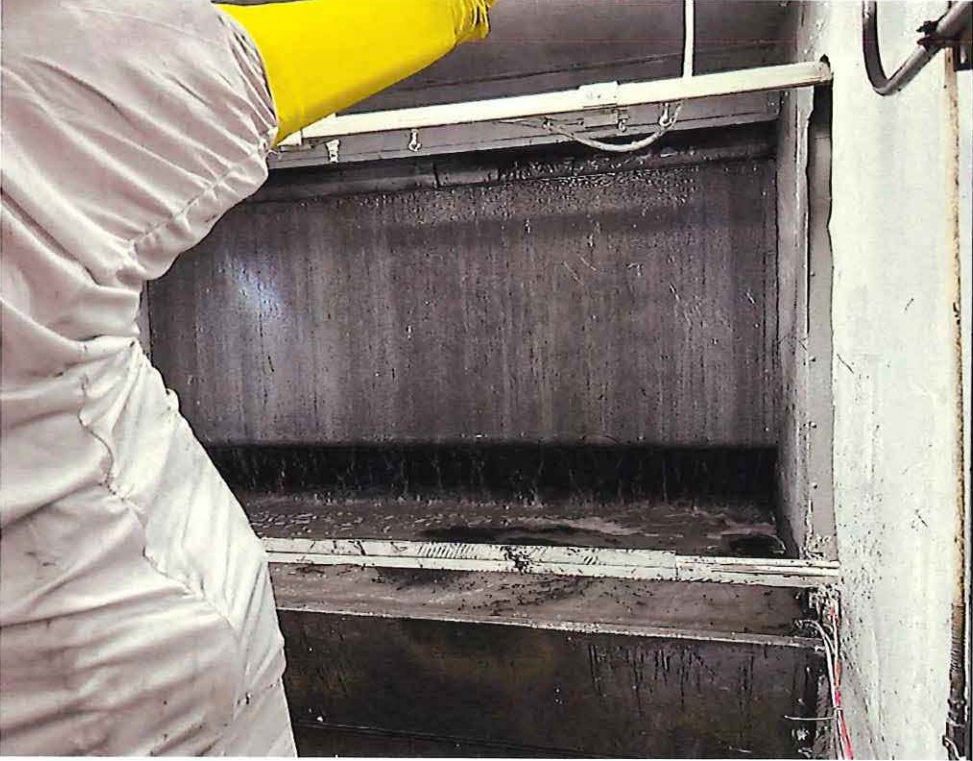
A photograph showing a water curtain system in an industrial setting. The water curtain is composed of several vertical panels of water, each supported by a metal frame. The water is dark and appears to be dripping. A yellow object is visible in the upper right corner of the frame.
<p>Photo 2 03/21/2022</p> <p>Area: EUPLASTICPARTS</p> <p>Description: Operational water curtain</p>
