DEPARTMENT OF ENVIRONMENTAL QUALITY
AIR QUALITY DIVISION
ACTIVITY REPORT: On-site Inspection

N521154279

FACILITY: Stoneco of Michigan		SRN / ID: N5211
LOCATION: 6301 BELLEVIEW, FLINT		DISTRICT: Lansing
CITY: FLINT		COUNTY: GENESEE
CONTACT: Michael McIntosh , General Manager		ACTIVITY DATE: 07/21/2020
STAFF: Daniel McGeen	COMPLIANCE STATUS: Compliance	SOURCE CLASS: MINOR
SUBJECT: Scheduled inspection.		
RESOLVED COMPLAINTS:

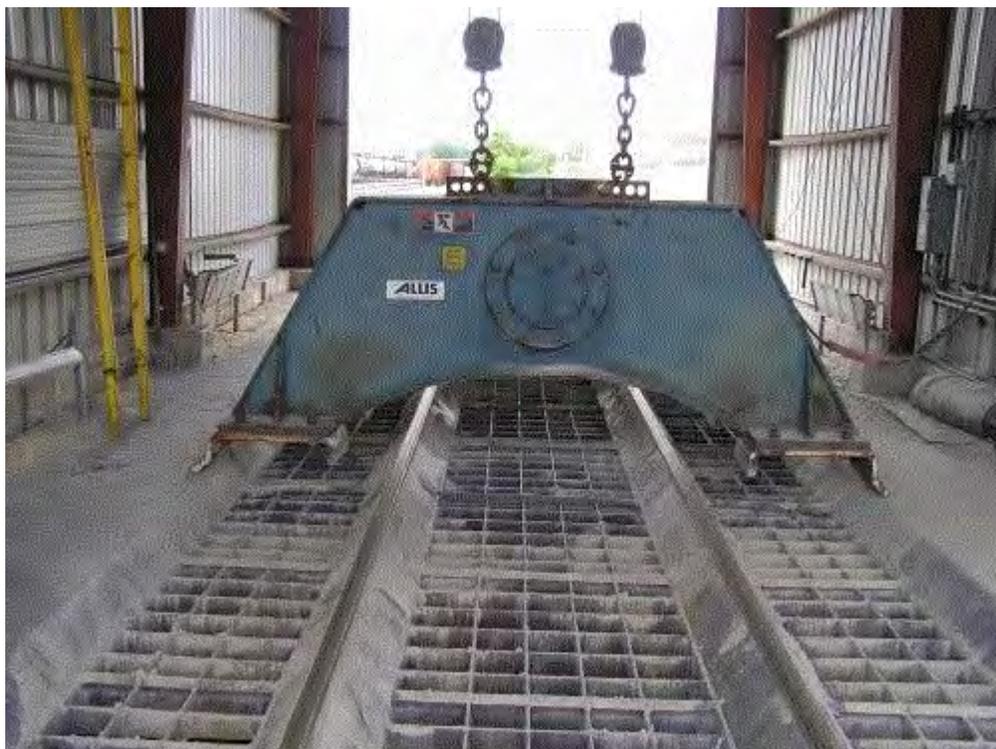
I was shown the Hewlett car shaker, which physically shakes railcars, to help unload the coal into a receiving pit below. Please see attached photo No. 001. The hopper below has two feeders, and leads to a 36 inch conveyor belt.

Image 1(001) : Hulett railcar shaker.

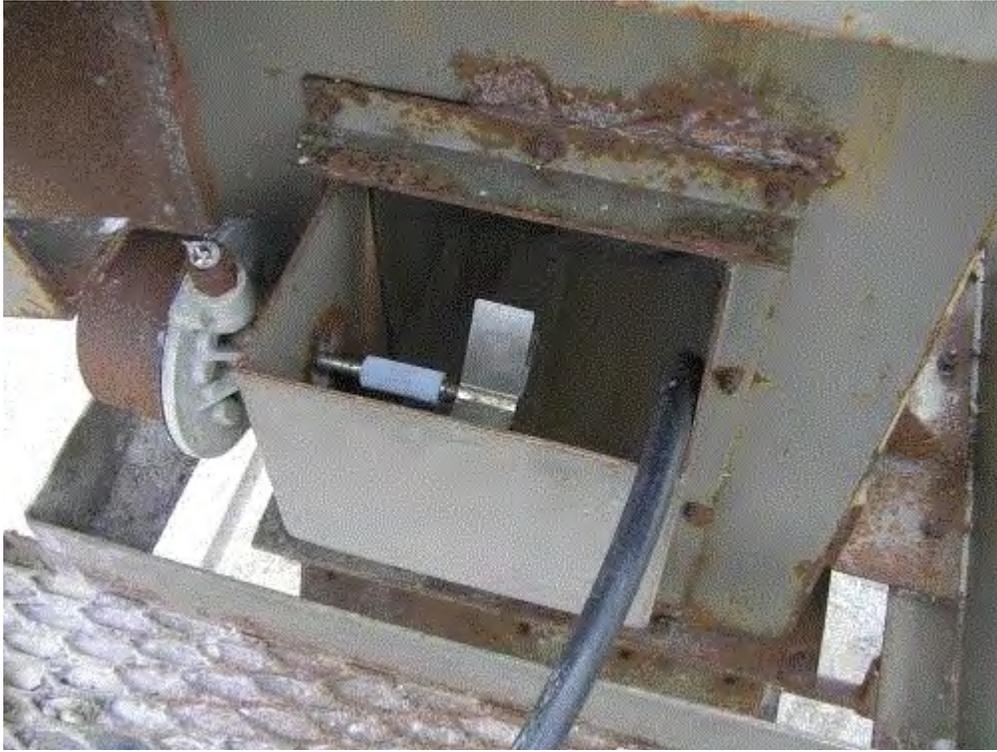
Unloaded aggregates are conveyed by the 36 inch conveyor to on-site storage piles. The conveyor and subsequent conveyor are covered, in a number of places. Water sprays are located at various transfer points, which I was shown, throughout the site, with two serving the unloading conveyor system. The hoses for the dust suppression all looked to be in good condition. Please see photo No. 002 for a representative example, at a transfer point leading away from the railcar unloading building.

Image 2(002) : Hose to supply water to transfer point.
