DEPARTMENT OF ENVIRONMENTAL QUALITY
AIR QUALITY DIVISION
ACTIVITY REPORT: Scheduled Inspection

FACILITY: SAGE CONTROL ORDNANCE INC		SRN / ID: N5459
LOCATION: 6340 SAGE ST, OSCODA		DISTRICT: Saginaw Bay
CITY: OSCODA		COUNTY: IOSCO
CONTACT: John Klein , President		ACTIVITY DATE: 01/04/2018
STAFF: Meg Sheehan	COMPLIANCE STATUS: Compliance	SOURCE CLASS: MINOR
SUBJECT: One Permit to Install (PTI 588-94) is associated with the referenced facility and was issued on March 15, 1995. The referenced permit is for an ammunition loading process for crowd control ("tear gas") chemical agents with a two-stage filtration system (activated carbon and a HEPA filter). Site inspection activities were conducted with the intent of determining the compliance status of the facility.		
RESOLVED COMPLAINTS:

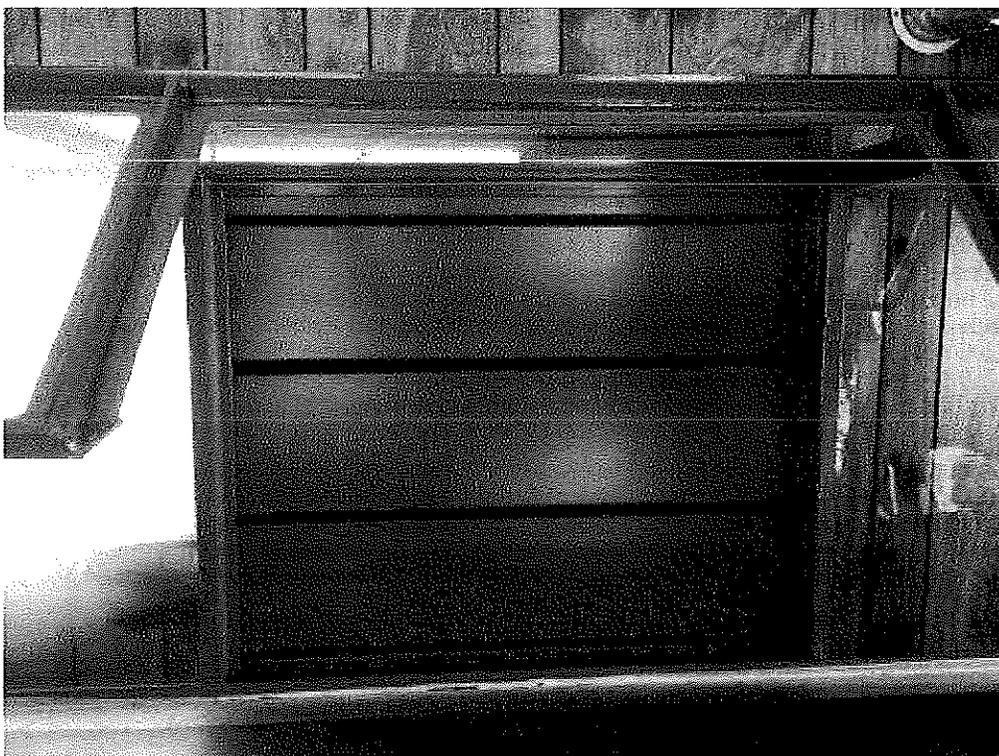
Image 2(Vent) : The vent behind the work station and under glass that connects to the two-stage filtration system outside.

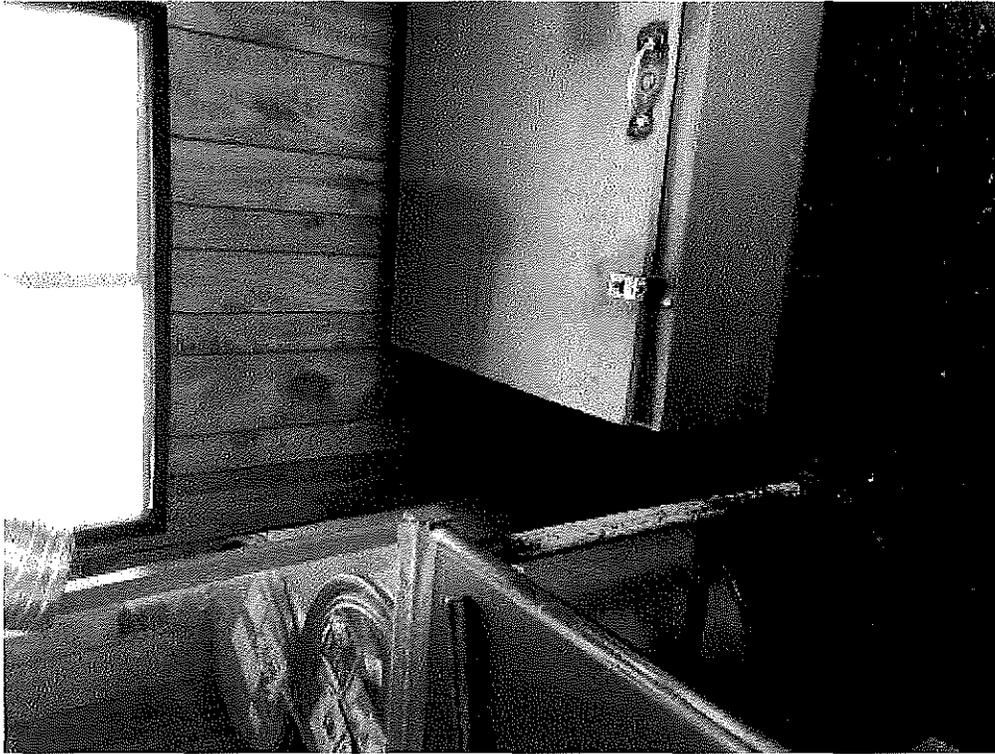
Image 3(Chemical Storage) : The drums on the left contain OC and CS back-up product, and the locked metal box on the floor contains OC and CS currently in use.
