DEPARTMENT OF ENVIRONMENTAL QUALITY
AIR QUALITY DIVISION
ACTIVITY REPORT: Scheduled Inspection

FACILITY: PASCHAL BURIAL VAULT SERVICES		SRN / ID: N5944
LOCATION: 431 SCHOOL ST, HUDSON		DISTRICT: Jackson
CITY: HUDSON		COUNTY: LENAWEE
CONTACT:		ACTIVITY DATE: 11/02/2017
STAFF: Mike Kovalchick	COMPLIANCE STATUS: Compliance	SOURCE CLASS: MINOR
SUBJECT: Inspection of 2 incinerators at 2 nearby adjacent facilities about 1 mile apart.		
RESOLVED COMPLAINTS:

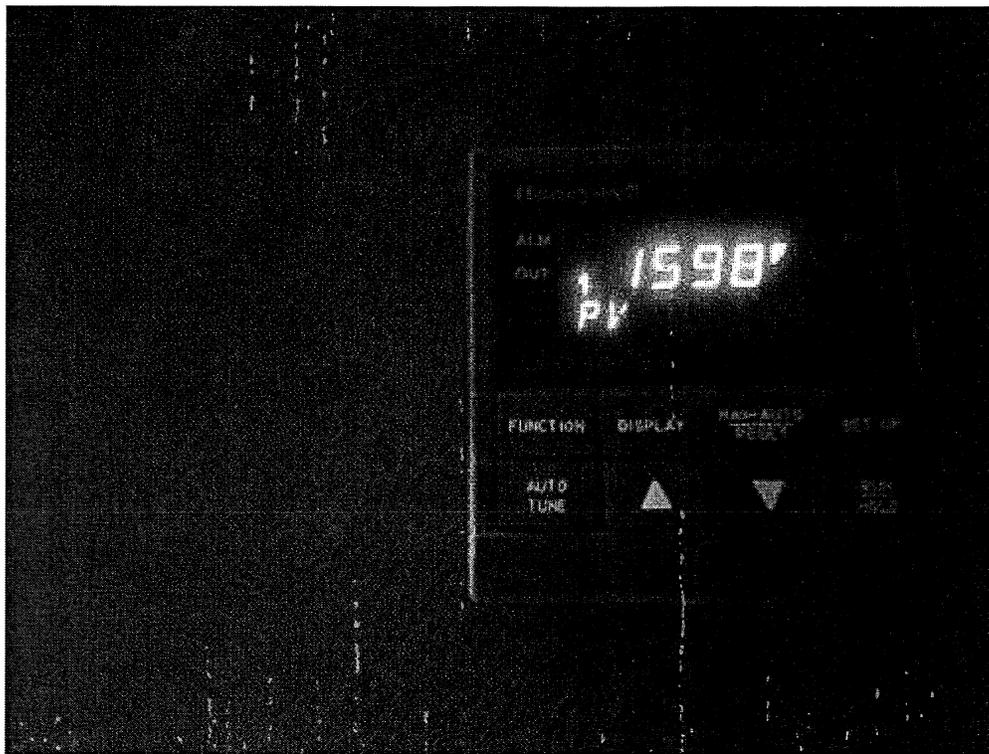
The older incinerator was operating 1598 deg F. (See photo.) The incinerator appeared to be in excellent condition. Ventilation pipes were in good shape exiting out a stack on the roof. No opacity and only heat waves were seen exiting the stack. The stack appeared to be at least 19 feet off the ground meeting permit requirements.

Image 2(Incinerator temp) : Old Incinerator temp.

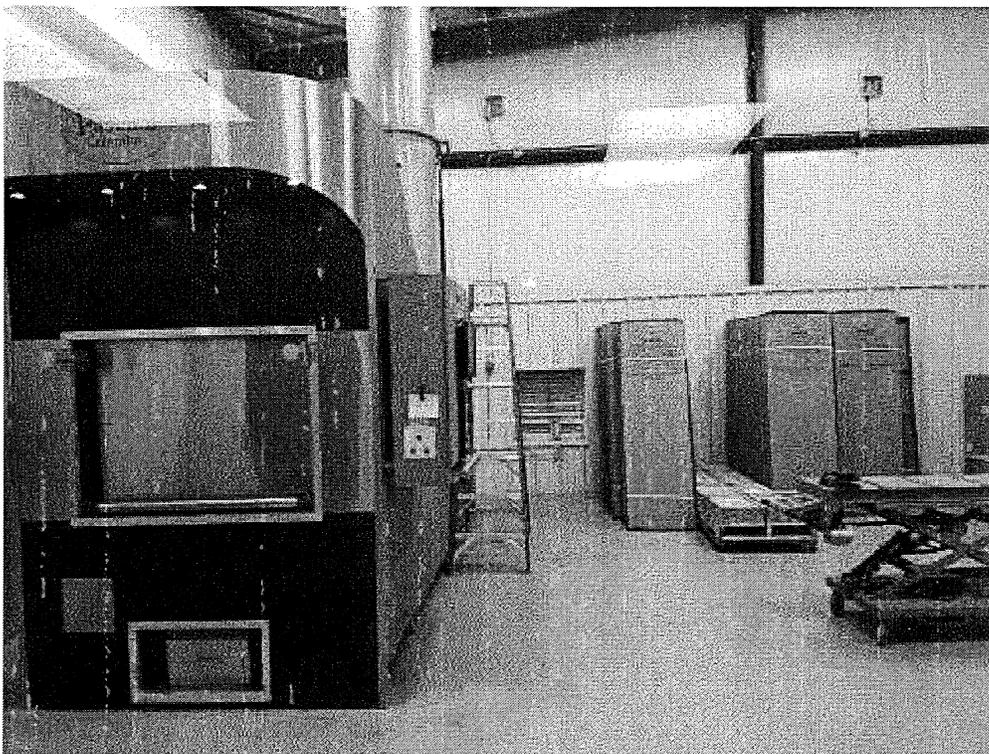
The incinerator appeared to be in mint condition and almost completed automated. LP explained how the incinerator optimizes every burn and learns over time. The temperature of the primary chamber was 987 degrees F. and temperature of the secondary chamber was 886 degrees F. The incinerator was still warm from an incineration from the previous evening. LP indicated it takes only a very few minutes to get up to proper temperature. No smoke was seen from the exhaust stack which appeared to be the required 24 feet high.

Image 3(New incinerator) : New incinerator

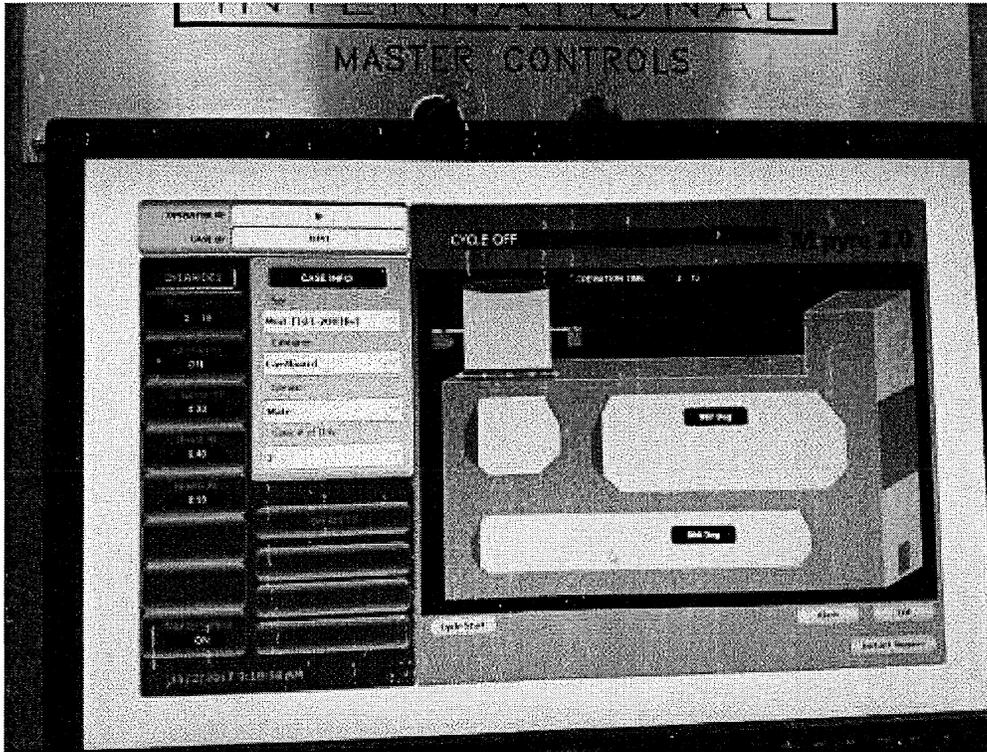
The circular charts are daily charts with each cremation hand annotated on the chart. It appears that temperature is maintained at 1700 degrees F. during the cremation in the afterburner chamber. (Permit limit is 1600 Deg. F.) The control panel shows the temperature for both the main chamber and the afterburner but only the

afterburner temperature is recorded on the circular chart.

Image 4(Control Panel) : Control Panel-new incinerator.

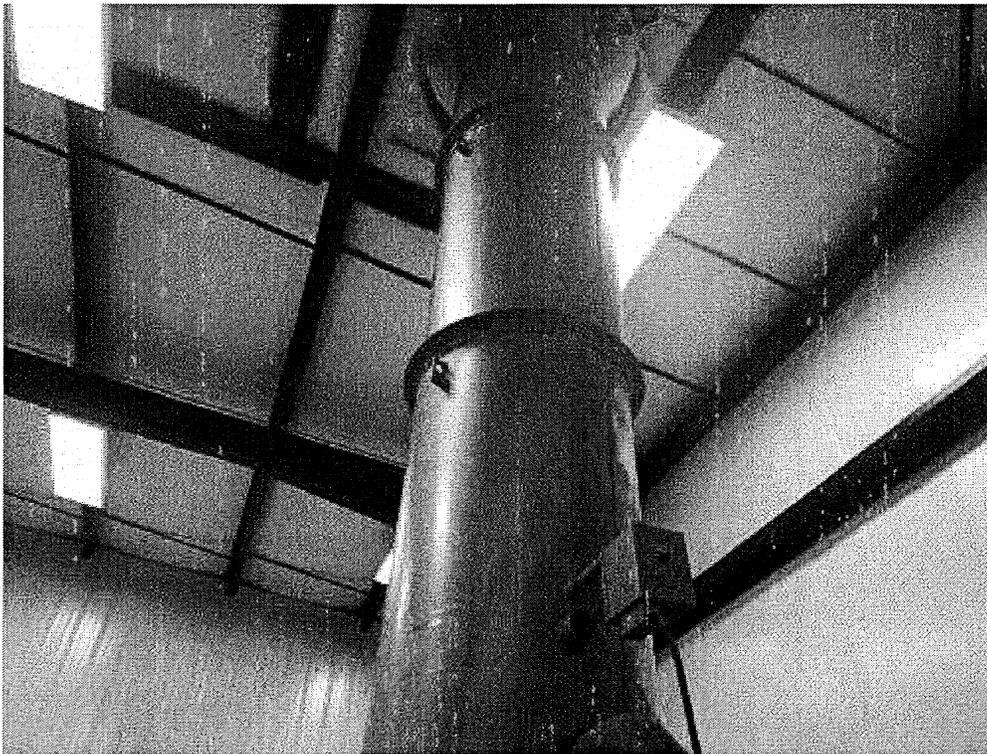
Image 5(Exhaust stack) : Exhaust ventilation pipe to roof exhaust stack.

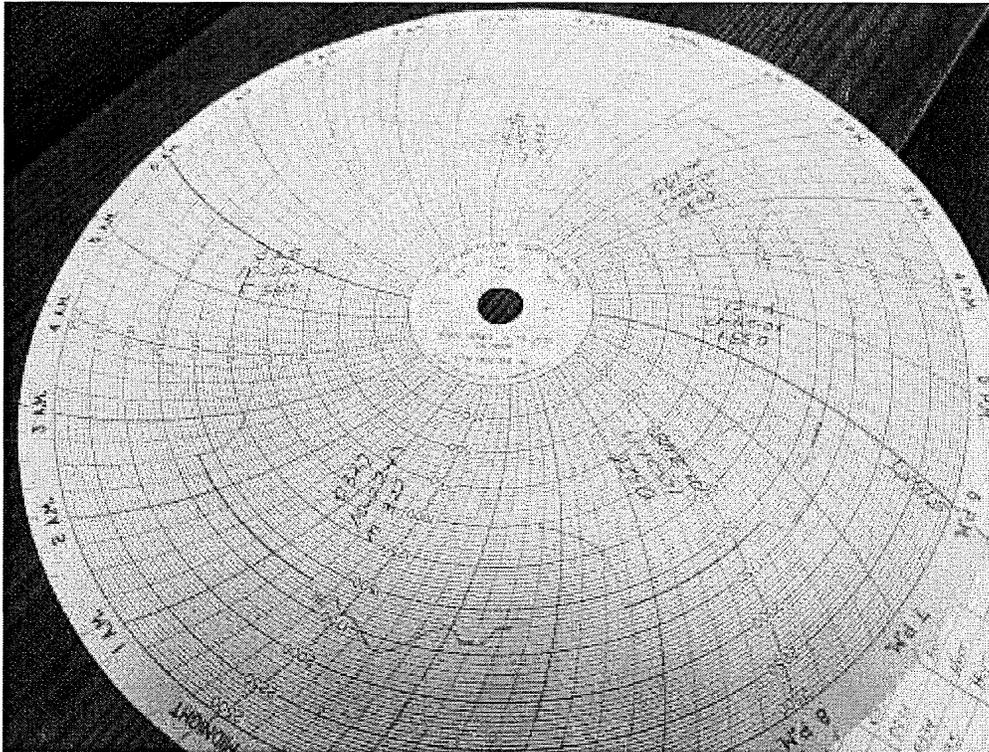
Log books and the temperature circular charts showed that the required incinerator temperatures are being maintained.

Image 6(Circular chart) : Circular chart showing afterburner temp on new incinerator.

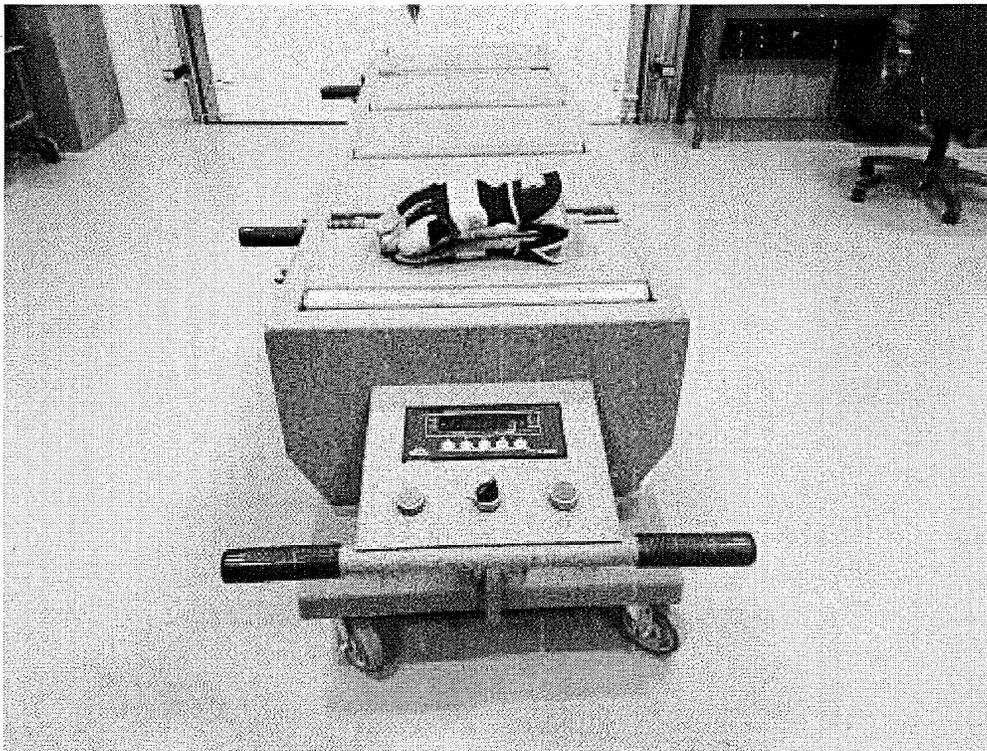
The weight scale appeared to be in working order.

Image 9(Weight scale) : Weight scale associated with new incinerator.

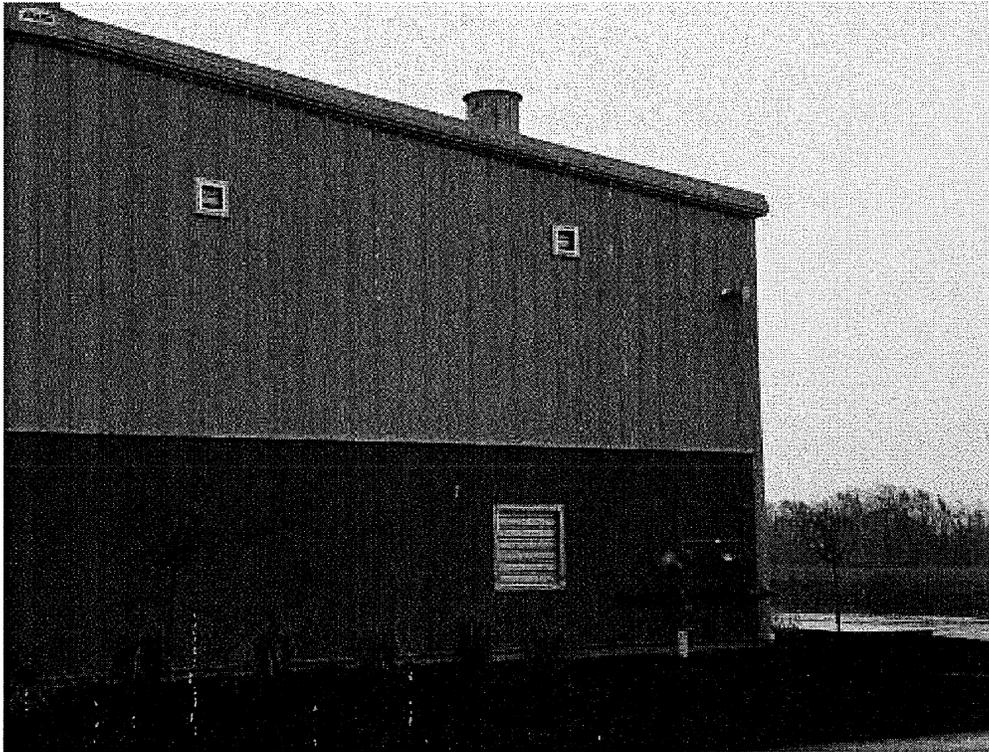
Image 10(New incinerator bldg) : New incinerator building showing incinerator exhaust stack.
