DEPARTMENT OF ENVIRONMENTAL QUALITY
AIR QUALITY DIVISION
ACTIVITY REPORT: Self Initiated Inspection

FACILITY: R H HUHTALA AGGREGATES INC #75-01		SRN / ID: N6590
LOCATION: T 49N R 34W SE 1/4 SE 1/4 Sec 12, LANSE		DISTRICT: Upper Peninsula
CITY: LANSE		COUNTY: BARAGA
CONTACT: ROLAND H HUHTALA , OWNER		ACTIVITY DATE: 08/02/2019
STAFF: Michael Conklin	COMPLIANCE STATUS: Compliance	SOURCE CLASS: MINOR
SUBJECT: Unannounced inspection to determine compliance with PTI No. 75-01.		
RESOLVED COMPLAINTS:

Inspection

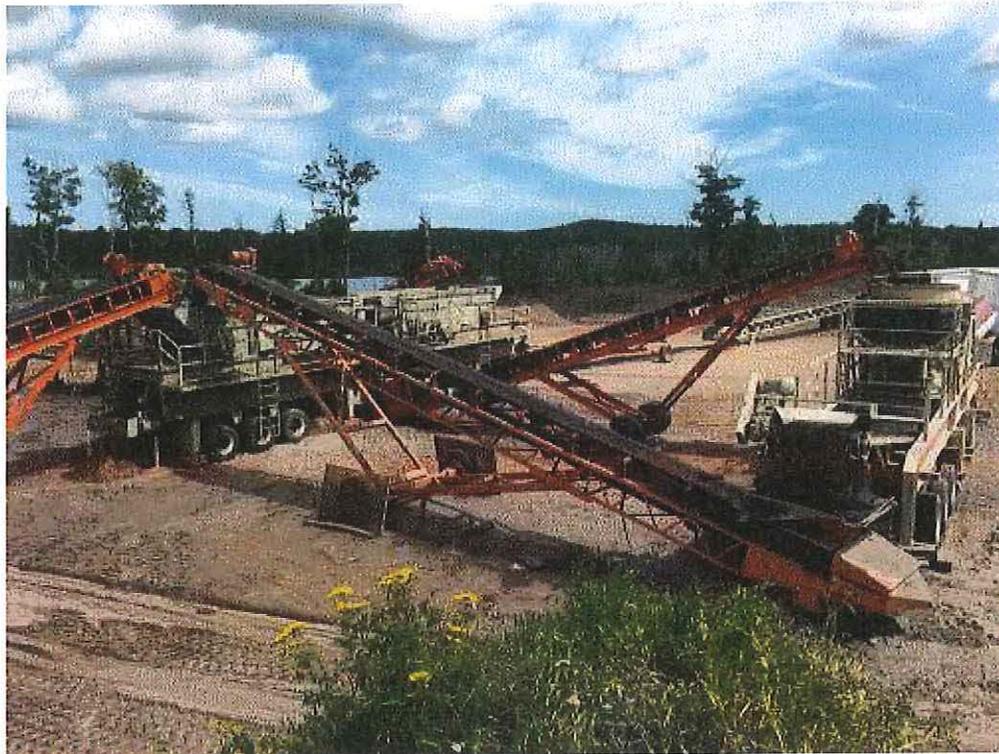
Image 1(Crushing Plant) : Screens and tertiary crusher.

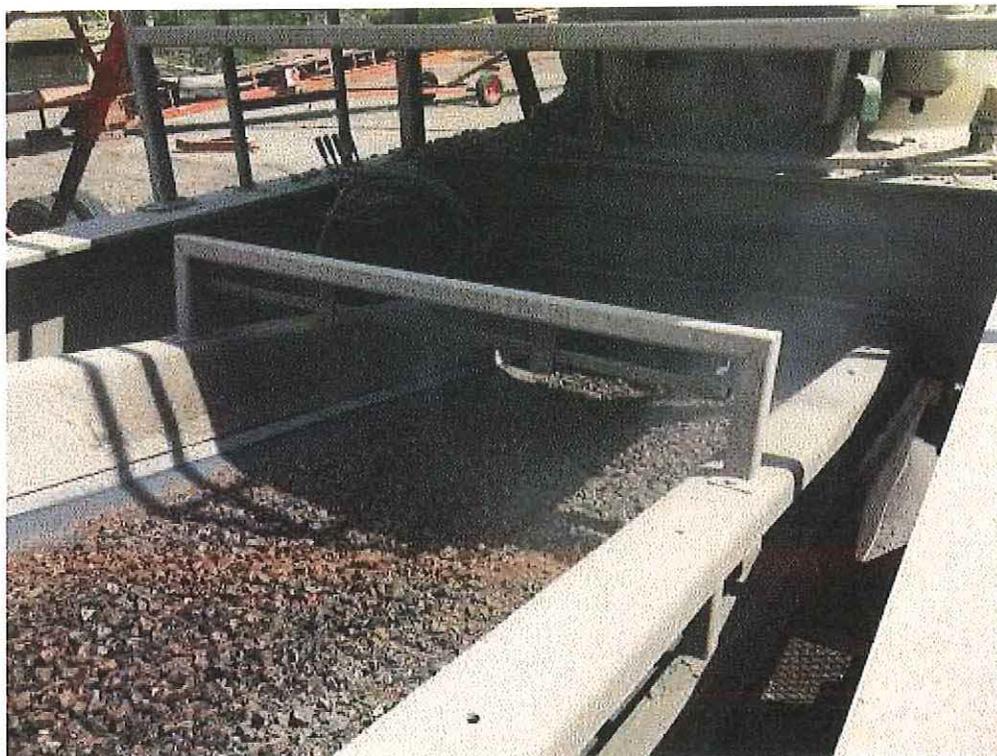
Image 3(Tertiary Crusher) : Spray bars installed and operating.

PTI No. 75-01 states that each crusher and screen shall be equipped with a water spray. Each crusher observed had a spray bar installed, however, the screens did not have spray bars installed. Some of the conveyors that feed material into the screens have spray bars installed. Mr. Hutula stated that there are no visible emissions from the screening operations and that spray bars are not installed on the screens because the material can clump together causing difficulties in screening. Mr. Hutula also stated that the screens operate at below 10% opacity and if visible emissions are observed, spray bars would be installed on the screens. All equipment at the plant appeared to be relatively clean and did not indicate to be operating over opacity limits.

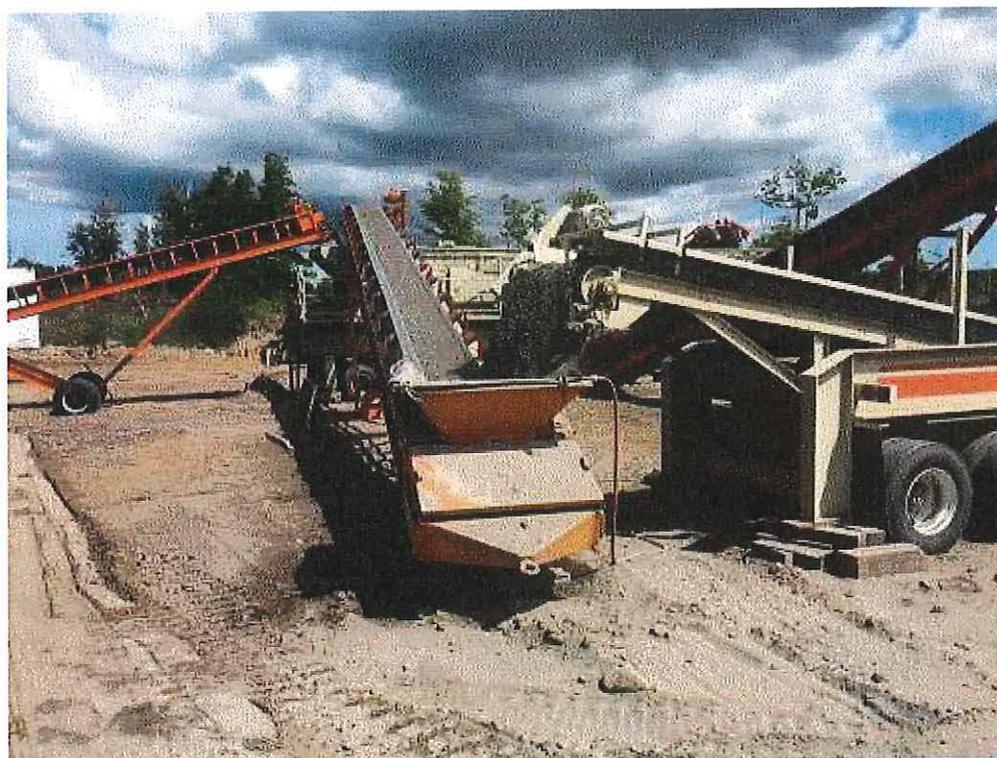
Image 4(Transfer Point) : Transfer point from tertiary crusher.

On August 13, 2019, I revisited the Sickler Industries pit, unannounced, to observe the plant in operation and to check visible emissions from equipment. Upon arrival, visible emissions were observed from the three crushers, transfer points from crushers onto conveyors, and front-end loaders. The visible emissions observed appeared to be over 15%, 10%, and 5% respectively. After observing emissions, I inspected the equipment for spray bars. The spray bars were not on at the time and I spoke with Mr. Hutula stating that the equipment appears to be operating over the opacity limits. Mr. Hutula turned on the spray bars and installed an additional one on the secondary crusher to bring the opacity of the visible emissions to below the limits. Mr. Hutula stated that the spray bars should have been on and that a new operator at the plant may have turned them off by mistake. Also, the process was not operating at full capacity resulting in more dust than usual. A heavier load on the crushing equipment helps contain the fugitive dust through the process, Mr. Hutula stated. With Mr. Hutula acknowledging the issues at the time and immediately correcting the problem, a violation notice will not be issued. No visible emissions were observed from screens, storage piles, or any other process equipment that is part of the nonmetallic crushing facility other than what was mentioned above.

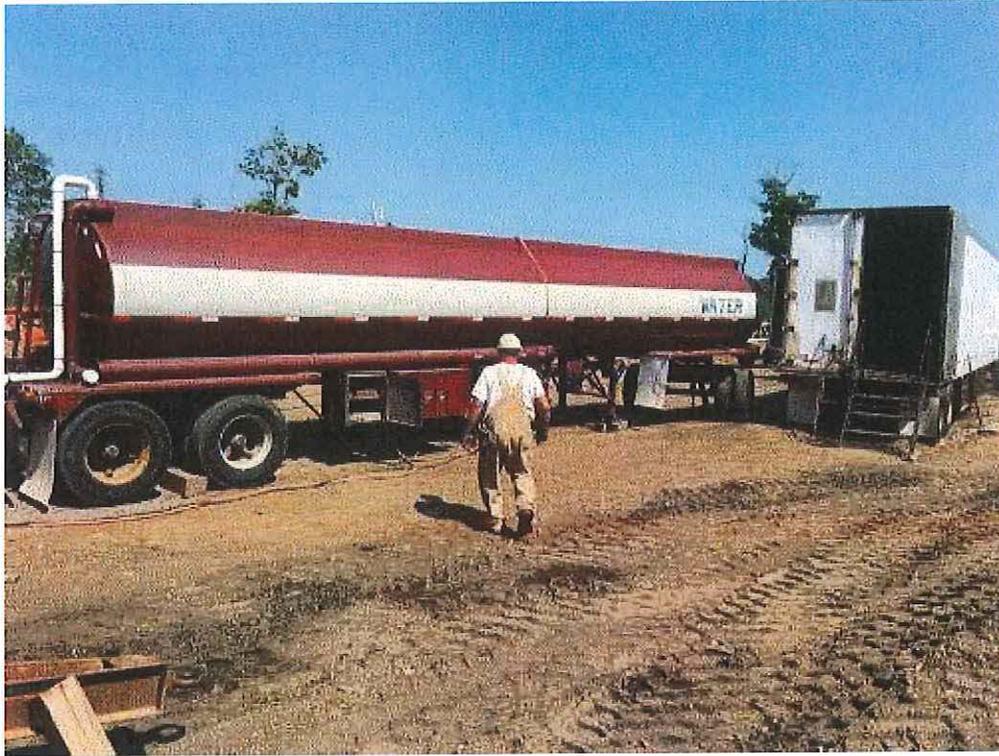
Image 5(Water Truck) : Water truck with pump.

With the plant not operating at the time of the inspection, no visible emissions from equipment, transfer points, storage piles, and roadways were observed. A 10,000 gallon water trailer was observed with lines connected from the pond to the trailer pump. Mr. Huhtala stated that the plant operates with no visible emissions and that the roadways and storage piles are watered as needed. Besides stating how much material was crushed on a daily basis, the records also indicate an estimation of the amount water (gallons) used to control fugitive dust.

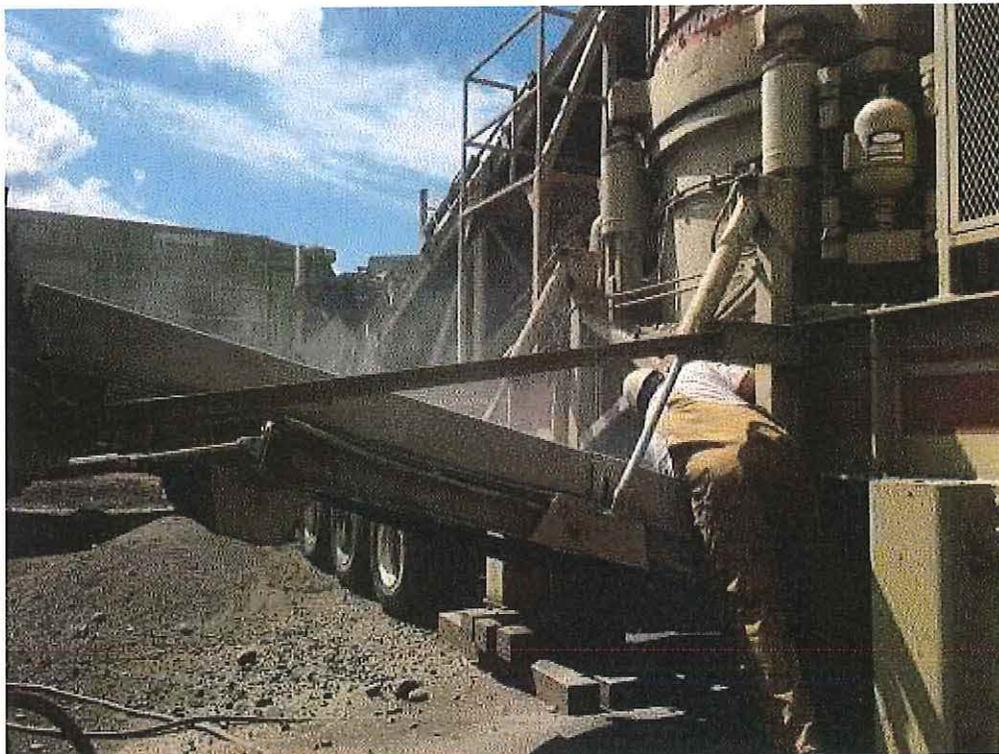
Image 6(Secondary Crusher) : Installing second spray bar on secondary crusher.

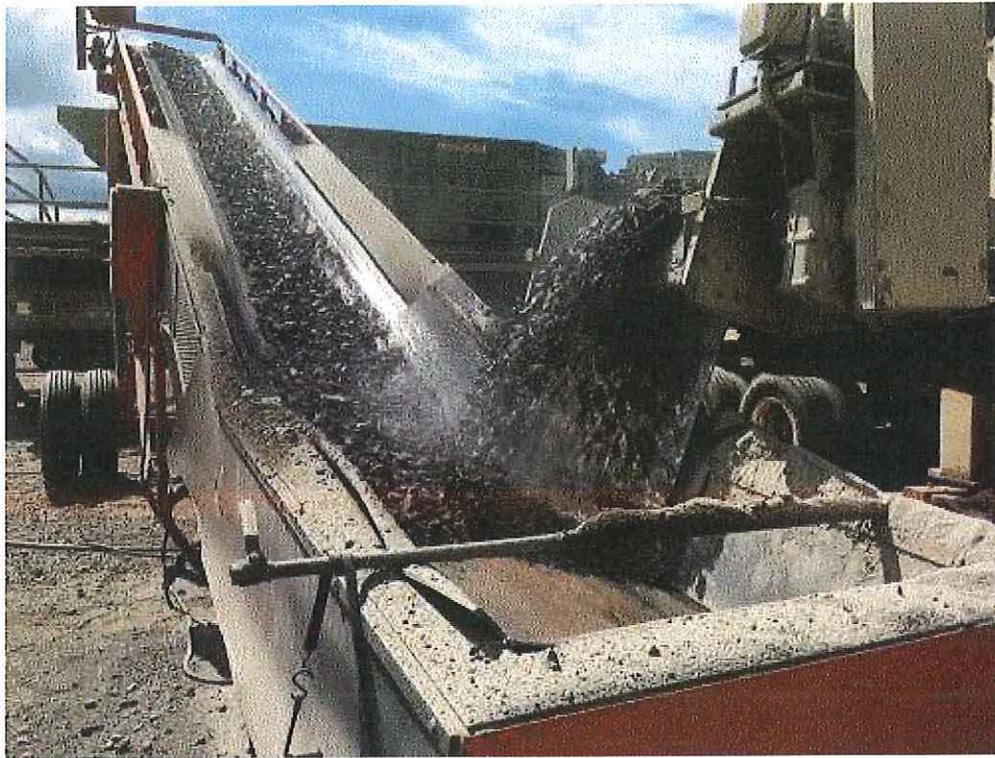
Image 7(Transfer Point) : Transfer point from secondary crusher.
