DEPARTMENT OF ENVIRONMENTAL QUALITY  
AIR QUALITY DIVISION  
ACTIVITY REPORT: Scheduled Inspection

FACILITY: DTE Gas Company - Willow Run Compressor Station		SRN / ID: N7421
LOCATION: 3020 East Michigan Avenue, YPSILANTI		DISTRICT: Jackson
CITY: YPSILANTI		COUNTY: WASHTENAW
CONTACT:		ACTIVITY DATE: 09/10/2020
STAFF: Mike Kovalchick	COMPLIANCE STATUS: Compliance	SOURCE CLASS: MAJOR
SUBJECT: Scheduled Inspection. A methane survey of the facility yard was also conducted using a SEM5000 methane device.		
RESOLVED COMPLAINTS:

**Major / ROP Subject Source. Full Compliance Evaluation (FCE) and Partial Compliance Inspections (PCEs) SRN N7421**

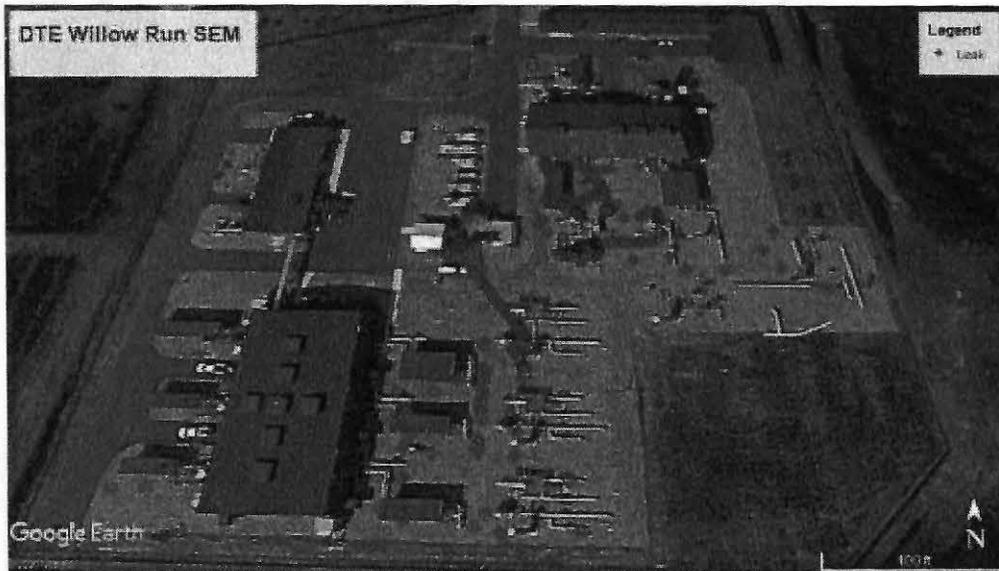
Upwind reading was determined to be around 2 ppm methane (natural methane background), downwind around 5 ppm. See attached graphic which shows the basic path followed while surveying the facility. I stayed outside the buildings during the survey. Overall, everything was tight as would be expected with new piping etc. Any

type of pipe fitting generally had about 20 ppm or less leakage with some exceptions. I did find one leak of 1100 ppm while doing the survey on a small pipe connection. After the survey was over, DTE asked me to re-check the leak as they had a repair man working on it while I was waiting. I was able to verify that they had fixed it. However, I noted about 50 ppm background in this part of the plant yard like what I found when I had walked through it the first time. Since it was clear it was not coming from the now fixed leak, I investigated further. I found a very significant leak on top of a 5000-gallon mixed hydrocarbon/used engine oil/water tank about 25 feet away from the other leak. The SEM5000 registered over 600,000 ppm methane. See photo of tank/leaking vent lid.) The DTE technician noted that they had noticed a natural gas odor coming from this tank about a week ago and ordered a replacement gasket for the lid on top of the tank but they ordered the wrong size and had yet to fix it. They estimated about 6000 gallons of liquid from this tank is loaded out each year but there was only 250 gallons in it when I was there as they had emptied it out 2 weeks ago. Liquids in the gas and oil from the engines flows into the tank in a batch fashion when pressure relief valves are triggered so it seems unlikely that the amount of methane released is over time is that significant since the tank is isolated from the rest of the system.

**Image 1(SEM Survey)** : Path followed and locations of methane leaks detected.

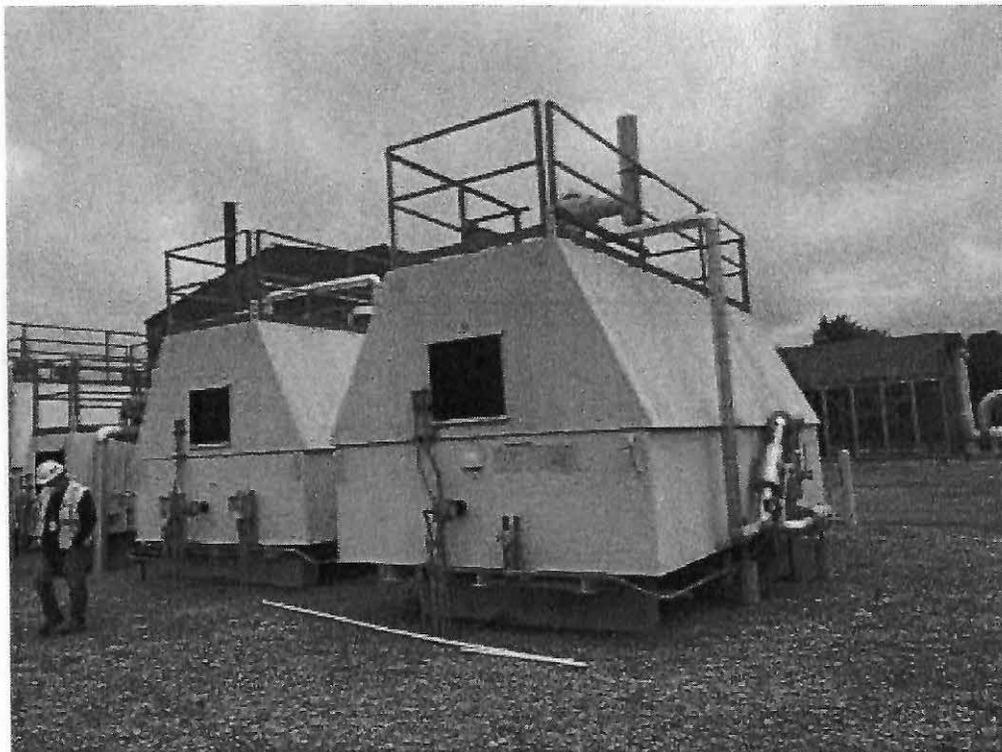
**Image 2(5000 gallon tank)** : 5000 gallon tank(on right) that had greater than 600,000 ppm methane leak coming out the top.

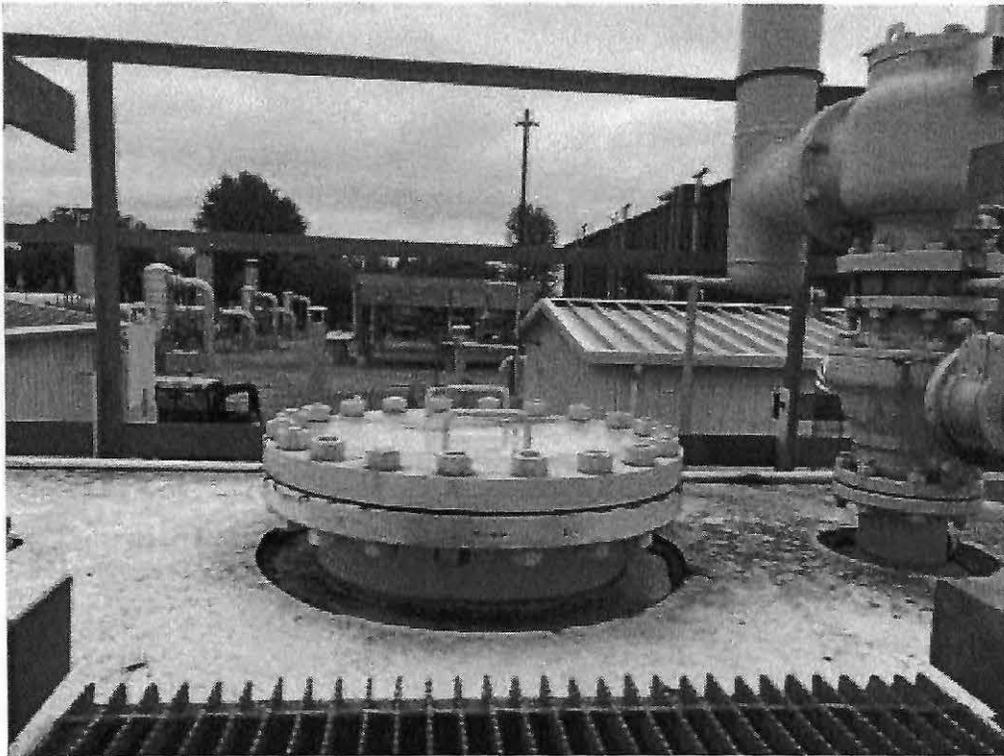
Image 3(Top of tank) : Top of tank showing where leak coming from.

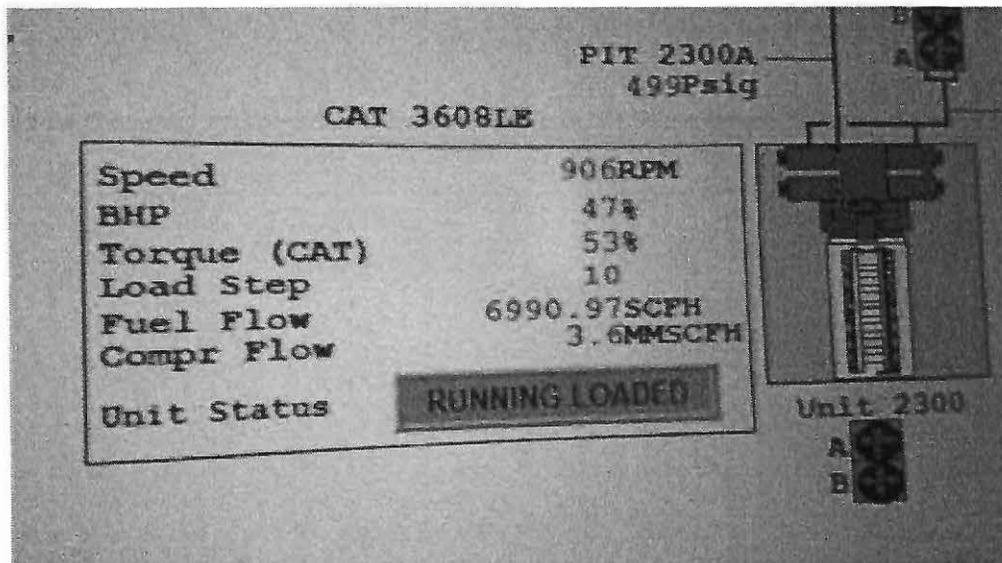
A visit to control room confirmed that only one engine was operating. A 2500 hp engine. (It was either EURICE1 or EURICE2.) See attached photos of the control screen showing operating parameters. The fuel flow into the engine was 7498.97 scfm and was processing 3.5MMSCFM of natural gas through the pipeline. Per the operator, this amount was considered average. The compressor station is only operating at a fraction of capacity. The recent large increase in pumping capacity is mostly not being utilized. To date, the new Nexus pipeline has not generated the level of gas pressure that was expected. Therefore, the gas pressure from the ANR/Panhandle lines that go through the facility do not have to be significantly increased to match the nexus pipeline to be added into that piping system. Only small increases in engine usage has occurred since the Nexus pipeline went online.

Image 4(EURICE1) : Snapshot of EURICE1(Or EURICE2) showing fuel flow and compressor flow.

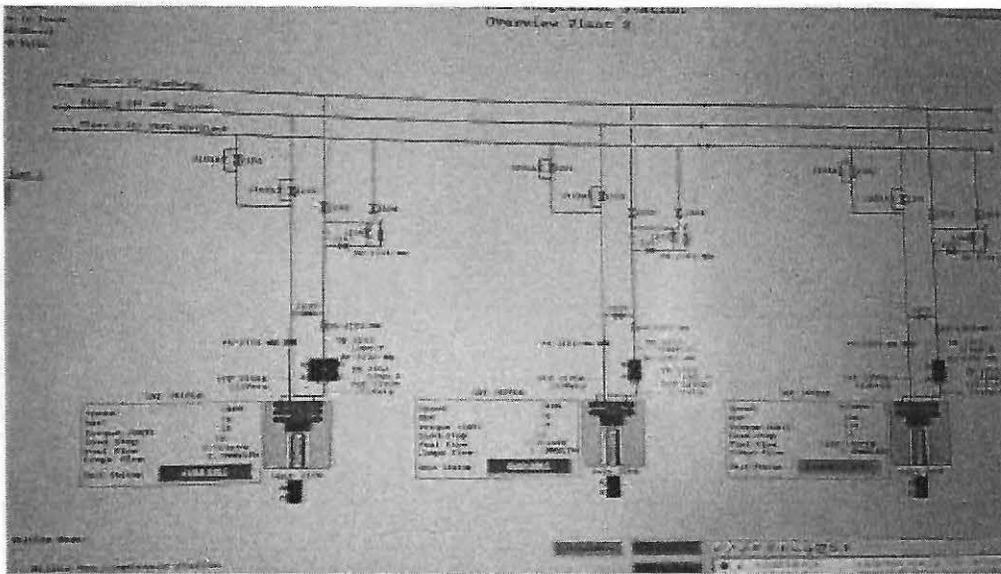
**Image 5(Plant 2) :** Plant 2 control diagram. Plant 1 was not operating.
