**DEPARTMENT OF ENVIRONMENTAL QUALITY
AIR QUALITY DIVISION
ACTIVITY REPORT: Scheduled Inspection**

FACILITY: W2Fuel LLC	SRN / ID: N7927
LOCATION: W BEECHER RD (M-34), ADRIAN	DISTRICT: Jackson
CITY: ADRIAN	COUNTY: LENAWEE
CONTACT: Perry Mulhollen , Environmental, Health & Safety	ACTIVITY DATE: 01/26/2017
STAFF: Mike Kovalchick	COMPLIANCE STATUS: Non Compliance
SUBJECT: Scheduled Inspection conducted on 1/26/17 and 1/2/17. Numerous compliance issues.	
RESOLVED COMPLAINTS:

Purpose

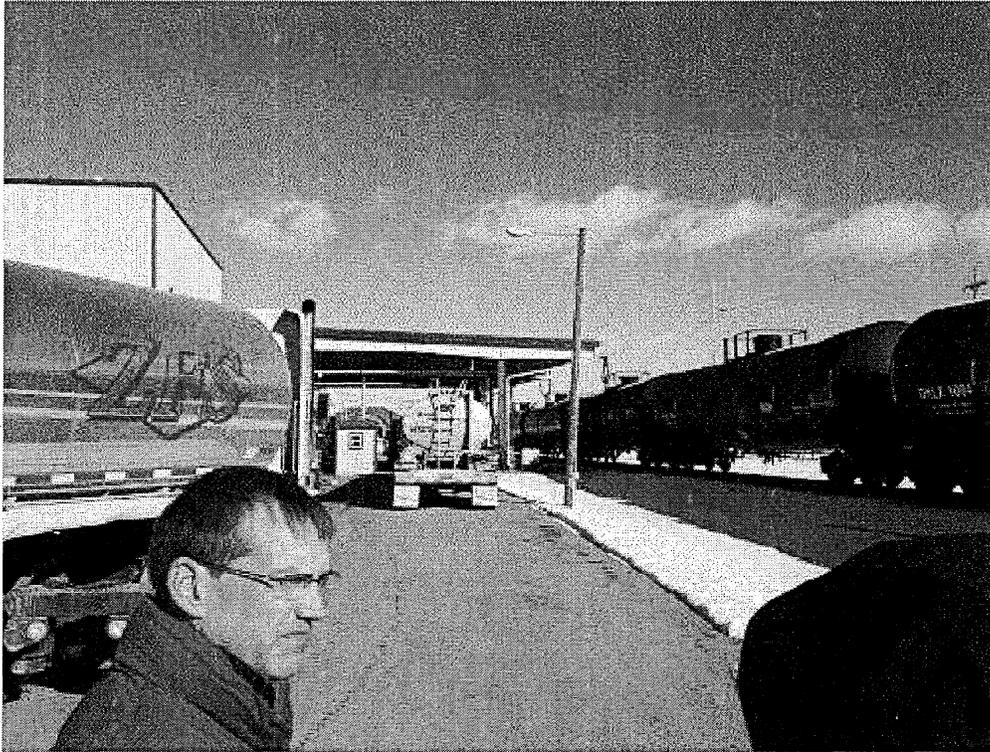
Image 7(Loading area) : Loading area. Vegetable feedstock being unloaded. Biodiesel is shipped via truck and railcar.

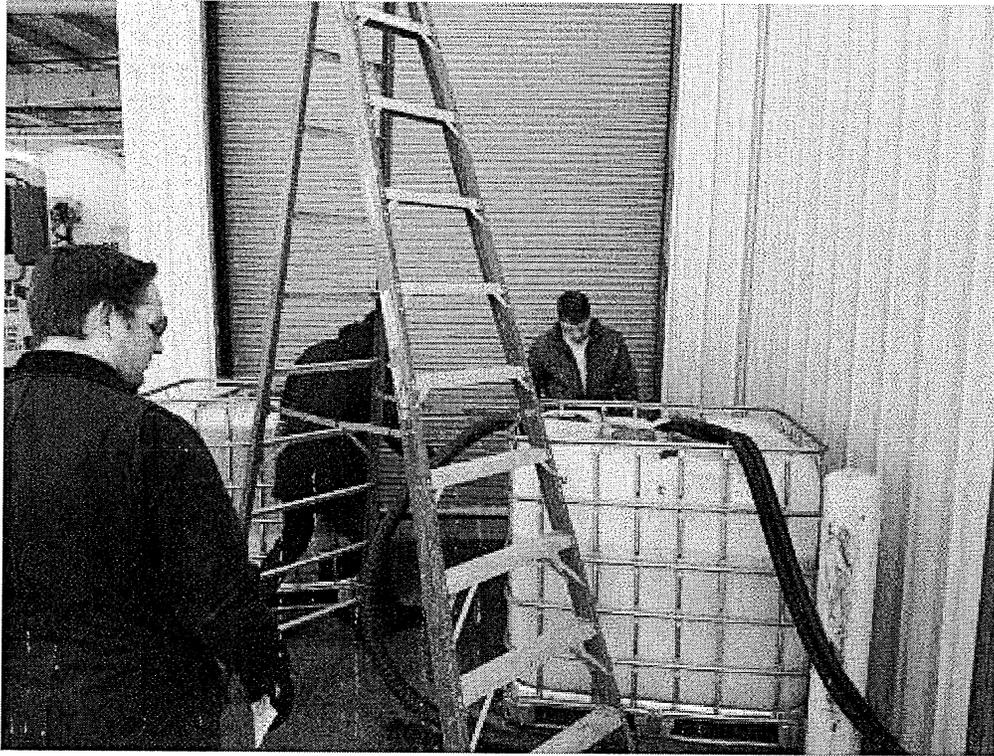
Image 10(Water Tote) : 300 gallon water tote. Note the 2 rubber hoses on the right entering the top of the tote. They contained methanol vapor.
