DEPARTMENT OF ENVIRONMENTAL QUALITY
AIR QUALITY DIVISION
ACTIVITY REPORT: On-site Inspection

FACILITY: PIDD BROTHERS FARM		SRN / ID: N8264
LOCATION: 5221 SWAN RD, STOCKBRIDGE		DISTRICT: Lansing
CITY: STOCKBRIDGE		COUNTY: INGHAM
CONTACT: Travis Pidd , Partner		ACTIVITY DATE: 05/06/2021
STAFF: Michelle Luplow	COMPLIANCE STATUS: Compliance	SOURCE CLASS: MINOR
SUBJECT: Onsite inspection of permanent storage anhydrous ammonia tank		
RESOLVED COMPLAINTS:

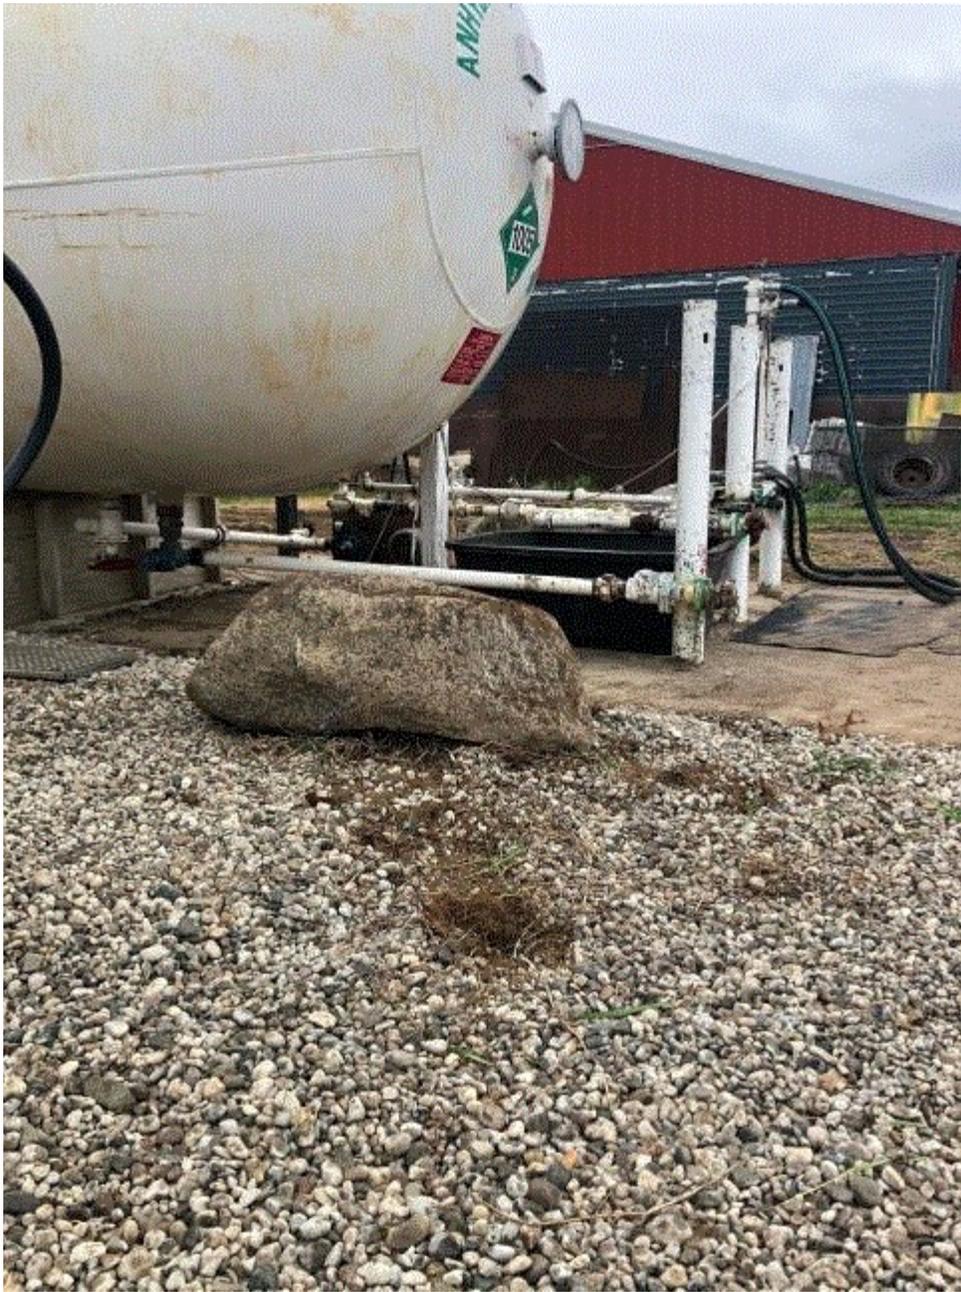
Image 1(Barrier 1) : Barrier installed on north side to protect pipes from accidental damage. Photo Credit: Travis Pidd

- The piping is supported and guards are in place (I consider “guards” as any type of physical barrier that prevents accidental collision of a moving vehicle, etc, with the tank). Physical barriers are present for the tank, but I requested that Pidd Brothers also install physical barriers around the bulkhead for the vapor and liquid transport lines to prevent accidental collisions. T. Pidd followed up with photos 2 days after the inspection, on May 7, 2021, showing the placement of large boulders on either side to protect the bulkhead.

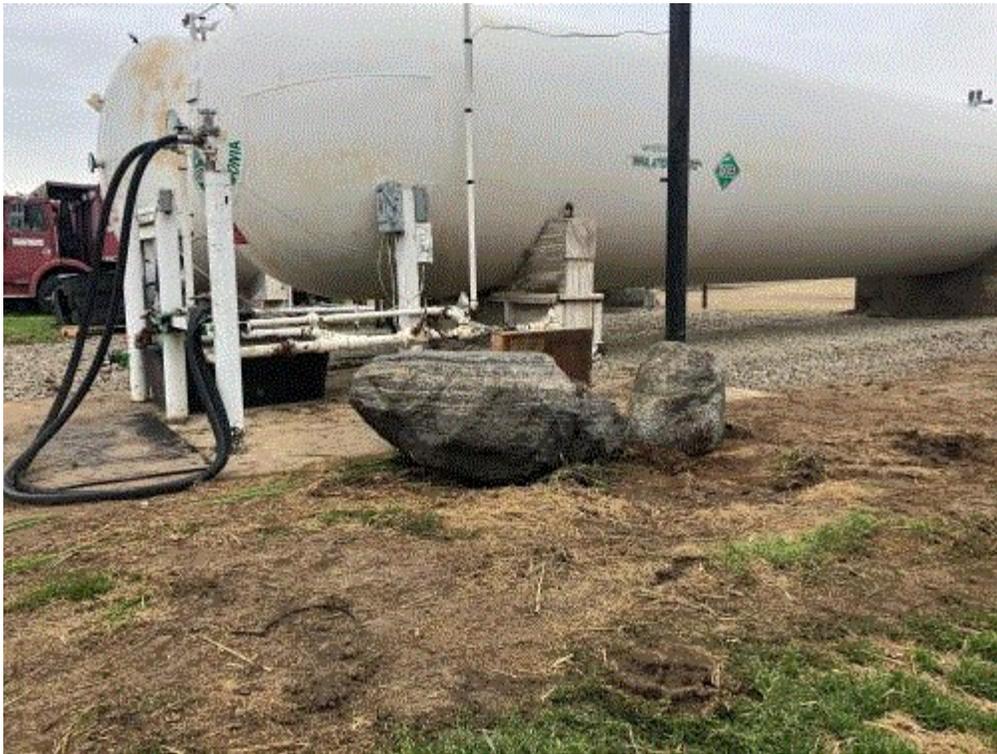
Image 2(Barriers 2) : South side barriers to protect anhydrous ammonia piping from accidental impact. Photo Credit: Travis Pidd

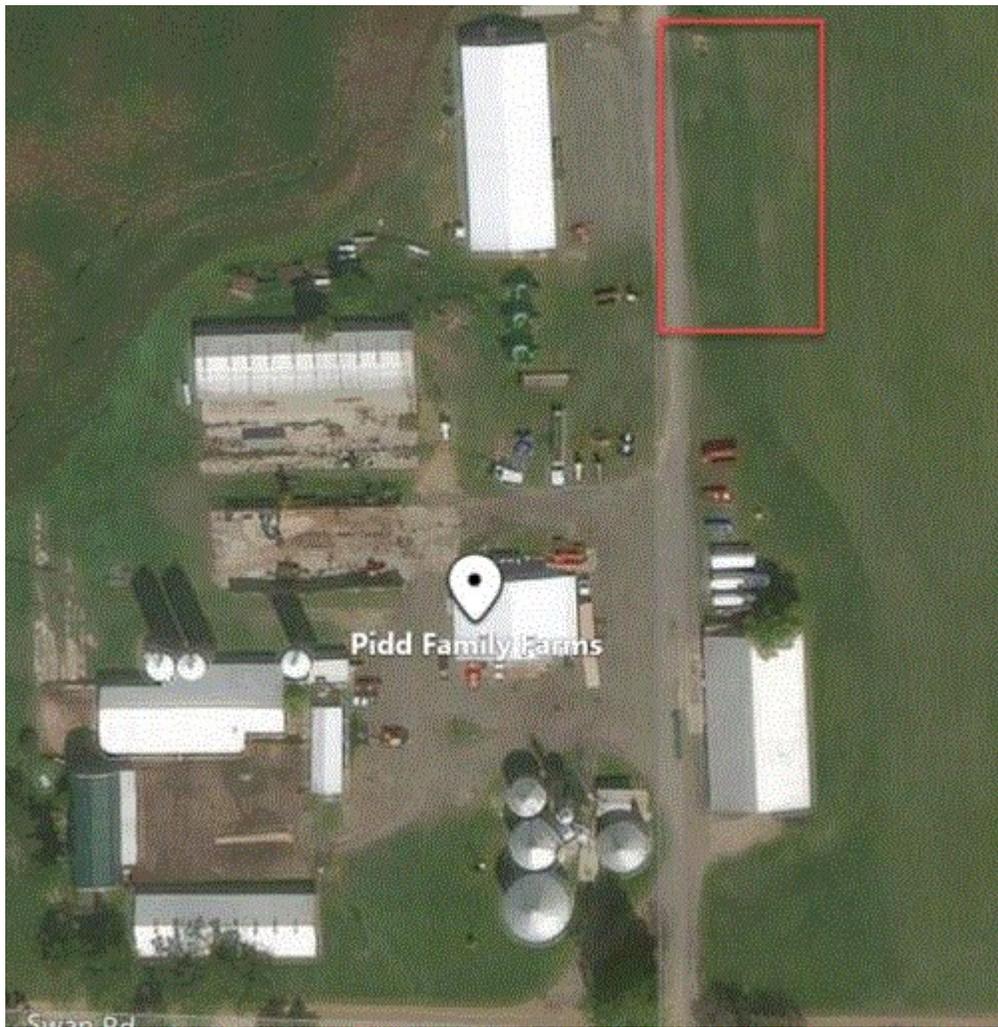
Image 3(Nurse Tank Location) : Red square indicates the general location of where the anhydrous ammonia nurse tanks and applicator tank are stored.

Nurse and applicator tank storage shall be no less than 50 feet from the property line; 150 feet from any existing places of residence or private or public assembly; 250 feet from a school, apartment building or institutional occupancy; and no less than 1000 feet from a hospital or nursing home. I was not able to verify nurse tank storage distances while onsite because the nurse tanks were not onsite during the inspection. The nurse and applicator tank storage area appears to be just north of the permanent anhydrous ammonia storage tank. Pidd Brothers own 1 applicator tank, 2 single nurse tanks, and 2 double nurse tanks. The closest residence, based on the location of the tanks during the inspection, is greater than 700 feet. There are no schools, apartments, institutions, hospitals or nursing homes within the specified distances of the permit.

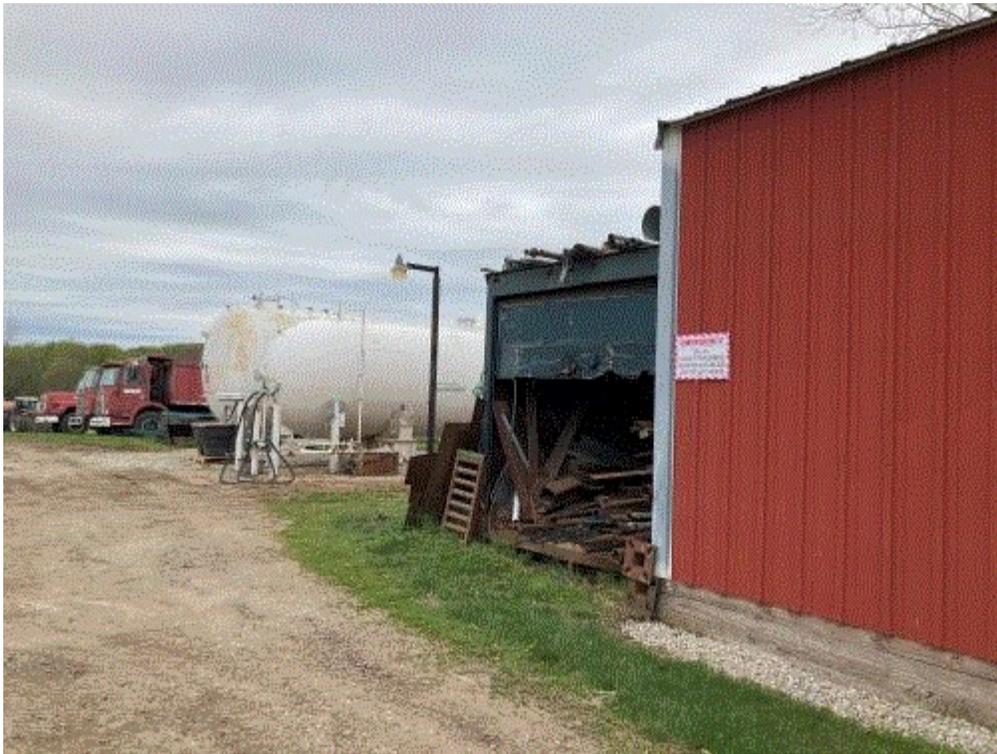
Image 4(Contact sign) : Emergency contact sign located on red barn, south of the anhydrous ammonia tank.

A sign is required to be conspicuously placed at the entrance of the facility with emergency contact information containing the owner, primary operator, local and state police, local fire department and ambulance service. I verified that a sign is conspicuously placed on the barn to the right of the storage tank.

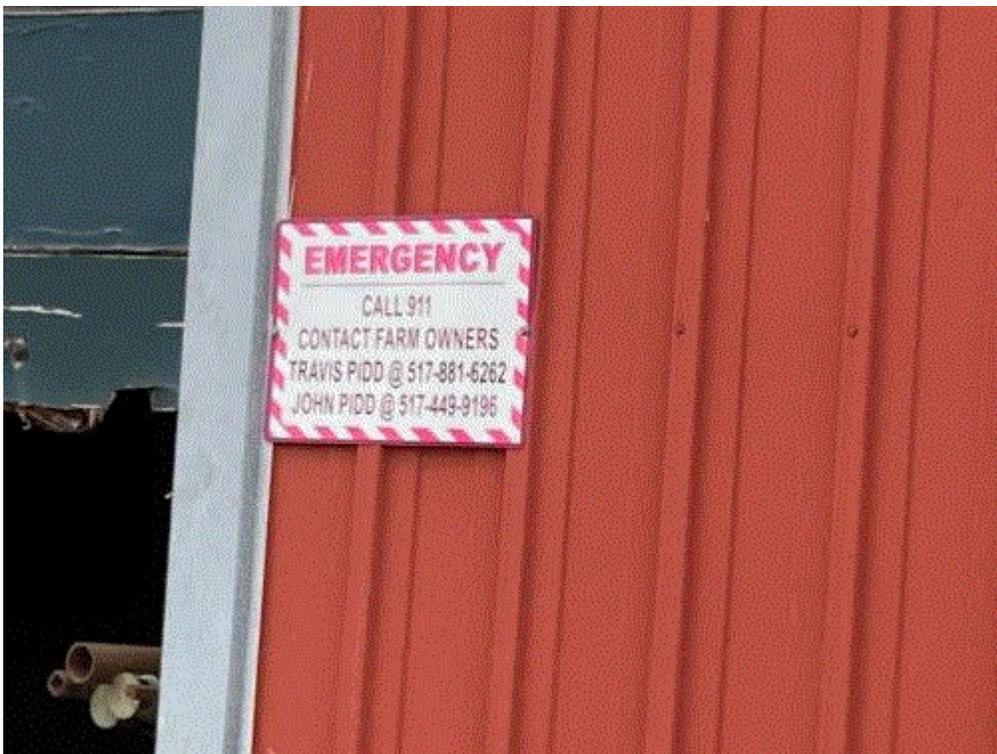
Image 5(Contact Sign Closeup) : Emergency contact information on emergency contact sign.

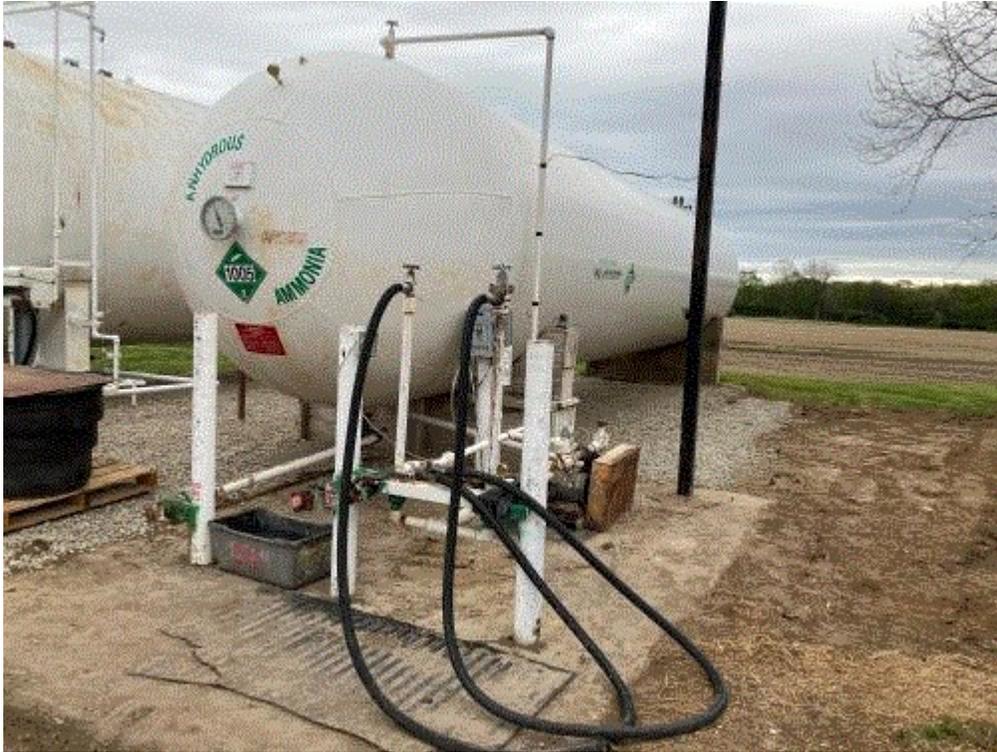
This standard requires the tank to have a reflective surface maintained in good condition. White or other colors with similar reflecting characteristics are acceptable. Pidd Brothers has painted the entire tank white and is therefore in compliance with this standard.

According to 6.4.1 the aboveground containers should be reinforced with concrete footings and foundations or structural steel supports mounted on reinforced concrete, and the lowest point of the tank should not be less than 18 inches above ground. Pidd Brothers' permanent storage tank has concrete footings and foundations. Additionally, the tank is at least 2 feet above the ground.

Image 6(Tank - full view) : Full view of the permanent storage anhydrous ammonia tank. Area to the right of the tank is where an unpermitted anhydrous ammonia tank (cited for Violation in 2016) has since been removed.

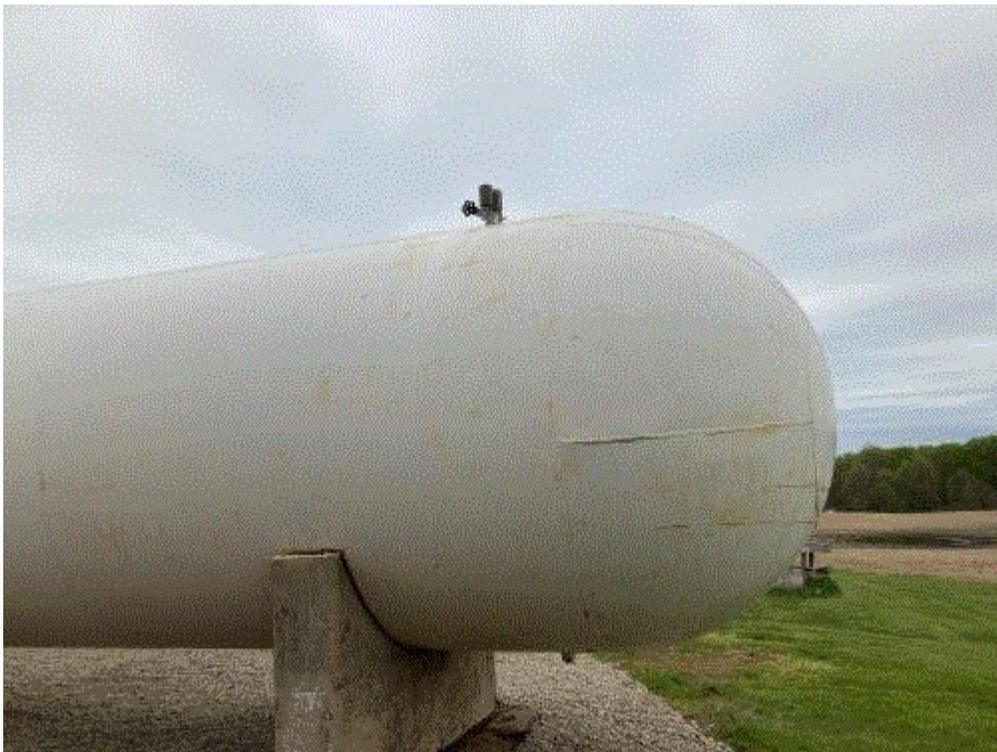
A safety relief valve is required to be installed with a manufacture date stamp so as to establish the replacement date of the valve (permit requires replacement, re-tested or recertified every 5 years). T. Pidd climbed to the top of the tank to take a photo of the manufacture date stamp on the valve. Date stamp read "8/2017." Pidd Brothers will need to replace, retest or recertify this valve by the end of 2022.

Image 7(Safety Relief Valves) : Safety Relief "pop-off" valves located on top of tank to the rear.

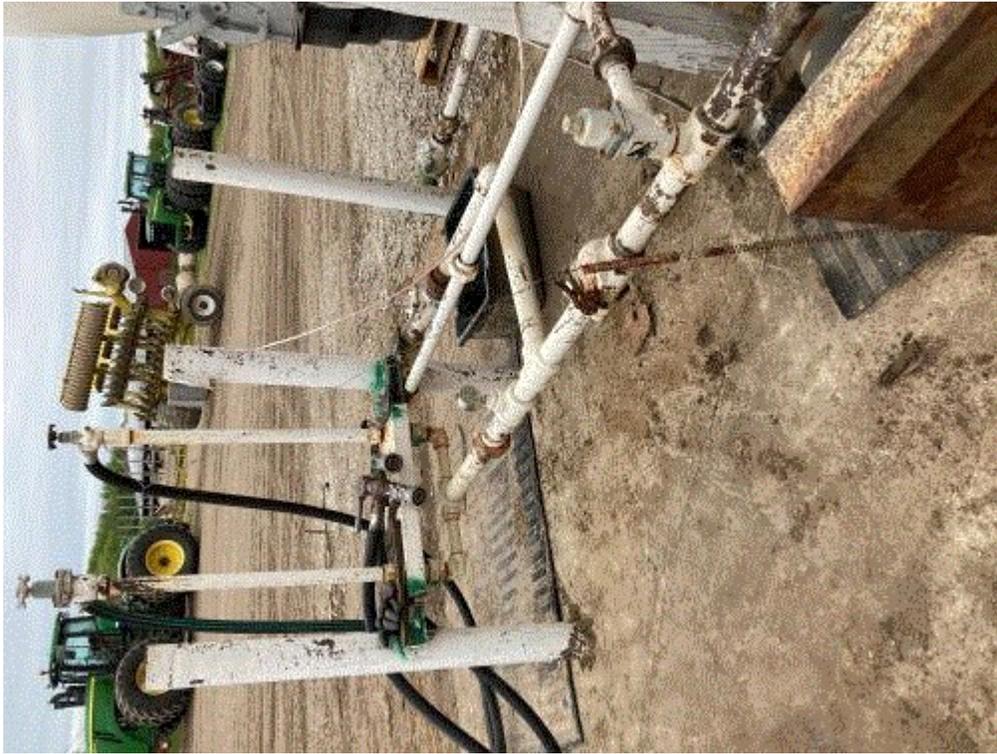
A remotely operated internal or external positive shut-off valve must be installed to allow for emergency shut-off of all flow from the permanent storage tank. T. Pidd showed me the remotely-operated shut-off valve mechanism that shuts off the flow in the liquid lines in the event of an emergency. The device operates using a series of springs and wires that are attached to the liquid lines post-bulkhead. It appears, based on the set-up of the system, that the liquid line valve will trigger to shut off if one of the vapor or liquid lines is ripped from off the bulkhead. I expressed my concerns with this setup. T. Pidd said that he was considering replacing this remote shut off valve with an upgraded version, similar to the one they have set up on their propane tank, which can be activated at the rear of the tank instead of near the vapor, liquid, and delivery lines. I recommended that they proceed to replace the existing external shut off system with something improved. T. Pidd said he would work on getting a new system installed this summer.

Image 8(Emergency shut off) : Remotely operated emergency shut-off system. Note: wire T's at the two lines on the bulk head, runs back to a spring system which is hooked to a lever-action valve.

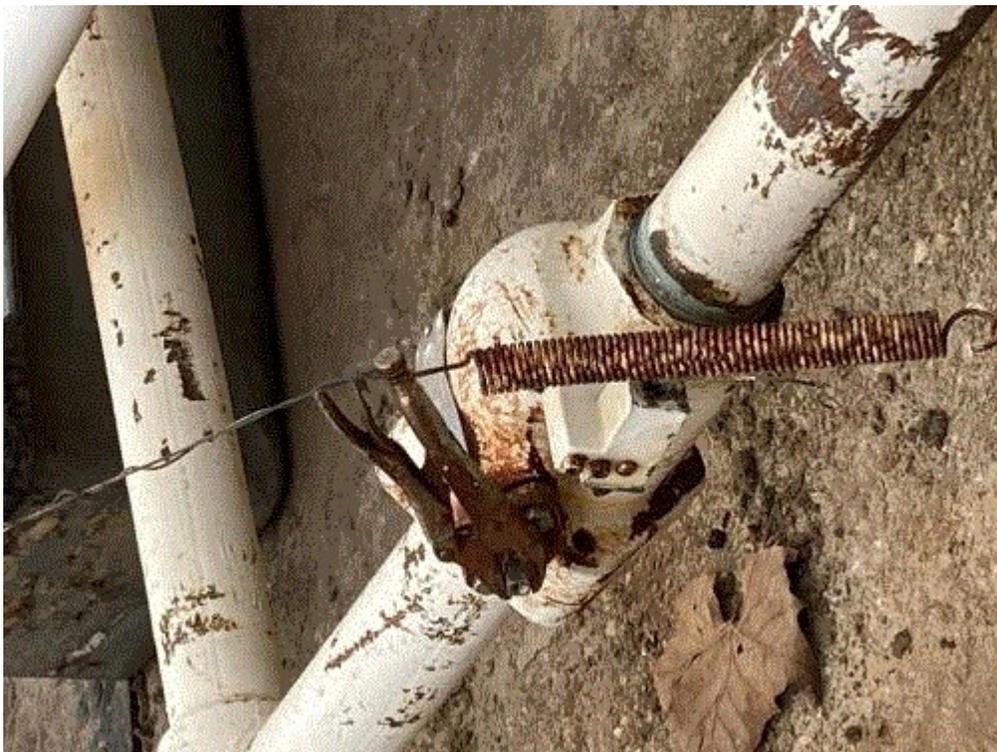
Image 9(Close-up Shut off) : Close up of the hand level that, when triggered by the spring system, can shut off flow to the liquid lines.

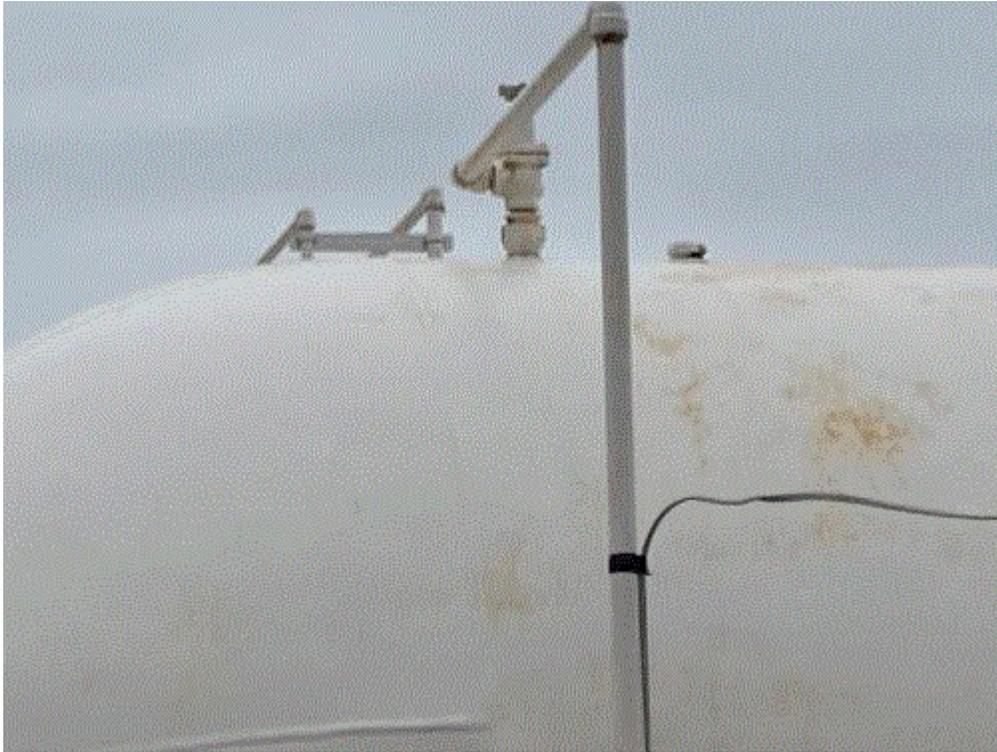
Vapor return lines are required to be employed when necessary to ensure an accidental release will not occur from the pressure relief valves during ammonia transfer operations. T. Pidd showed me the vapor return line on the tank, which connects to the delivery truck and runs up the side of the tank to the top to ensure vapor pressure is balanced.

Image 10(Vapor Return Line) : Vapor return line runs vertically up the side of the tank to ensure vapor equilibrium during transfers.

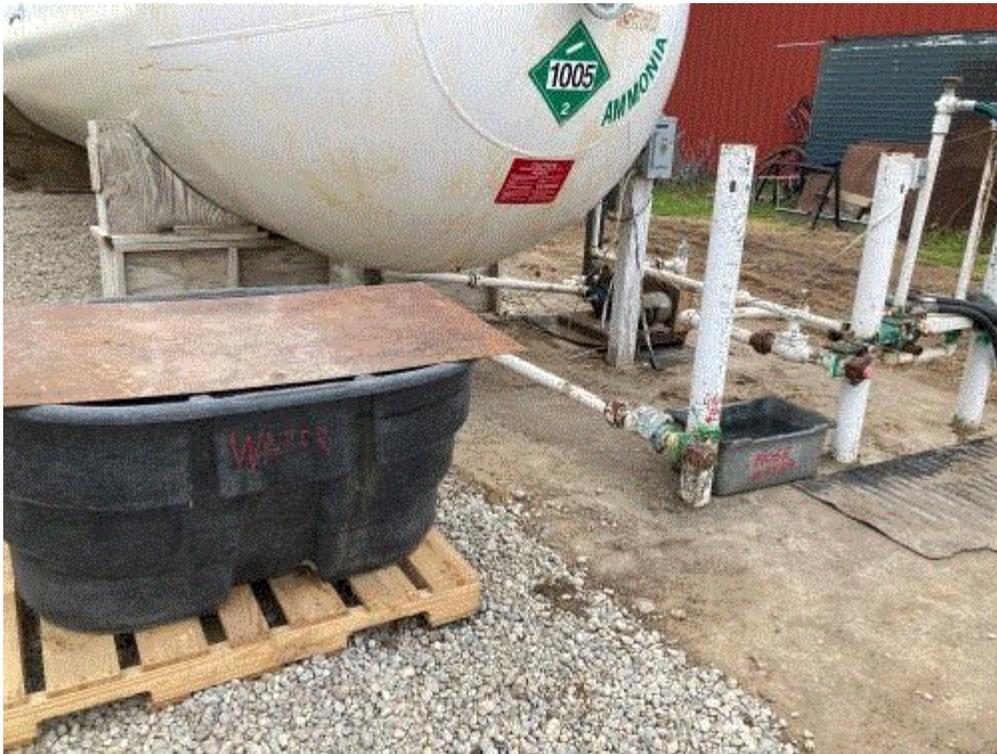
During the inspection, T. Pidd showed me a box located between the anhydrous ammonia and propane tanks that contained chemical splash goggles and gloves. He informed me that he would order the gas masks designed for anhydrous ammonia, as the masks they had onsite were rated for ammonia, but did not have canisters. A 100-gallon emergency water tub is kept nearby to be used in the event of an emergency.

Image 11(Emergency water tub) : T. Pidd moved this tub to a location further away than the location pictured here. This was done per my recommendation to ensure, in the event of an emergency, those impacted would be away from the source of the hazard.

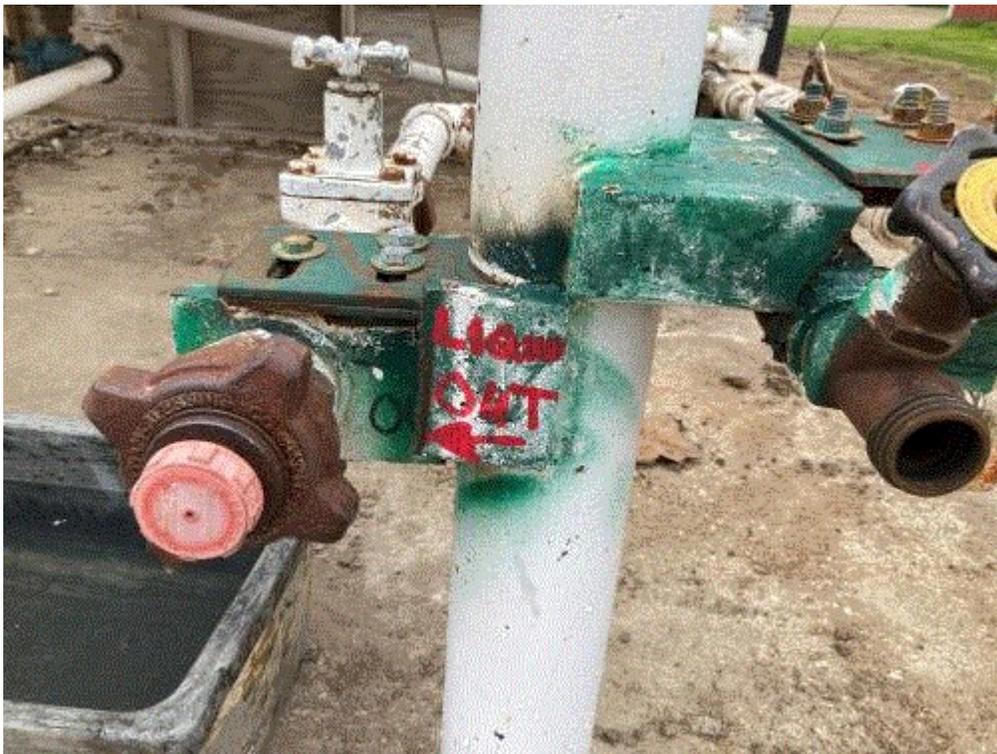
This condition requires that a bulkhead, anchorage, or equivalent system be used at the transfer area so that any break resulting from a pull will break at a predictable location while leaving valves and piping on the tankside of the transfer area intact. There is a bulkhead present through which the liquid and vapor lines run and through which the nurse tanks are filled and the permanent storage tank is filled. It appears that additions to the original bulkhead were made to ensure the "liquid out" line was supported by the bulkhead, as well as the vapor return line. These lines appeared to stand on their own, without anchorage to a bulkhead or other support until the additions were made. Pidd Brothers' is in compliance with this condition.

Image 12(Bulkhead Mods) : Modifications to bulkhead to ensure that, for example, the "Liquid Out" line was

attached to the bulkhead rather than freely hanging - this is to ensure a predictable break point in the event there is a pull-away break.

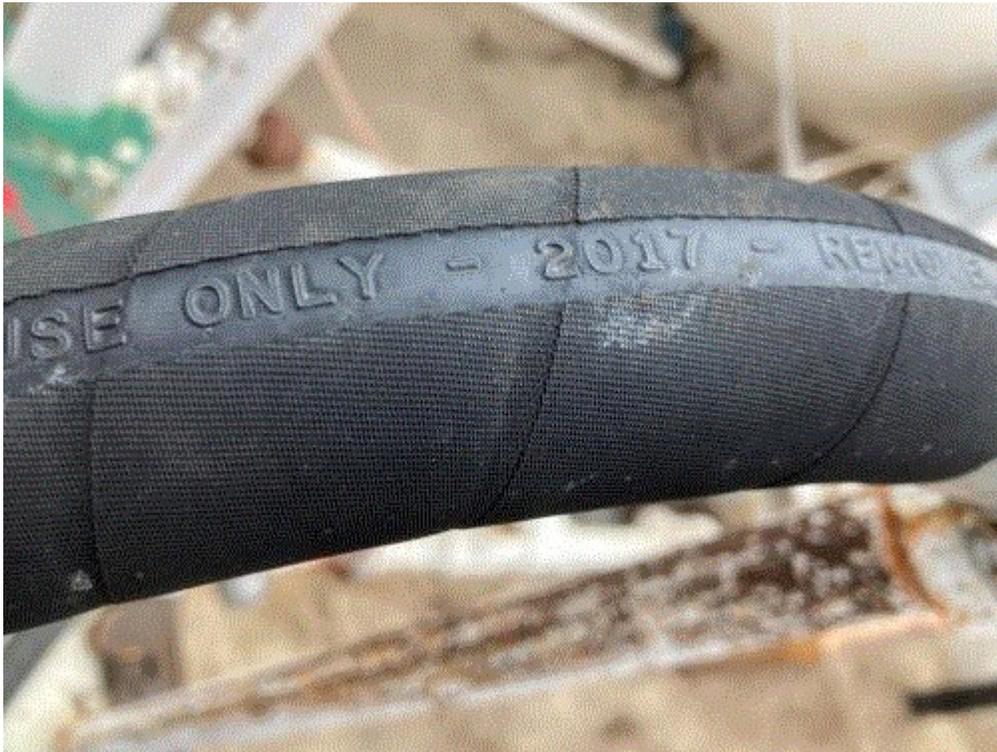
Hoses are required to be replaced 5 years after the date of manufacture or more often if there is evidence of damage or deterioration. T. Pidd had 2 hoses attached to the bulkhead lines during the inspection. He stated that these hoses stay attached to the tank year-round. There were no signs of damage or deterioration were present. Both hoses were dated 2017. Hoses should be replaced by the end of calendar year 2022 to meet the 5-year replacement date.

Image 13(Hose Date) : 2017 manufacture date on one of the permanent storage tank hoses.

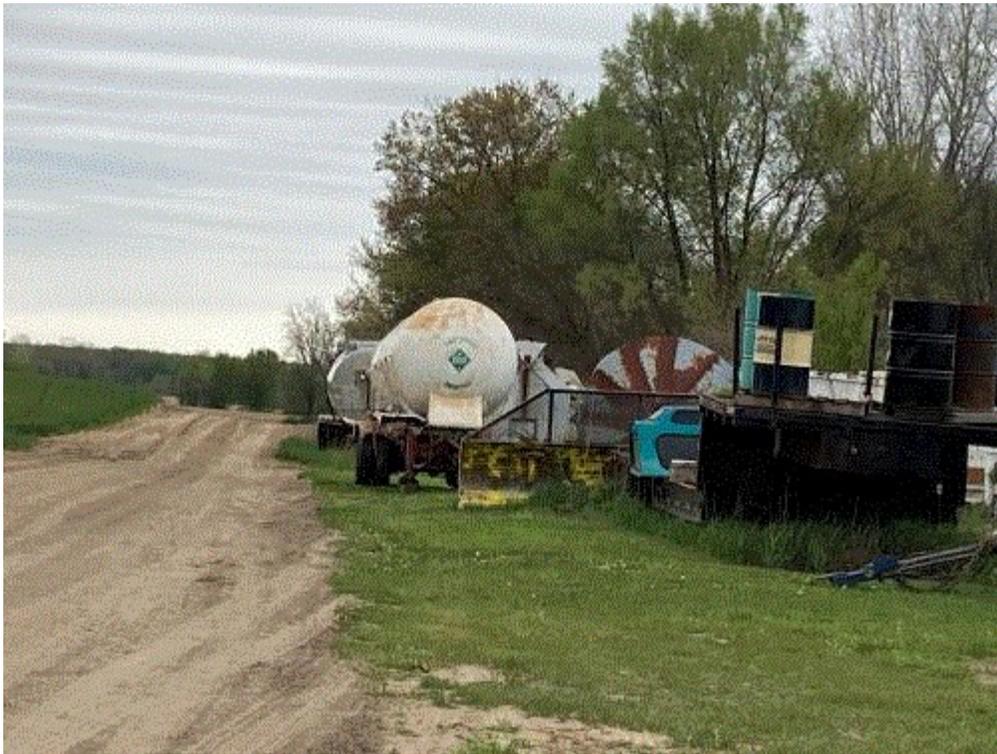
Pidd Brothers owns 2 permanent storage anhydrous ammonia tanks. One is installed, the other is currently on a trailer until Pidd Brothers can submit an application to install this additional permanent storage tank. T. Pidd said that they are currently working on the application for this unit. Pidd Brothers owns 2 single nurse tanks, 2 double nurse tanks, and 1 applicator tank. They currently only have a spring planting season that typically starts in April. T. Pidd said that this year's spring planting season began on April 15, 2021.

Image 14(Other Tank) : Photo - center is another anhydrous ammonia storage tank on a trailer. This tank was removed from its location as the result of the R 201 violation in 2016.

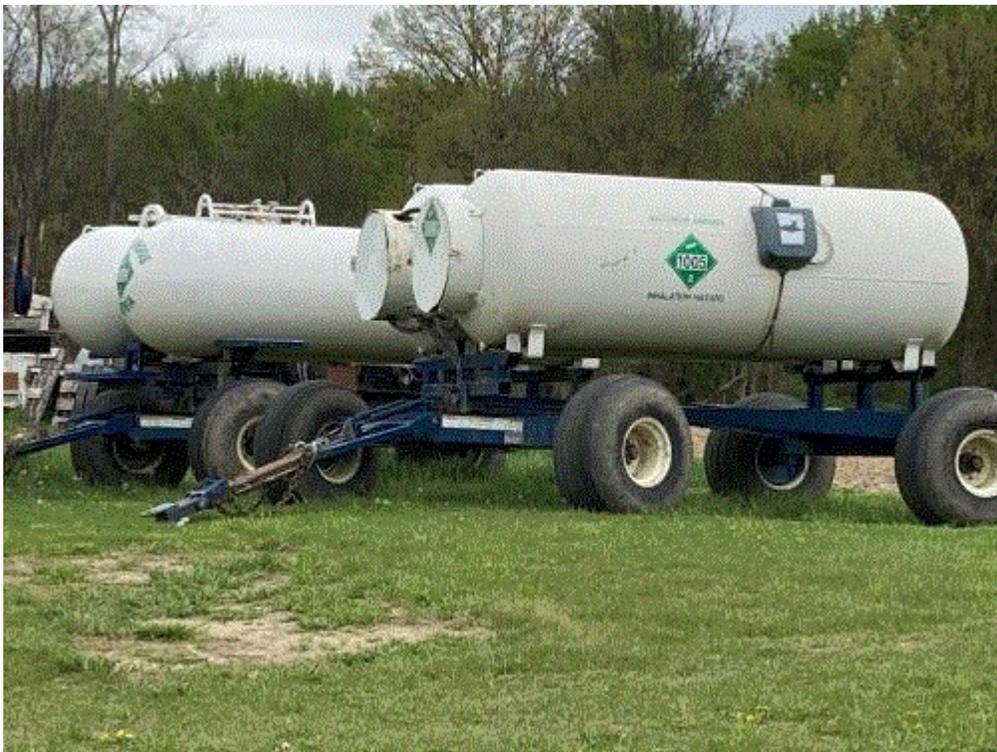
Image 15(Double Nurse Tank) : Double nurse tanks onsite.

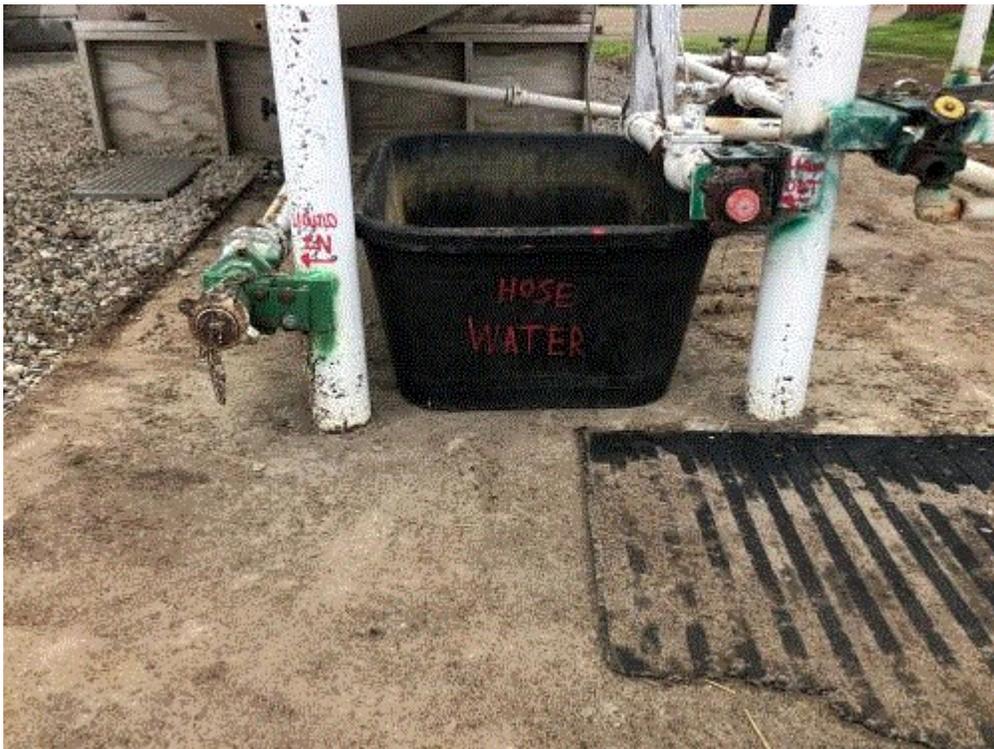
All vapor or liquid lines required to be vented after anhydrous ammonia transfer are to be vented into 55 gallons minimum of water. Pidd Brothers has vapor and liquid lines that, during the inspection, were noted to vent to a 5-10 gallon tub. I pointed out to T. Pidd that the minimum size of this tub must be 55 gallons. After the inspection, on May 7, 2021, T. Pidd sent me photos showing me that Pidd Brothers switched out the small tub to a larger tub that meets the 55-gallon requirement.

image 19(Replacement Tub): Tub replaced on 5/7/21 to 55 gallons from the 5-10 gallon tub onsite during inspection. Tub is used for bleeding off lines after transfer. Photo Credit: Travis Pidd
