**DEPARTMENT OF ENVIRONMENTAL QUALITY
AIR QUALITY DIVISION
ACTIVITY REPORT: Scheduled Inspection**

P010350236

FACILITY: Stoneco of Michigan (formerly CYDI)		SRN / ID: P0103
LOCATION: 3275 N. Martin Luther King Jr. Blvd., LANSING		DISTRICT: Lansing
CITY: LANSING		COUNTY: INGHAM
CONTACT: Dave Ward , Operations		ACTIVITY DATE: 08/21/2019
STAFF: Michelle Luplow	COMPLIANCE STATUS: Compliance	SOURCE CLASS: MINOR
SUBJECT: Scheduled, unannounced inspection to determine compliance with PTI 87-10, particularly with fugitive dust control requirements and the coal emergency response plan.		
RESOLVED COMPLAINTS:

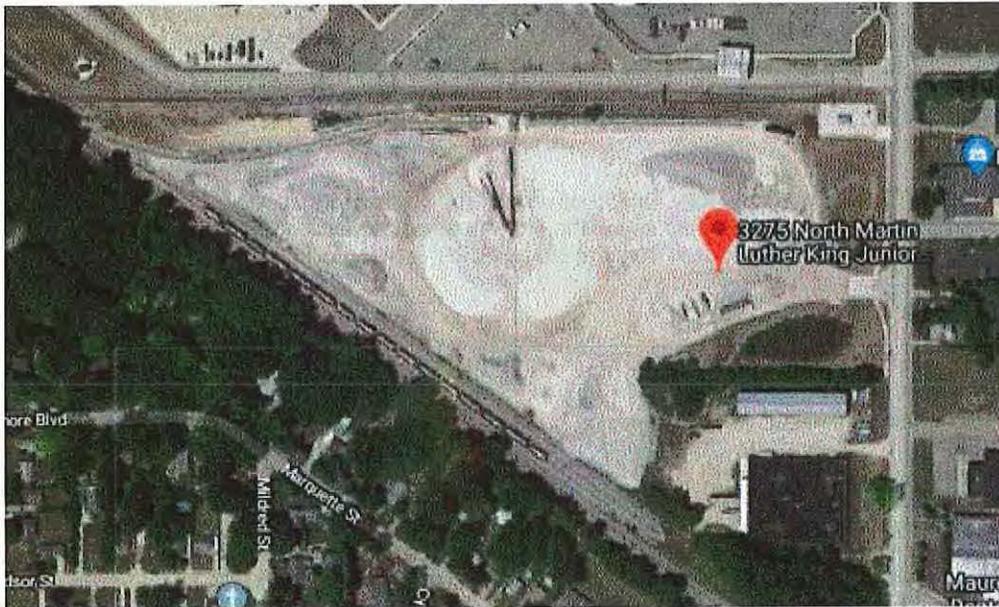
Image 1(Aerial View) : Google Satellite imagery shows there are no longer any coal piles at this facility.

As stated in the Facility Background description, Stoneco no longer handles coal, thus the Emergency Response Plan and any permit requirements associated only with coal handling are no longer applicable. While touring the site I noted very sparse areas of residual coal ground into the unpaved areas near some of the limestone aggregate piles. Attached are photos of the plant yard where residual coal is present and where I believe part of the unpaved yard roadways are tainted with residual coal. We walked around the plant yard and saw no coal piles. Additionally, Google aerial maps show that there are no coal piles (compared to Brian Culhams internet aerial photos of the coal piles in 2012).

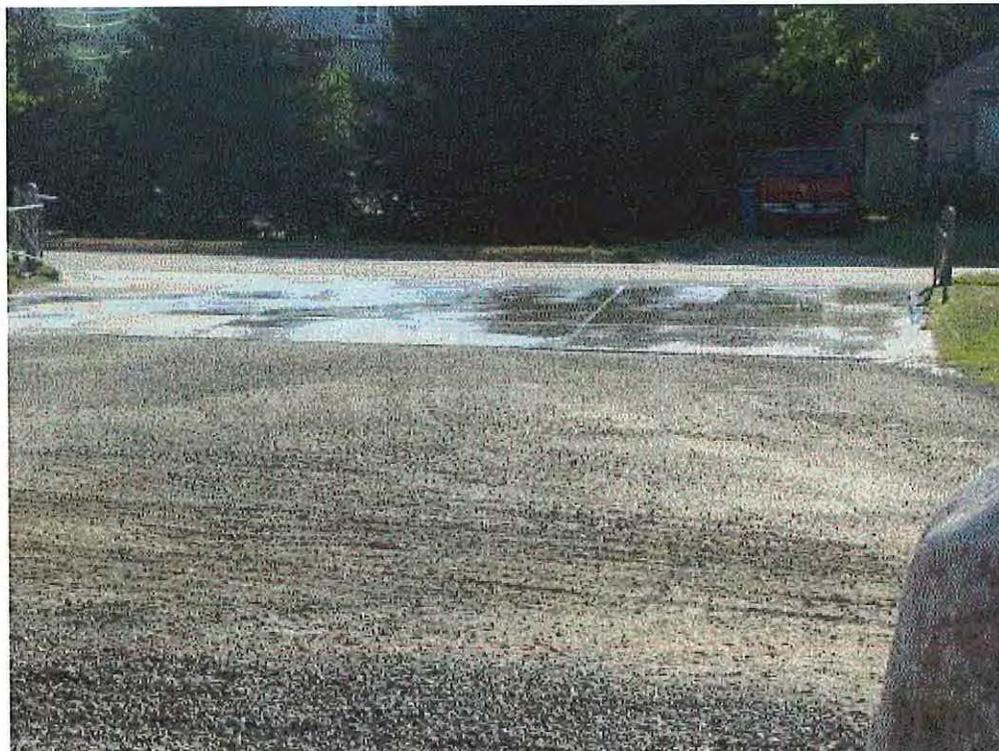
Image 2(Paved Entry) : Paved entryway wetted/controlled for dust - sprinkler systems used

D. Ward said that the paved portions of the road are watered down with a loader bucket to wash the paved entry roadway, and wash all dust to the sides of the property on a daily basis. In addition to this, Stoneco installed a sprinkler system at the paved entryway last year, and began operating it this year. D. Ward said he turns the sprinkler system on when the road is getting dry in order to keep the dust down. He explained that he used to sweep it but found that water is more effective and so now only uses water. He turned on the sprinkler system to show us that it covers the entire paved roadway (with sprinklers on both sides of the road). Although they do not sweep, it appears based on this inspection, that the processes D. Ward is using to control dust on the paved roadway is preventing trackout onto MLK Blvd, in addition to controlled the dust onsite. Historically, AQD has received complaints of dust track out onto MLK, but during this inspection the paved road was well maintained (free from dust) and there was no trackout onto MLK (see attached photos).

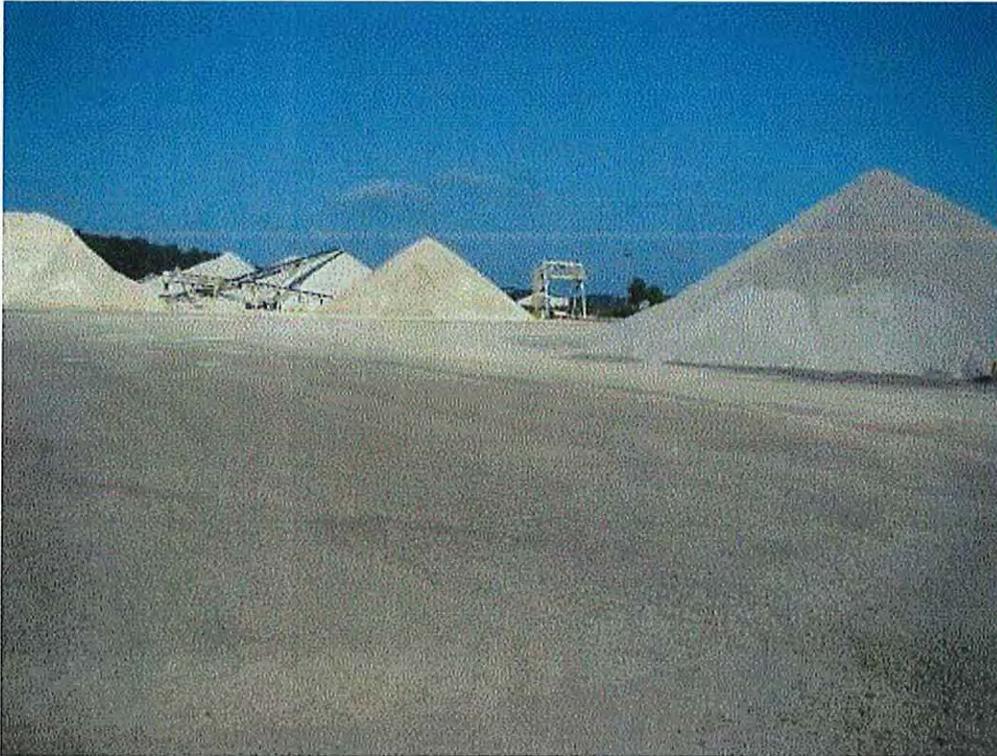
Image 3(Storage Piles) : aggregate storage with crushed limestone unpaved yard

The crushed limestone/unpaved roadways and plant yard were also well maintained. Even with truck traffic, I saw no signs of opacity, or if there was opacity, it did not exceed any of the opacity limits within the PTI. D. Ward said that the entire plant yard is controlled with calcium chloride. He said that they have applied calcium chloride to the yard twice already this year, with the last application being done approximately 3 weeks ago. He said they apply the chloride as needed and may chloride the yard once more before the end of the load-out season.

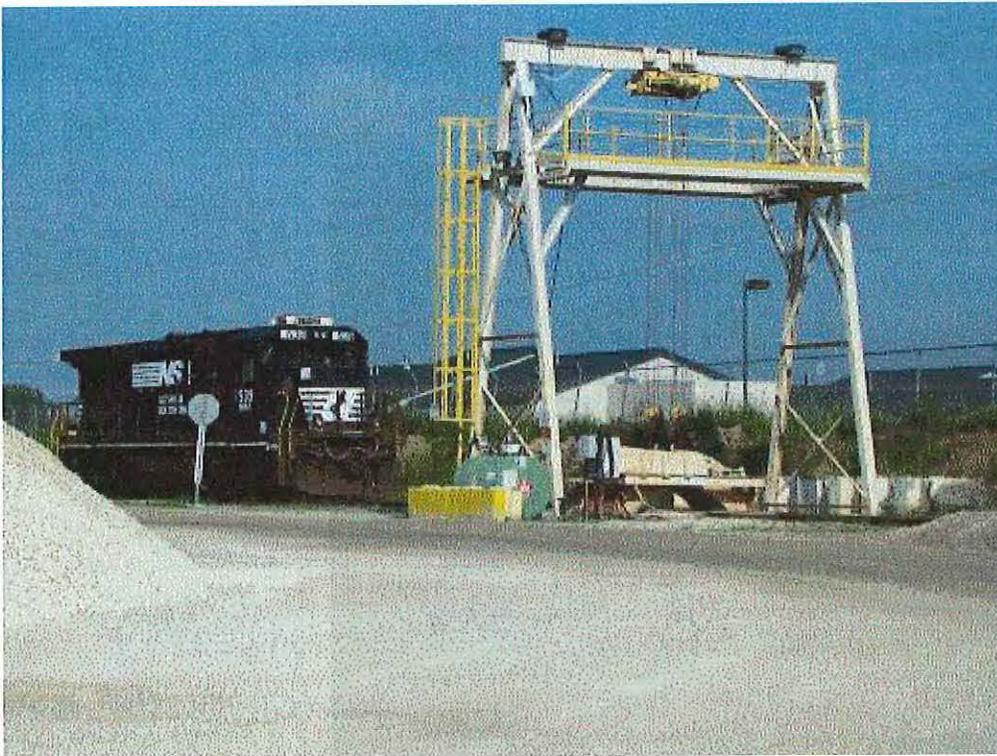
Image 4(Railcar Unloading) : Railcar unloading is hooked up beneath the surface to conveyors that pull material up to stacking conveyors.

EURAILUNLOAD consists of the rail yard, rail and truck receiving, and aggregate loading/shipping, as well as the onsite conveyors used to convey aggregate brought in via railcar to the storage piles. D. Ward said that they may install a stacking conveyor. Installing a stacking conveyor would be exempt under Rule 285(2)(t) (sand, gravel unloading), but I reminded D. Ward that with that install, Stoneco would still be responsible to keep transfer and dropoint opacities to at or less than 10%. If not, the dust will need to be controlled. D. Ward indicated that he understood this requirement.

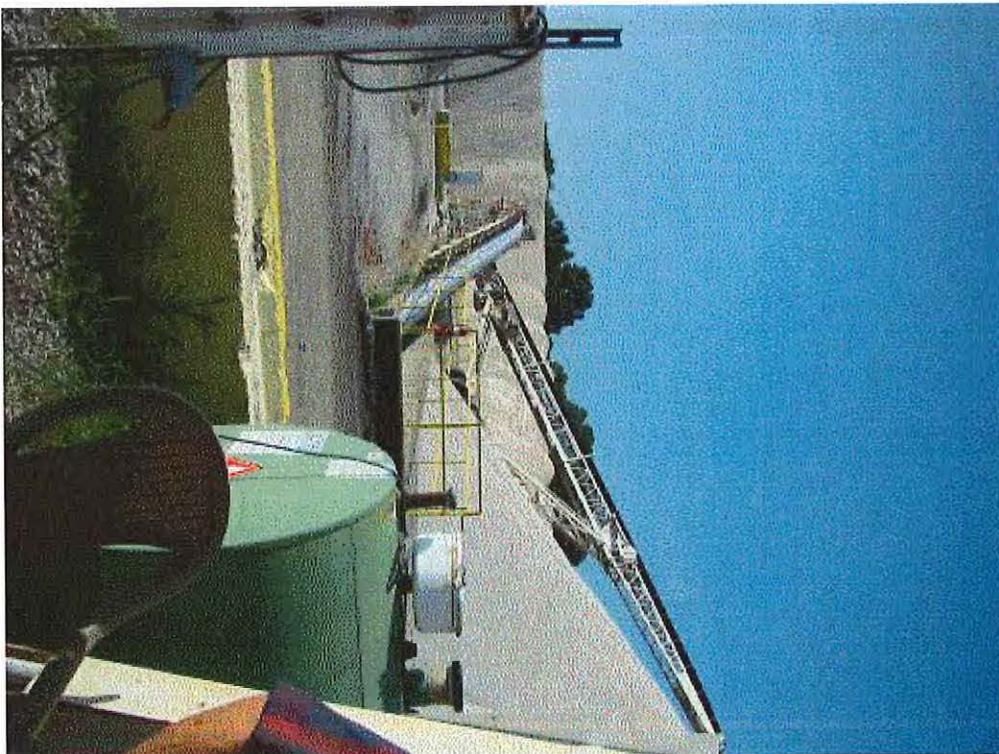
Image 5(Conveyors) : Conveyors coming up from ground to stack material on piles

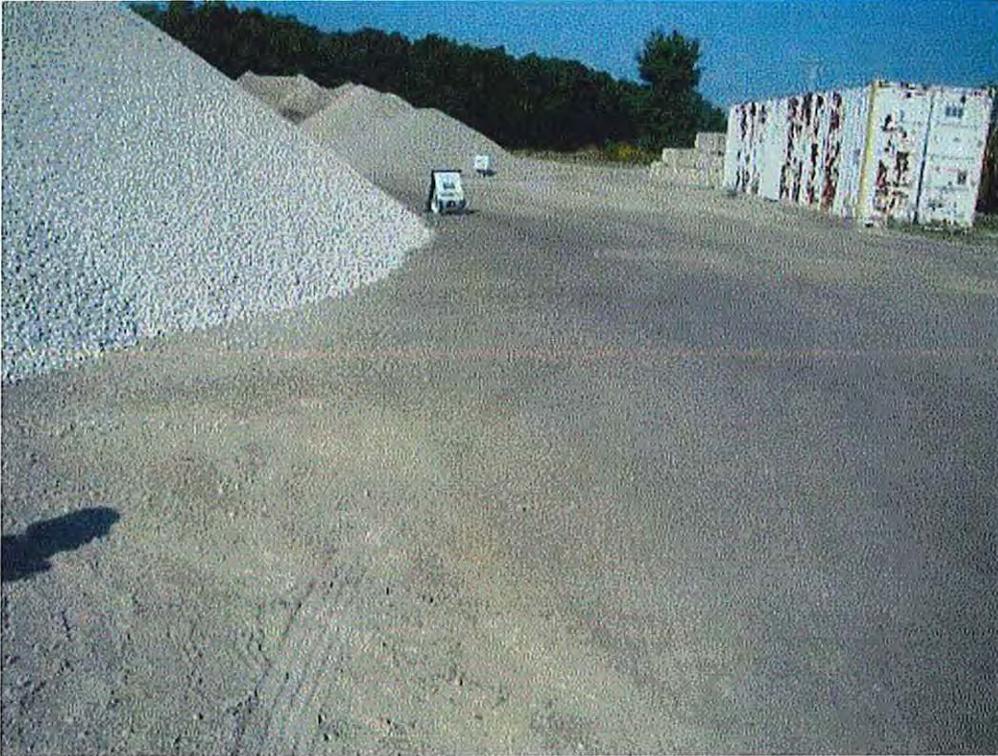
Image 6(Residual coal) : Darker portions of yard are from residual coal

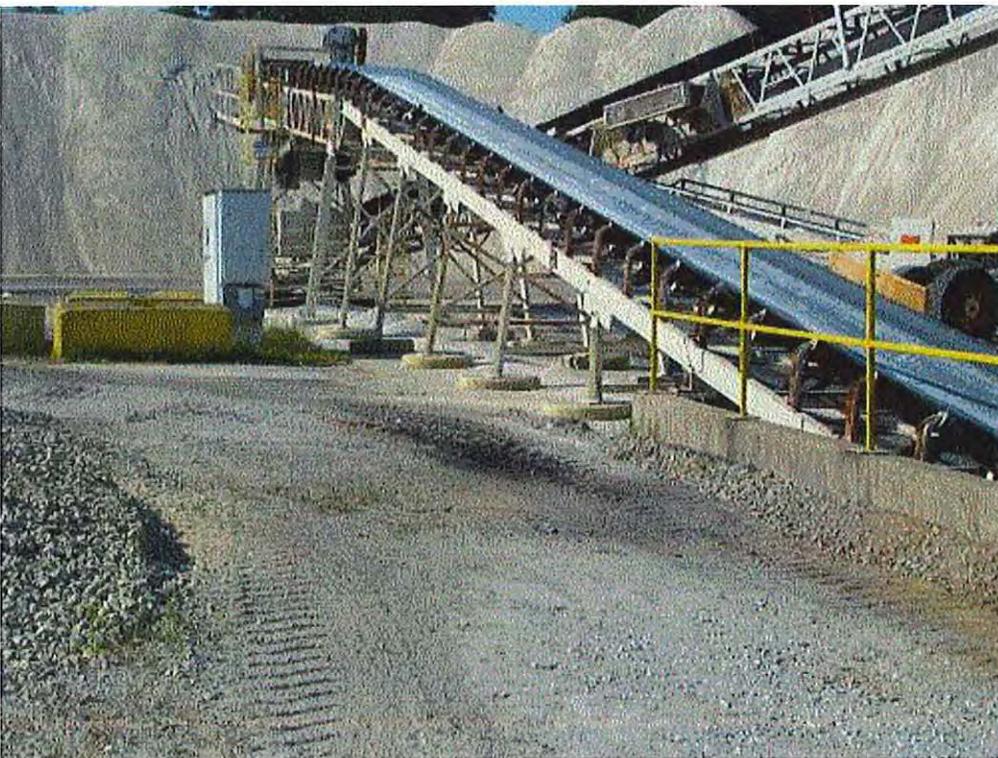
Image 7(Residual Coal #2) : Darker area by conveyor is residual coal from past coal handling activities
