DEPARTMENT OF ENVIRONMENTAL QUALITY
AIR QUALITY DIVISION
ACTIVITY REPORT: Self Initiated Inspection

FACILITY: DEXTER STAMPING COMPANY, LLC		SRN / ID: P0398
LOCATION: 1013 THORREZ ROAD, JACKSON		DISTRICT: Jackson
CITY: JACKSON		COUNTY: JACKSON
CONTACT: Christopher Trapp , Weld, Controls and Automation Engineer		ACTIVITY DATE: 11/30/2017
STAFF: Mike Kovalchick	COMPLIANCE STATUS: Compliance	SOURCE CLASS: MINOR
SUBJECT: Inspection of a stamping plant.		
RESOLVED COMPLAINTS:

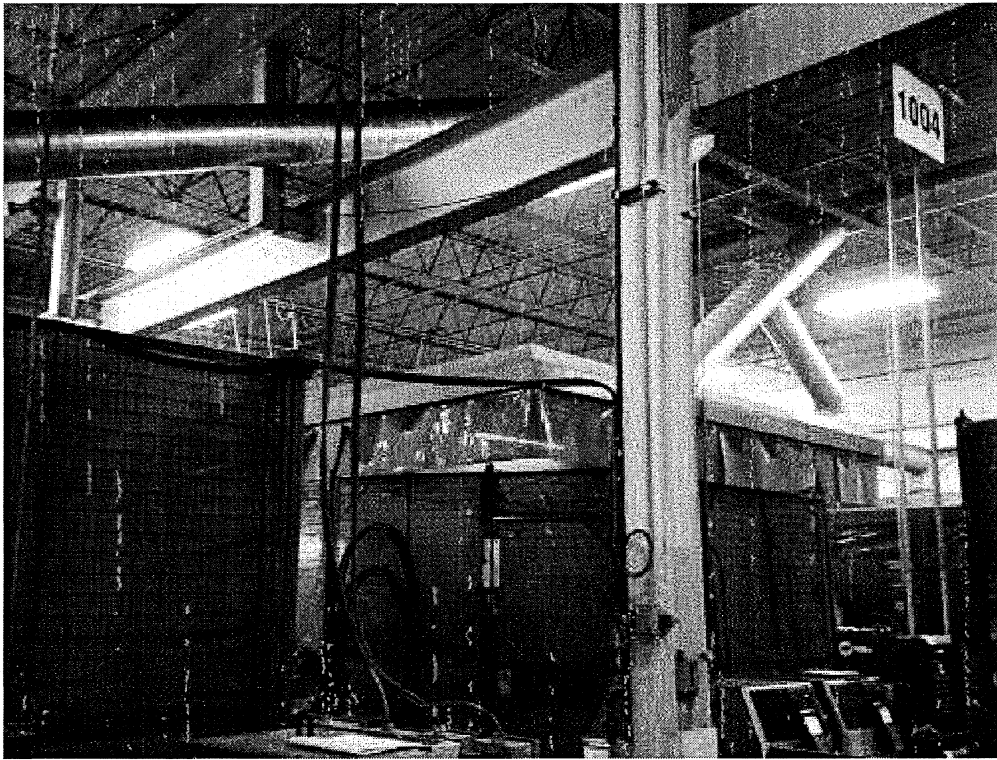
He first showed me the robotic MIG welding stations. The booths were fully enclosed and exhaust outside. A check inside the booth showed that it appeared to be spot welding with only brief periods of smoke being generated. (See attached photos.)

Image 2(MIG welding) : MIG welding booths with exhaust stacks.

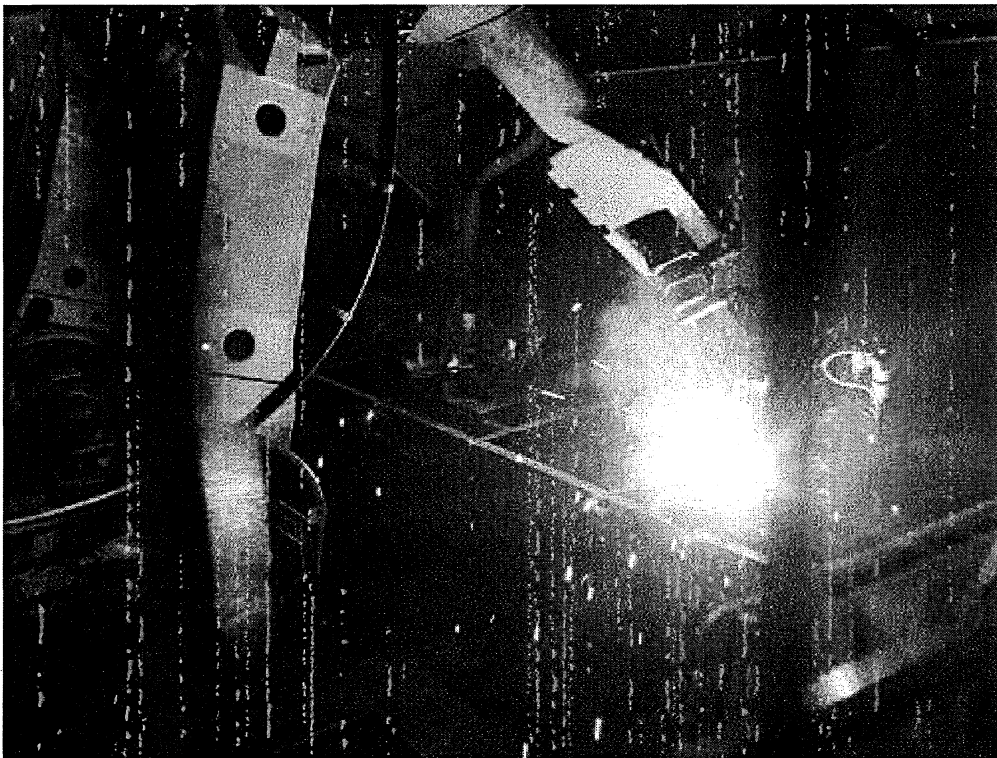
A roof inspection was not conducted due to bad weather. Based on the small amount of smoke generated inside the MIG welding booths, it appeared that opacity would not be an issue in the exhaust stacks on the roof.

Image 3(MIG welding) : Inside MIG welding booth.

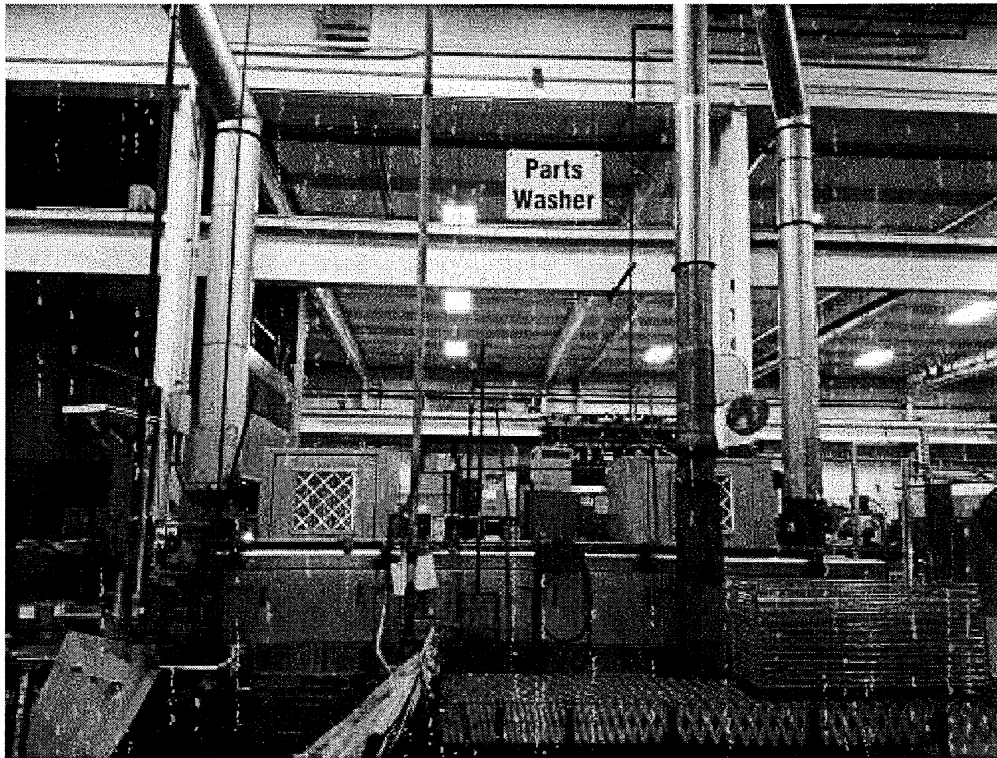
We walked past some stamping presses and then observed the parts washer near the back of the building. It appeared to have a couple of exhaust stacks for the steam/vapor. (See attached photos.)

Image 4(Parts washer) : Parts washer using steam and detergent.

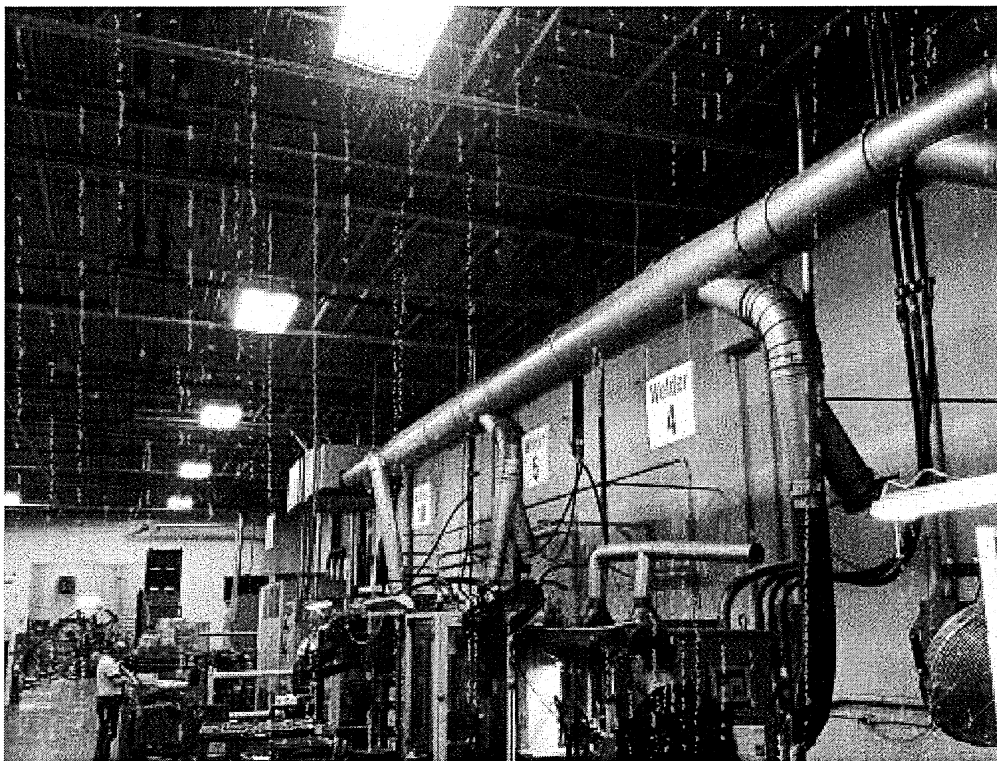
Finally, we observed the resistance welding stations. Emissions from these stations were ducted to 3 or 4 Smog Hog type dust collectors that do not vent externally. (See attached photos.)

Image 5(Resistance welding) : Resistance welding stations and ventilation ducts.
