DEPARTMENT OF ENVIRONMENTAL QUALITY
AIR QUALITY DIVISION
ACTIVITY REPORT: On-site Inspection

FACILITY: WEBER SAND & GRAVEL INC.-NORTH BRANCH		SRN / ID: P0539
LOCATION: 4242 Fish Lake Road, NORTH BRANCH		DISTRICT: Lansing
CITY: NORTH BRANCH		COUNTY: LAPEER
CONTACT: Gregg Weber , President		ACTIVITY DATE: 06/21/2023
STAFF: Daniel McGeen	COMPLIANCE STATUS: Non Compliance	SOURCE CLASS: MINOR
SUBJECT: Unannounced inspection, conducted in response to a fugitive dust complaint received the previous day.		
RESOLVED COMPLAINTS: C-23-01540

On June 21,2023, the Michigan Department of Environment, Great Lakes, and Energy (EGLE), Air Quality Division (AQD), conducted an unannounced inspection of Weber Sand & Gravel Inc. - North Branch, a portable non-metallic mineral processing plant with State Registration Number P0539. The inspection was in response to a complaint received on 6/20, discussed below:

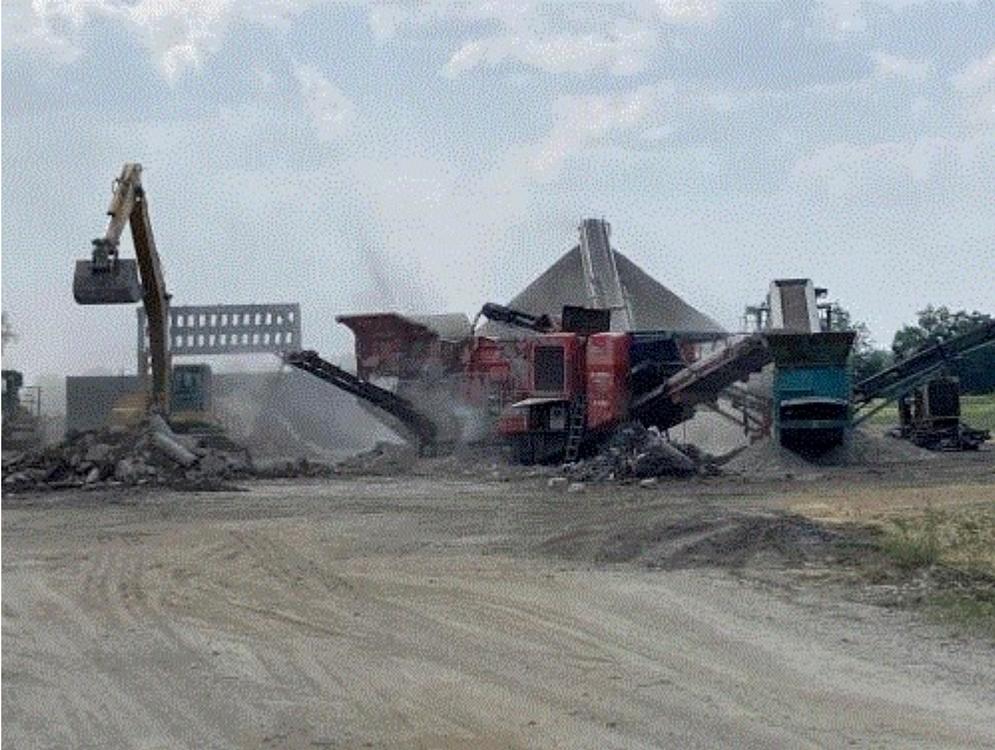
Image 1(1) : Overall view of plant.

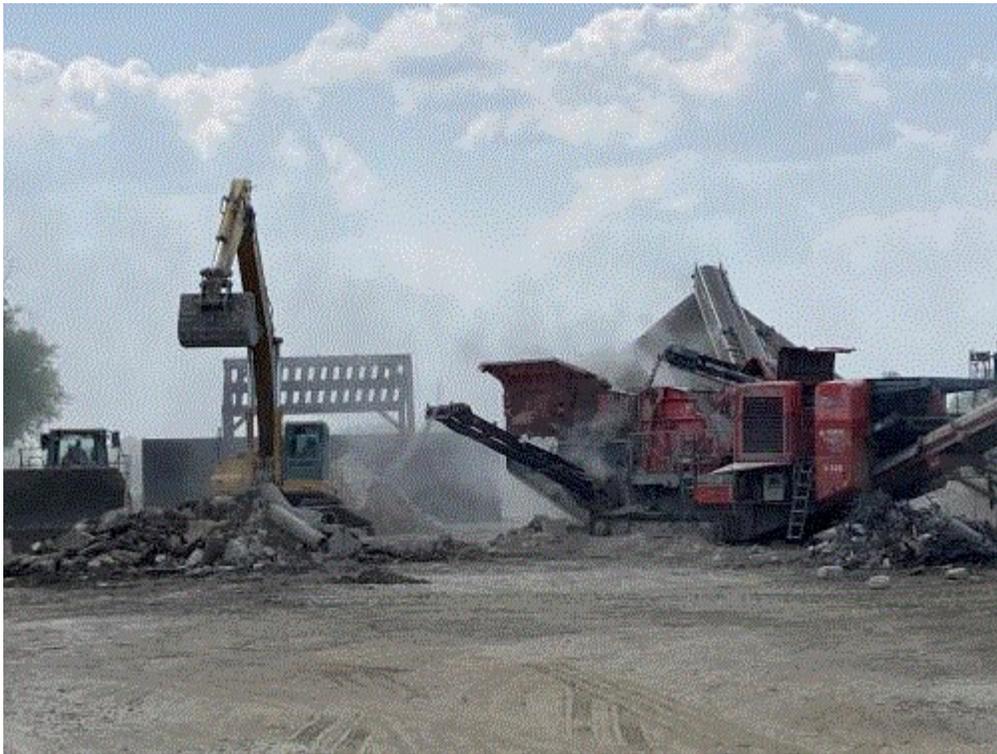
No water was in use for the plant, and opacity was excessive, on a fairly steady basis. Intermittent opacity was also excessive for front end loader traffic.

Although the plant finished all production at the site before D. McGeen could conduct Method 9D visible emission readings, numerous photos were taken, which showed frequent instances of excessive fugitive dust from parts of EUPROCESS. No violations of opacity limits were confirmed, however, due to the absence of actual opacity readings.

Image 2(2) : Dust from Terex Finlay feeder, primary crusher, and side conveyor, identified as ID # TF, TD, and TDS, respectively, in PTI 69-23.

During the inspection, there was no water being used for the crusher, and no water or other acceptable dust suppressant being used for the site itself. This resulted in several instances of noncompliance with PTI 69-23. A VN is being sent, requesting a written response with a corrective action program.

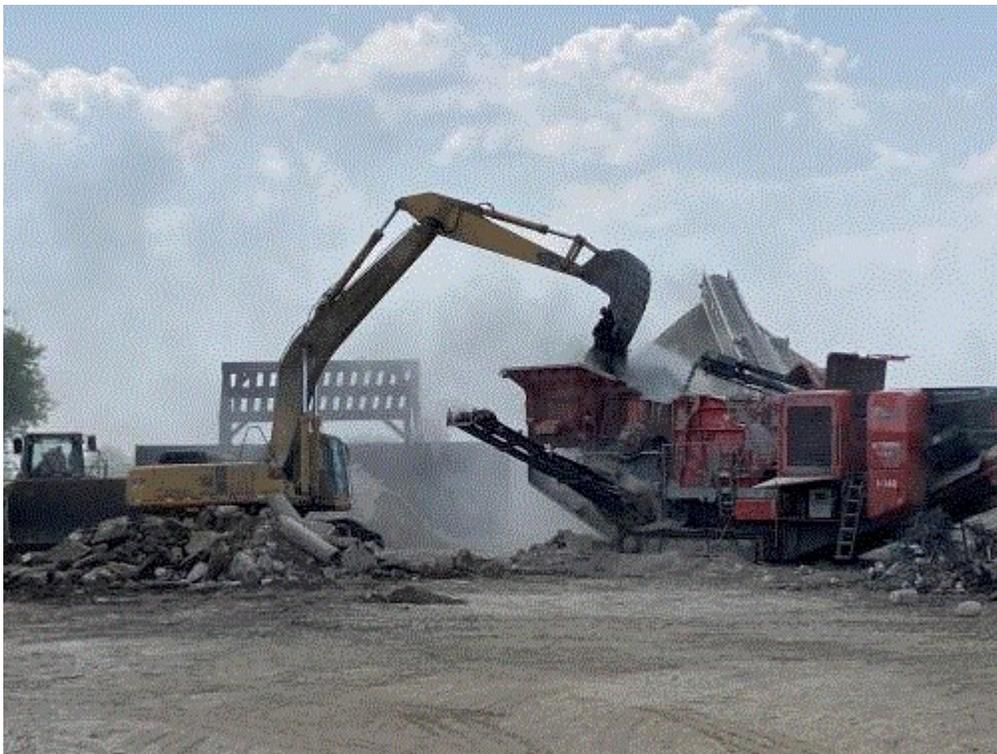
Image 3(3) : Closer view of crusher.

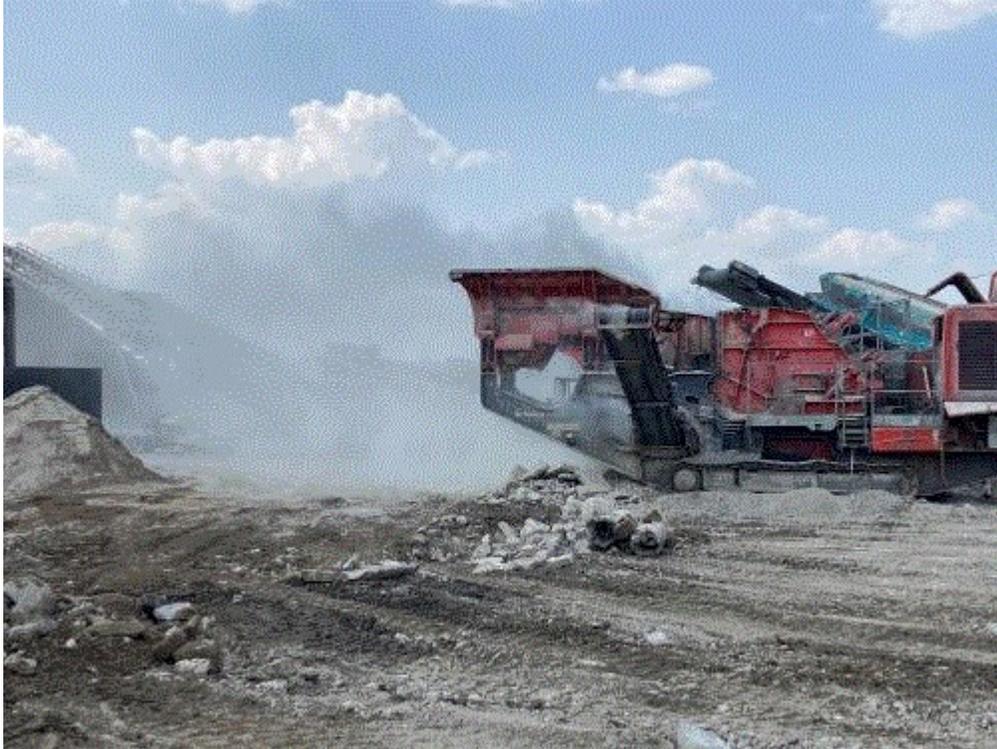
The plant continued operating until the last of the remaining raw material storage pile had been used up. Weber Sand & Gravel personnel then spoke with D. McGeen. He expressed concern to Foreman Gage Webb about the excess opacity and fugitive dust which had been witnessed. He was advised that there was a water spigot at the site, but it did not have high enough pressure to be useful for the crusher.

Image 4(4) : Heavy opacity from Terex Finlay feeder (TF) and portable crusher (TC) just before shutdown.
