DEPARTMENT OF ENVIRONMENTAL QUALITY
AIR QUALITY DIVISION
ACTIVITY REPORT: Scheduled Inspection

P056927815

FACILITY: PADNOS GRANDVILLE RECYCLING		SRN / ID: P0569
LOCATION: 3485 VIADUCT STREET SW, GRANDVILLE		DISTRICT: Grand Rapids
CITY: GRANDVILLE		COUNTY: KENT
CONTACT: Kris Randall, Supervisor		ACTIVITY DATE: 11/10/2014
STAFF: April Lazzaro	COMPLIANCE STATUS: Pending	SOURCE CLASS: Minor
SUBJECT: Unannounced, scheduled inspection.		
RESOLVED COMPLAINTS:

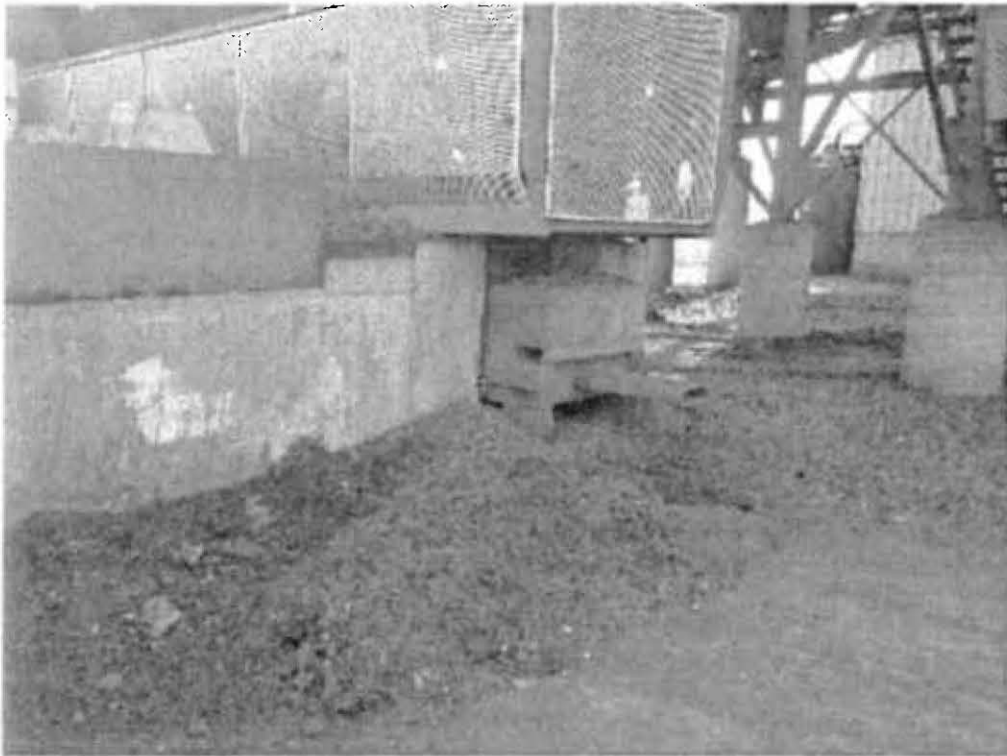
Image 1(Padnos Grandville) : Outdoor pile of material sorted from eddy current separation system. Other photos in confidential folder.
