DEPARTMENT OF ENVIRONMENTAL QUALITY  
AIR QUALITY DIVISION  
ACTIVITY REPORT: Scheduled Inspection

FACILITY: Paschal Burial Vault		SRN / ID: P0769
LOCATION: 15725 Steger Industrial Drive, HUDSON		DISTRICT: Jackson
CITY: HUDSON		COUNTY: LENAWEE
CONTACT:		ACTIVITY DATE: 11/02/2017
STAFF: Mike Kovalchick	COMPLIANCE STATUS: Compliance	SOURCE CLASS:
SUBJECT: Inspection of 2 incinerators at 2 nearby adjacent facilities about 1 mile apart.		
RESOLVED COMPLAINTS:

**Minor Source- (Note: This inspection report is for both SRN N5944 & SRN P0769 and identical reports have been placed in MACES under each SRN.)**

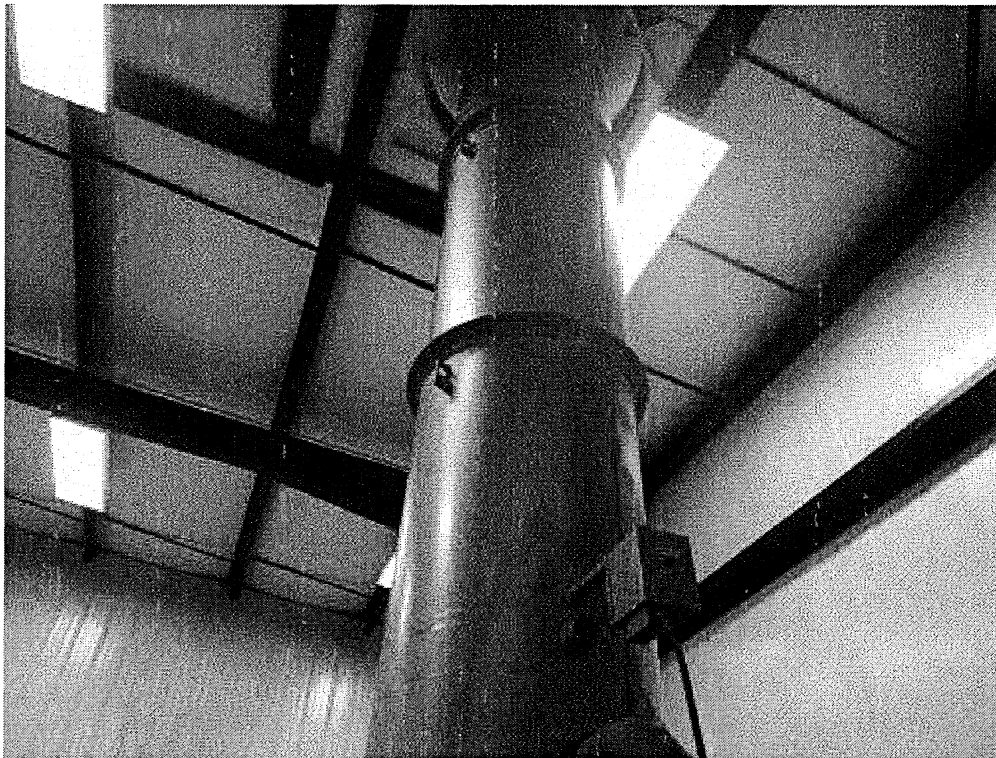
The older incinerator was operating 1598 deg F. (See photo.) The incinerator appeared to be in excellent condition. Ventilation pipes were in good shape exiting out a stack on the roof. No opacity and only heat waves were seen exiting the stack. The stack appeared to be at least 19 feet off the ground meeting permit requirements.

**Image 1(Exhaust stack)** : Exhaust ventilation pipe to roof exhaust stack/

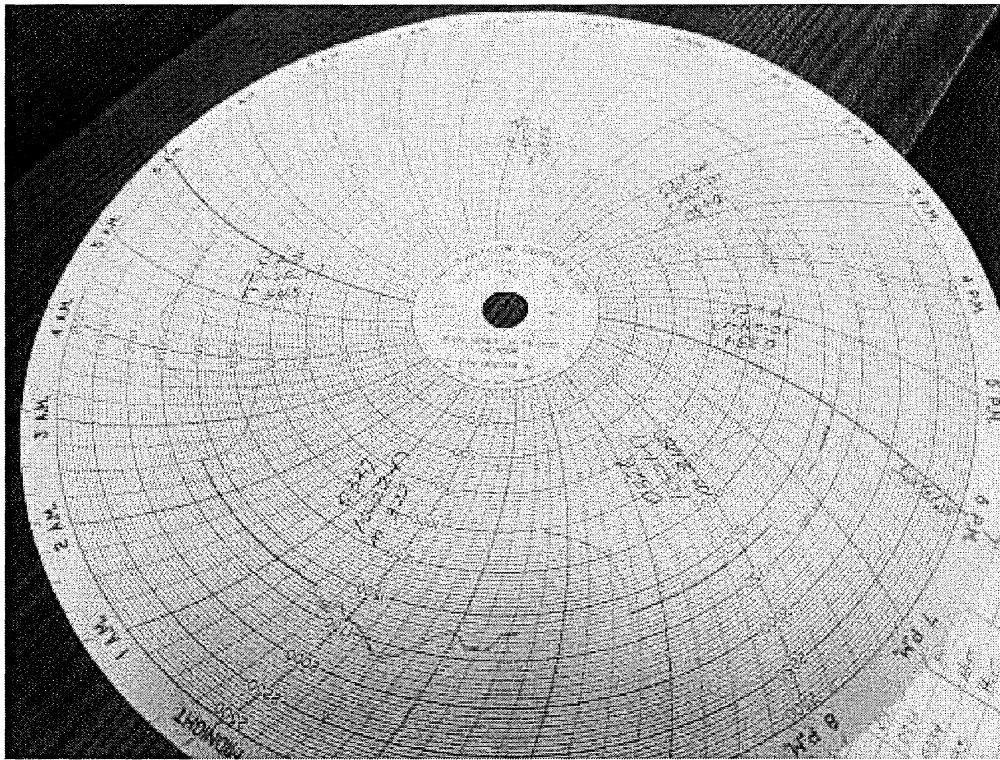
The circular charts are daily charts with each cremation hand annotated on the chart. It appears that temperature is maintained at 1700 degrees F. during the cremation in the afterburner chamber. (Permit limit is 1600 Deg. F.) The control panel shows the temperature for both the main chamber and the afterburner but only the

afterburner temperature is recorded on the circular chart.

**Image 2(Circular chart)** : Circular chart showing afterburner temp on new incinerator.

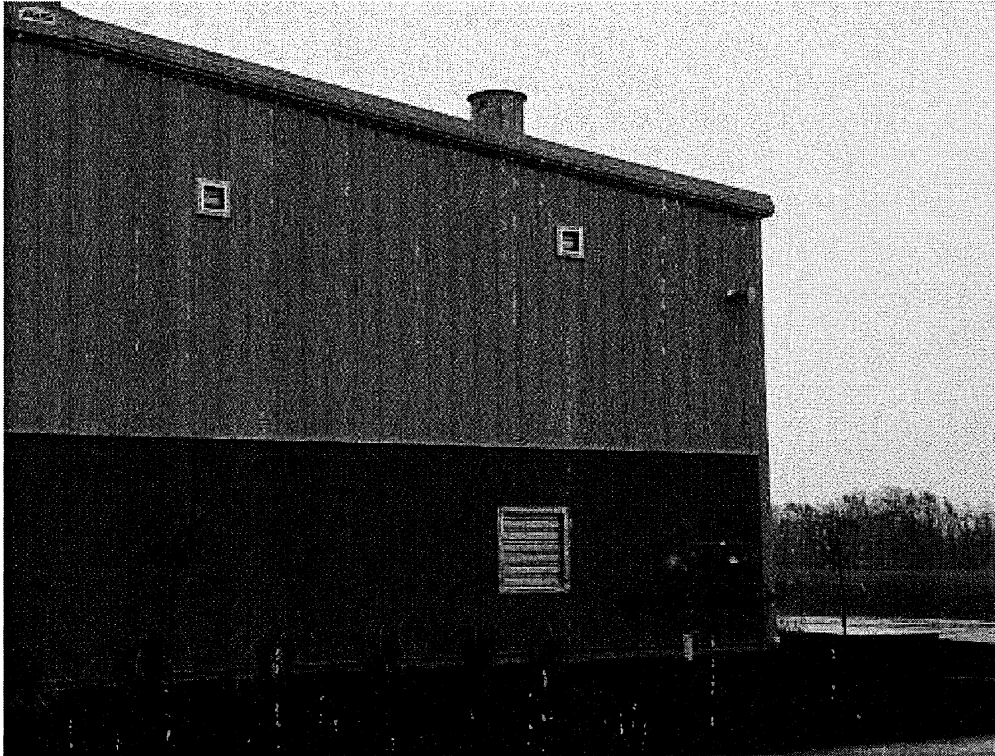
The incinerator appeared to be in mint condition and almost completed automated. LP explained how the incinerator optimizes every burn and learns over time. The temperature of the primary chamber was 987 degrees F. and temperature of the secondary chamber was 886 degrees F. The incinerator was still warm from an incineration from the previous evening. LP indicated it takes only a very few minutes to get up to proper temperature. No smoke was seen from the exhaust stack which appeared to be the required 24 feet high.

**Image 6(New Incinerator bldg)** : New incinerator building showing incinerator exhaust stack.

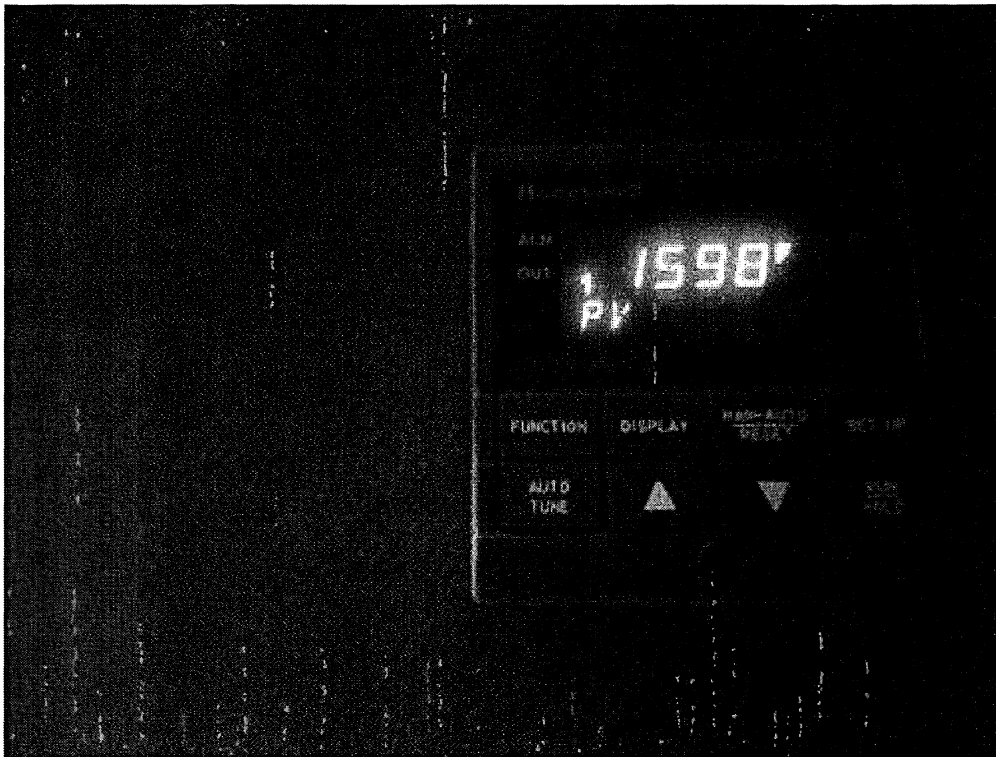
**Image 8(Incinerator temp)** : Old incinerator temp.

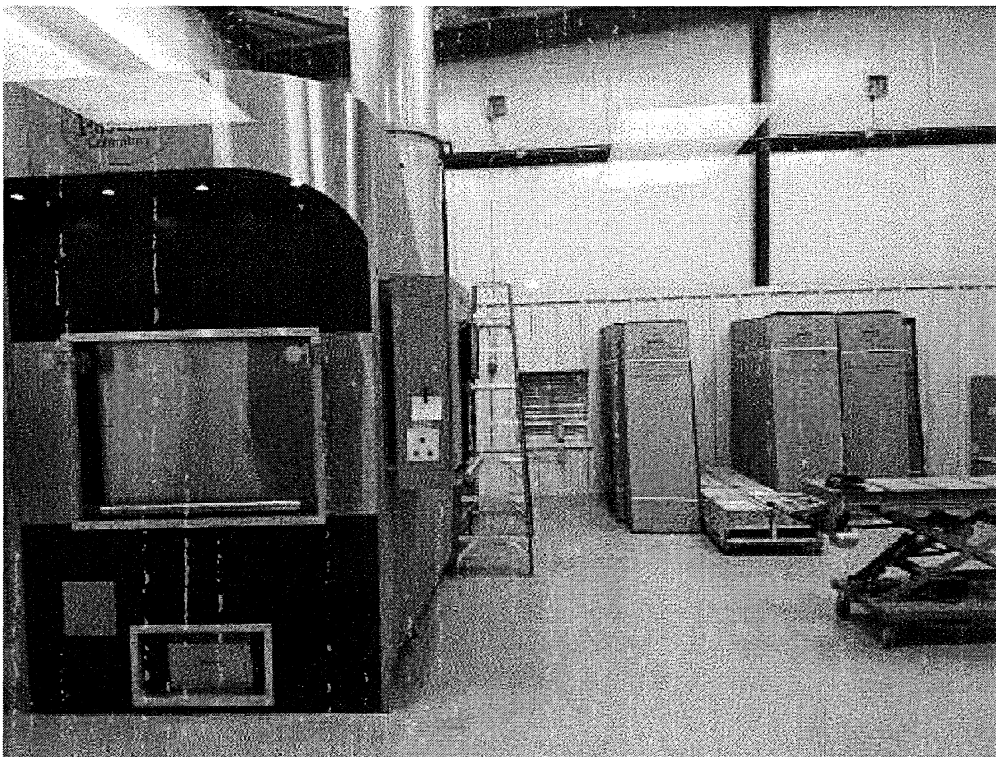
LP gave me a tour of the facility which includes a large walk-in refrigerator, a large room where new caskets are stored, a viewing room which has a window facing the incinerator room, and the incinerator room with an incinerator (Matthews Model #IE43-PPII Plus) and a weight scale.

**Image 9(New Incinerator)** : New incinerator.

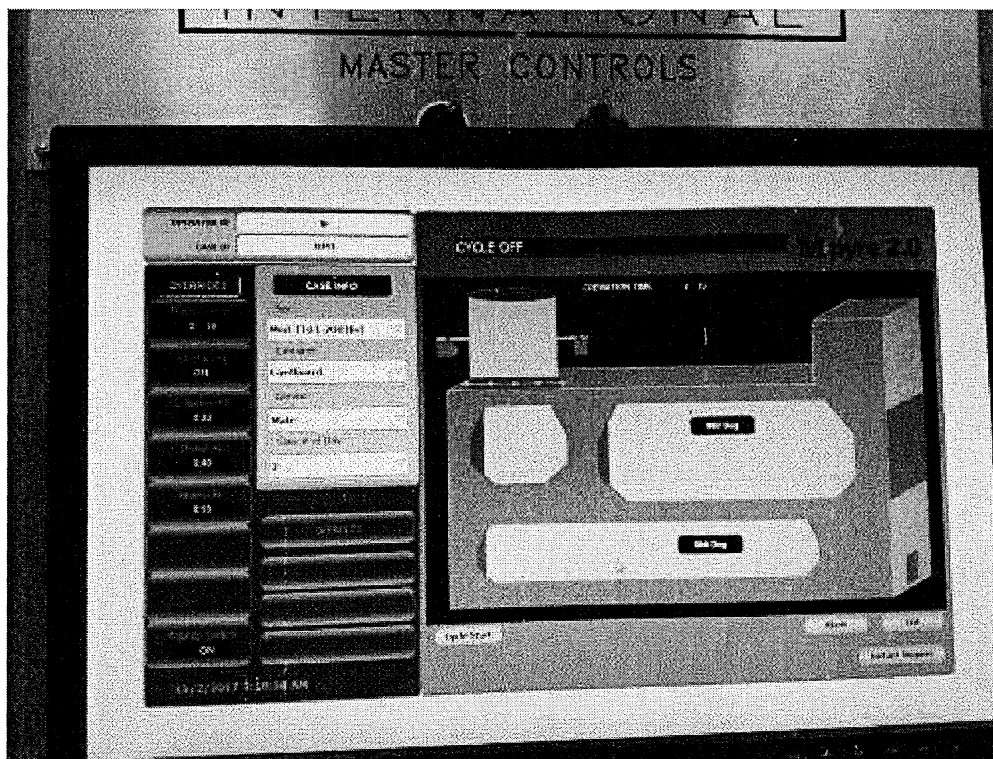
**Image 10(Control Panel) :** Control Panel-new incinerator.
