DEPARTMENT OF ENVIRONMENTAL QUALITY  
AIR QUALITY DIVISION  
ACTIVITY REPORT: Self Initiated Inspection

FACILITY: Westlund Plating		SRN / ID: P0800
LOCATION: 1415 South Cooper, JACKSON		DISTRICT: Jackson
CITY: JACKSON		COUNTY: JACKSON
CONTACT: Thomas Frankini , Owner		ACTIVITY DATE: 03/07/2017
STAFF: Mike Kovalchick	COMPLIANCE STATUS: Non Compliance	SOURCE CLASS: Minor
SUBJECT: Self initiated inspection based on finding a small chrome plater that was listed on the internet.		
RESOLVED COMPLAINTS:

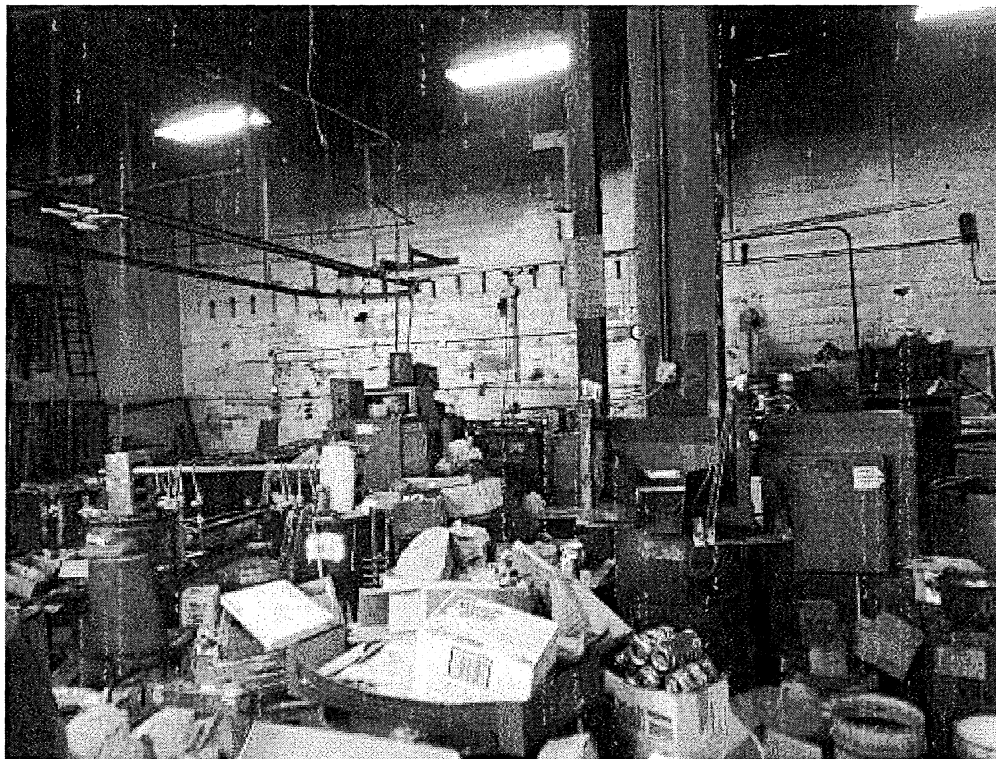
**Image 5(Main room)** : Main room

TF gave me a brief tour of the facility. It basically consists of a main room and smaller adjacent room. The main room contains a 50 gallon in size hard chrome plating tank, 2 nickel plating tanks(160 gallons), several dilute acid containers/tanks and some containers containing detergent. There was also some evaporation tanks that are used to concentrate sludge from the plating tanks. (He indicated that he gives the sludge to a smelter for free.) A 1928 vintage boiler was being used to heat the water in the plating tanks. 2 small rectifiers were being used to provide low voltage current to the plating tanks. In a separate room, a single grinding wheel was being used to grind/polish metal. Overall, both the main room and the adjacent room were very disorderly. (See attached photo.) The walls were all stained brown. The ceiling had no ventilation openings but along the edges of the roof line there was some small openings. The floor of the building was cement.
