DEPARTMENT OF ENVIRONMENTAL QUALITY  
AIR QUALITY DIVISION  
ACTIVITY REPORT: Self Initiated Inspection

FACILITY: M.A. Energy Resources, LLC		SRN / ID: U071601074
LOCATION: 17691 U.S. Hwy 41, L'Anse		DISTRICT: Upper Peninsula
CITY: L'Anse		COUNTY: BARAGA
CONTACT: Steve Puhl, Manager		ACTIVITY DATE: 05/02/2016
STAFF: Ed Lancaster	COMPLIANCE STATUS: Compliance	SOURCE CLASS:
SUBJECT: Meeting was to gather more information on MA Energy's relationship to LWEC and to determine if pentachlorophenol treated railroad ties were still on the property.		
RESOLVED COMPLAINTS:

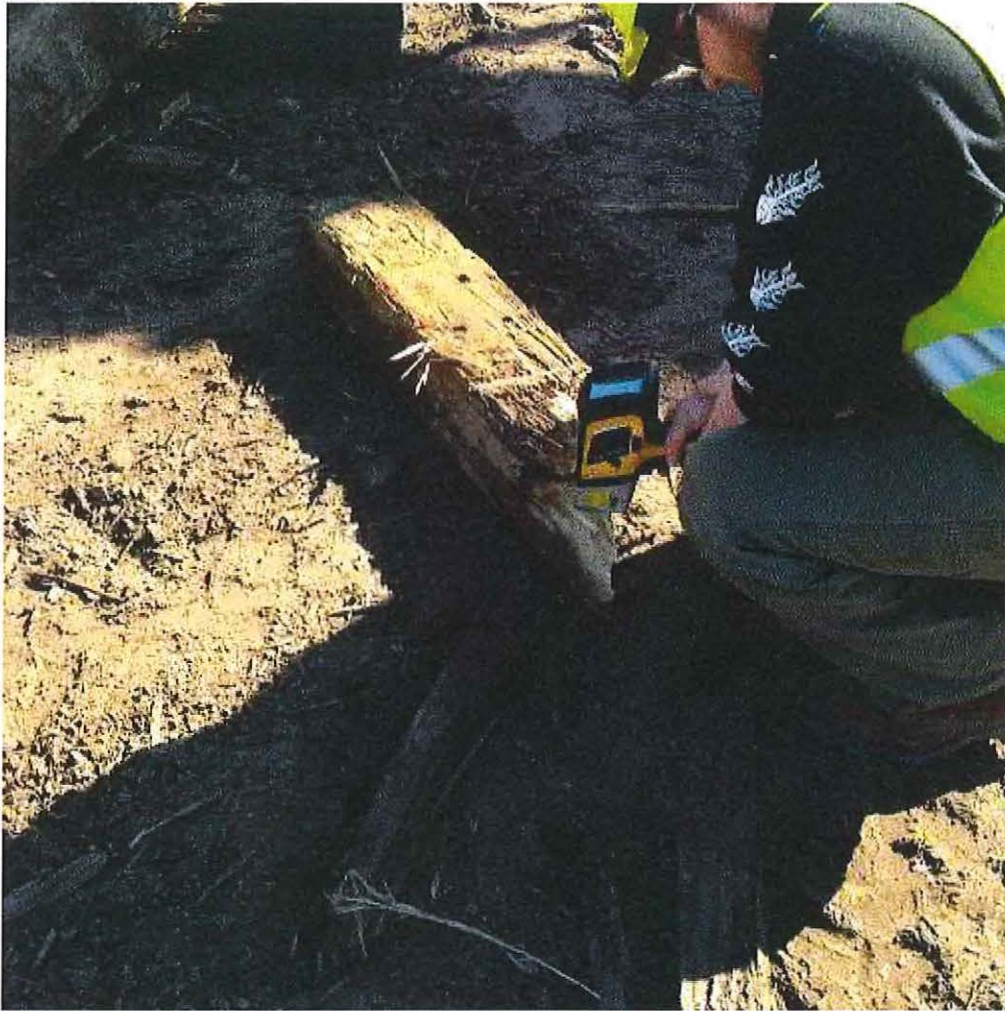
Tie	Chlorine (ppm)			
	End	Middle	Interior	Under plate

1	159	480		
2	3384	448		
3	4672/5319	1333	ND/125	ND

Readings were taken at both ends of Tie #3. The tie was then broken in two and each interior end was sampled. A final reading was taken at the point where a metal plate had been removed from the tie.

**Image 2(XRF of Tie #3)** : MA Energy employee using an XRF to monitor the chlorine content of the interior of Tie #3.

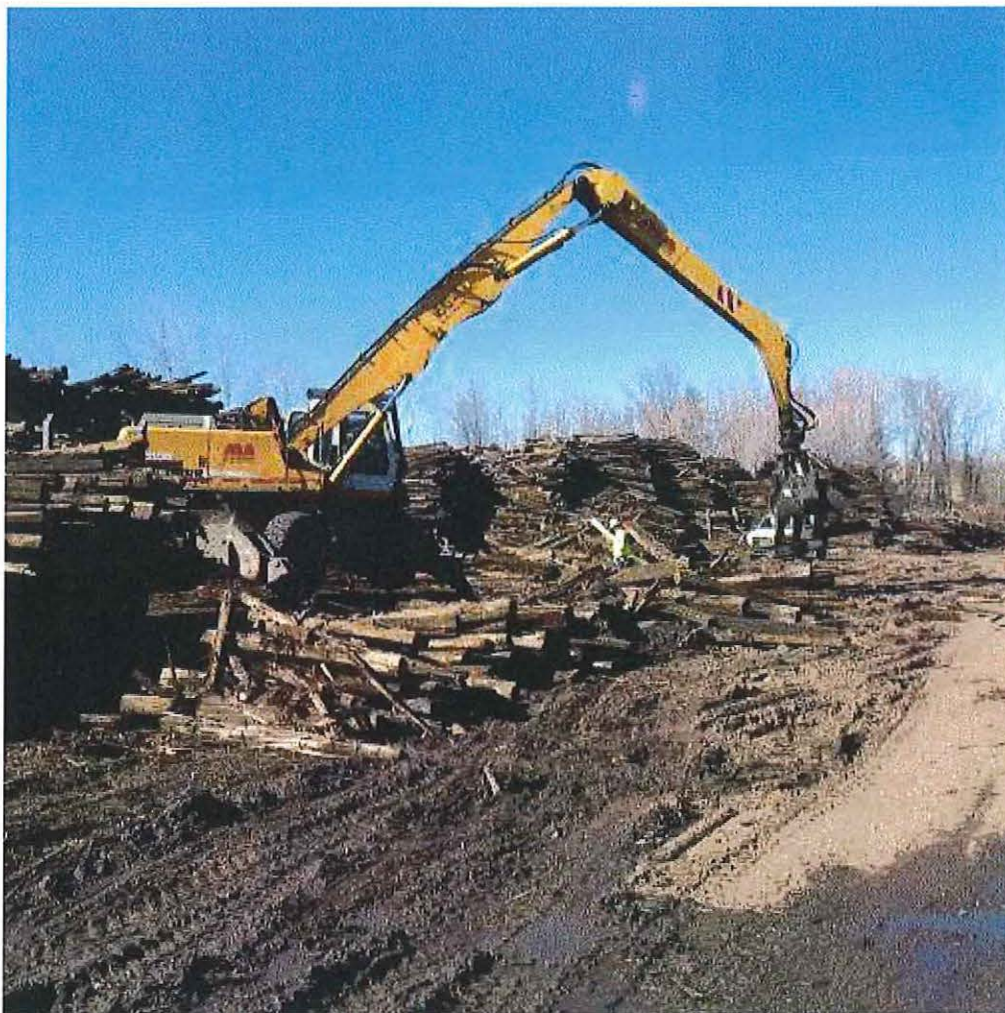
Mr. Puhl and I then walked into the fuel yard where he showed me a row of "legacy ties" that he estimated to contain 30,000 ties. He explained these ties are a mix of creosote and penta-ties and his employees are monitoring each one for chlorine content using the two XRF monitors they have on site. He estimated it would take at least a month to measure all the ties. Mr. Puhl said typically the end of the ties will give a higher chlorine reading than the middle section of the tie. While we were observing the employees, I asked if they could monitor the ends and middle of three random ties for.

**Image 3(Legacy pile)** : View of "Legacy Pile" of railroad ties on May 2, 2016.

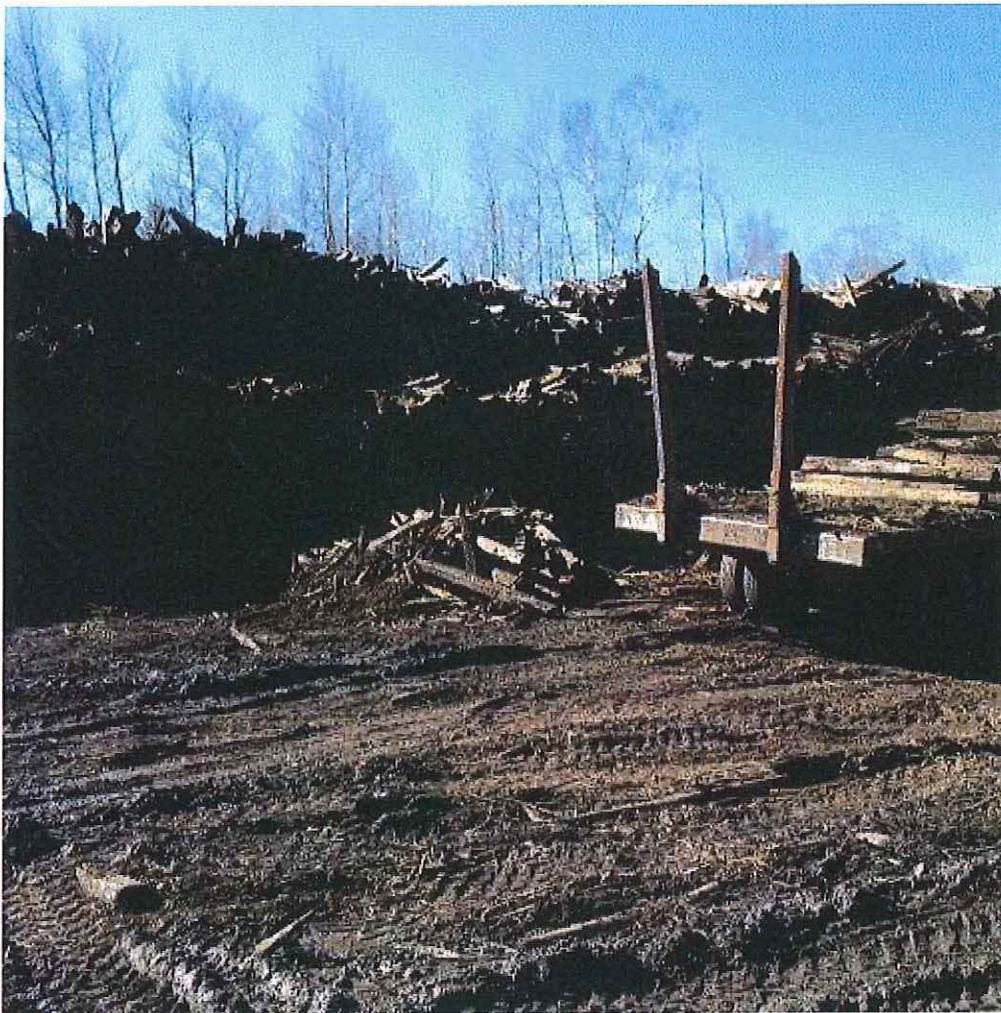
**Image 4(Legacy Pile vs 2) :** Second view of "Legacy Pile" on May 2, 2016.

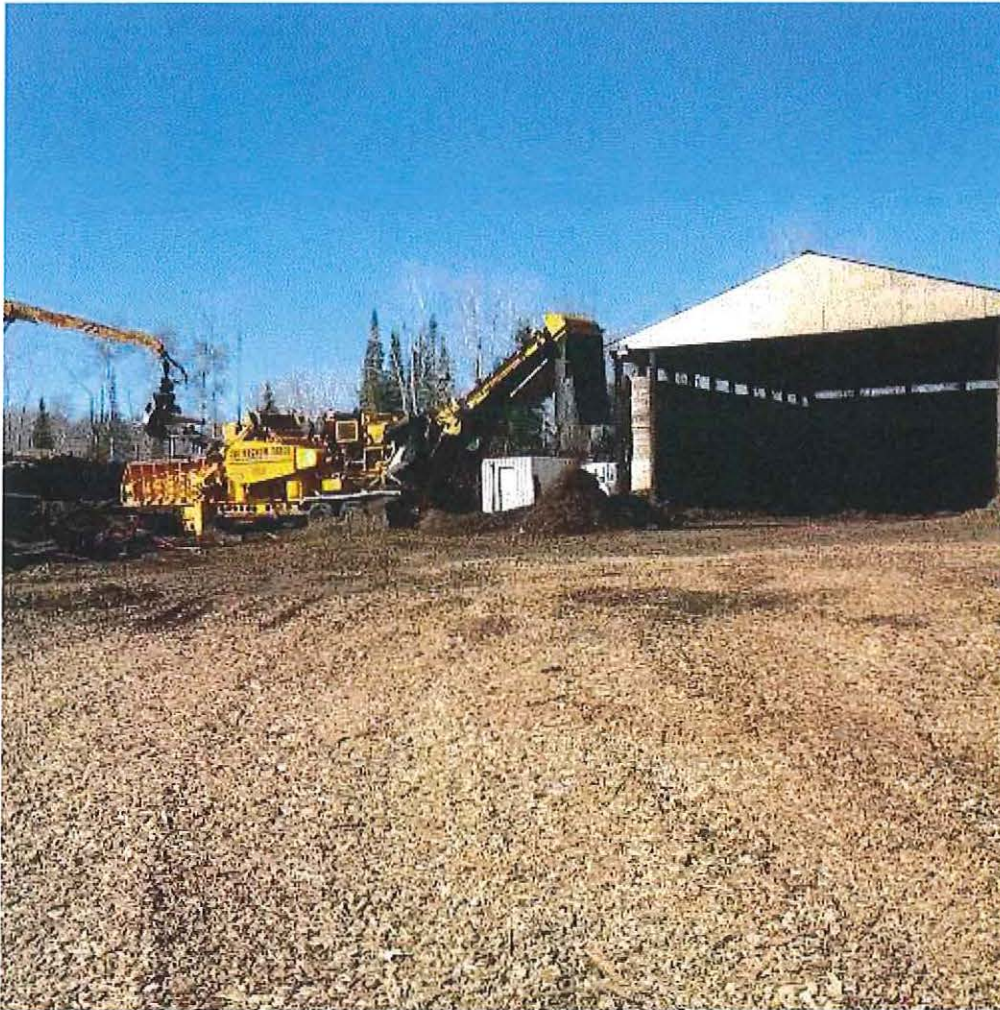
We finished the meeting by observing the grinding of the ties. No visible emissions were observed and Mr. Puhl stated there is a spray bar on the grinder and they use approximately 3,500 gallons of water per day to control the dust.

**Image 6(RR tie grinder) :** View of MA Energy's RR tie grinder in operation on May 2, 2016, at 10:45 AM.
