**DEPARTMENT OF ENVIRONMENTAL QUALITY
AIR QUALITY DIVISION
ACTIVITY REPORT: On-site Inspection**

FACILITY: Lambda Energy Resources LLC - Ricci 19 (Blue Lk)		SRN / ID: N6279
LOCATION: SUNSET TRAIL, KALKASKA		DISTRICT: Cadillac
CITY: KALKASKA		COUNTY: KALKASKA
CONTACT: Nick Summerland , HSE Manager		ACTIVITY DATE: 07/24/2024
STAFF: Tammie Puite	COMPLIANCE STATUS: Compliance	SOURCE CLASS: SM OPT OUT
SUBJECT: 2024 Full Compliance Evaluation Inspection		
RESOLVED COMPLAINTS:

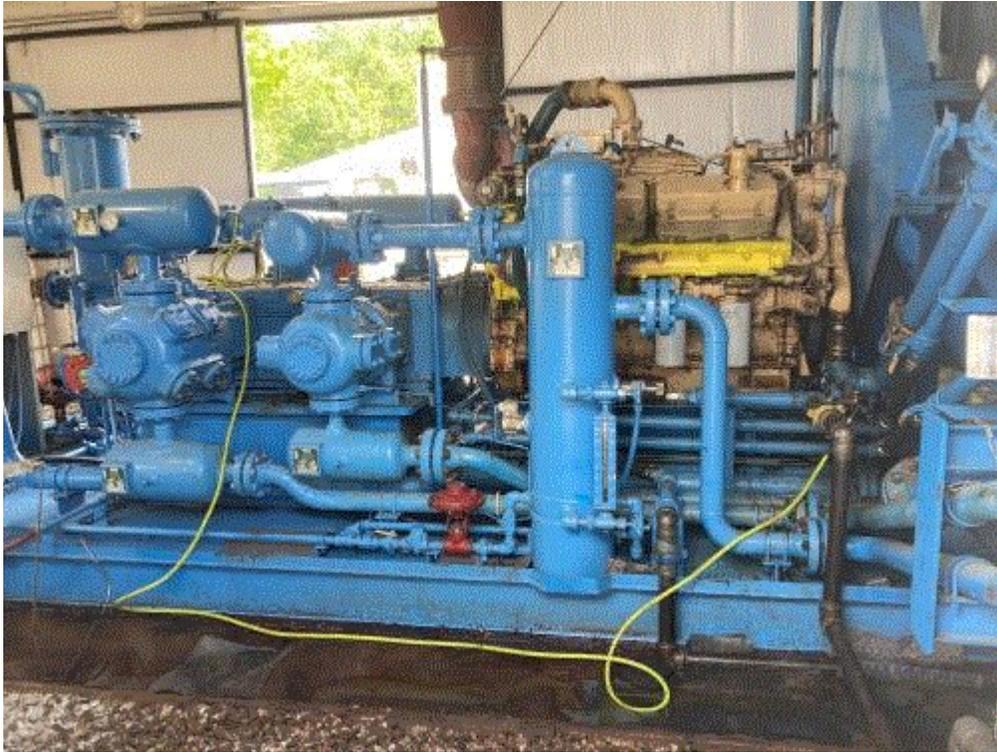
Upon arrival onsite maintenance men were there working on the Caterpillar G3412, Skid number CC1199. The site was found to be well kept, records were onsite to demonstrate that this site was being maintained per industry standards.

The G3412CLE is a Caterpillar V-12, 4-stroke engine that is rated at 637 HP and operates without a catalytic converter. It was manufactured in 2008 and is a leased unit provided by Correct Compression, and installed November 5, 2020. The Correct Compression compressor skid identification number is CC1199. Name Plate on Engine Model G3412, Serial # 6ZM02605, Performance Spec # OK2616. Caterpillar Engine Spec Sheets says that this is a 637 HP, 1800 RPM Engine with NOx Emissions of 2 g/bhp-hr (12.3 TPY), and a fuel consumption of 7635 Btu/bhp-hr. NSPS JJJJ Testing in 2021 showed that the engine does not operate near its maximum load. Horsepower output and engine fuel flow during the test were a steady 272 HP and 833 scfm respectively. Lambda reports that they do not need to do any further testing due to the engine being governed to less than 500 hp. This is consistent with Page 5 of the Permit to Install Evaluation document for PTI 79-21, which states that as long as the engine continues to be governed to 75% load, 478 hp, than they only need to do the initial test.

Image 1(Caterpillar Engine) : G3412CLE is a Caterpillar V-12, 4-stroke engine that is rated at 637 HP and operates without a catalytic converter. It was installed November 5, 2020. Skid # CC1199.

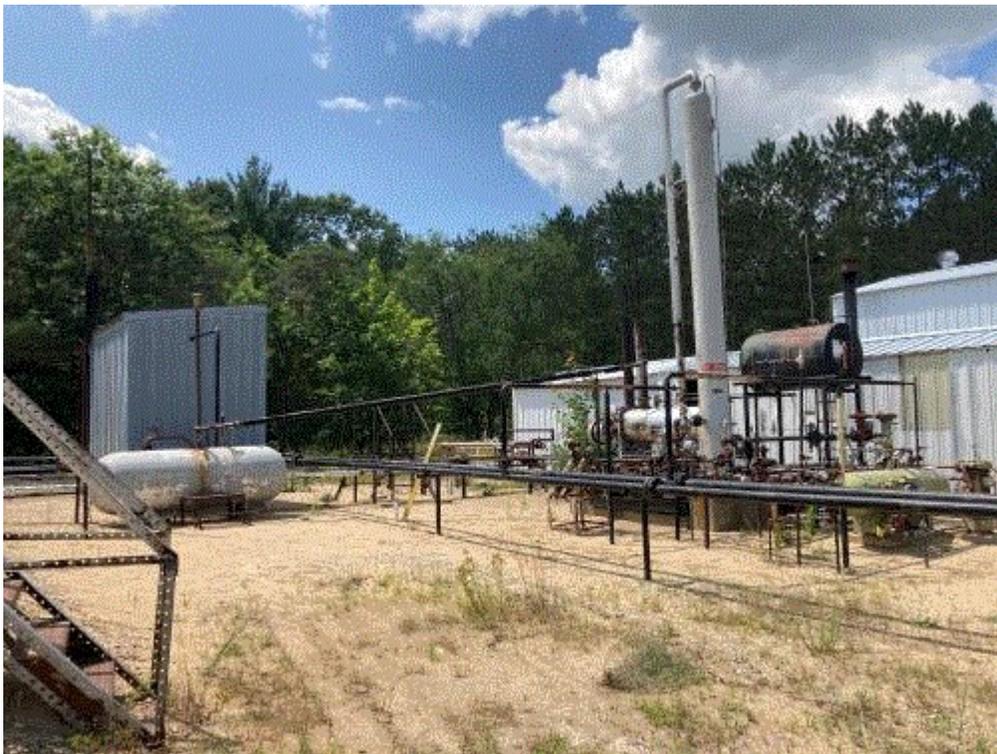
Image 2(Dehy & Separator) : There were low odors coming from the Dehy unit and the vent from the 500 gallon

propane / separator tank, but nothing that was leaving site or objectionable.

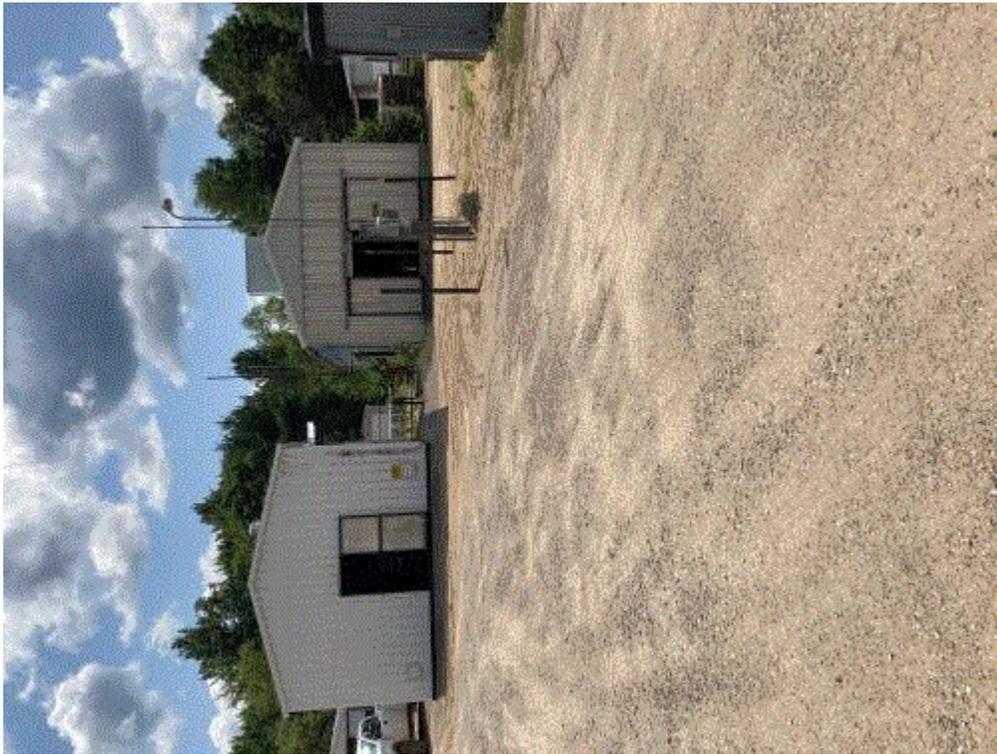
Image 3(Engine Buildings) : Caterpillar and Joy Engine Buildings

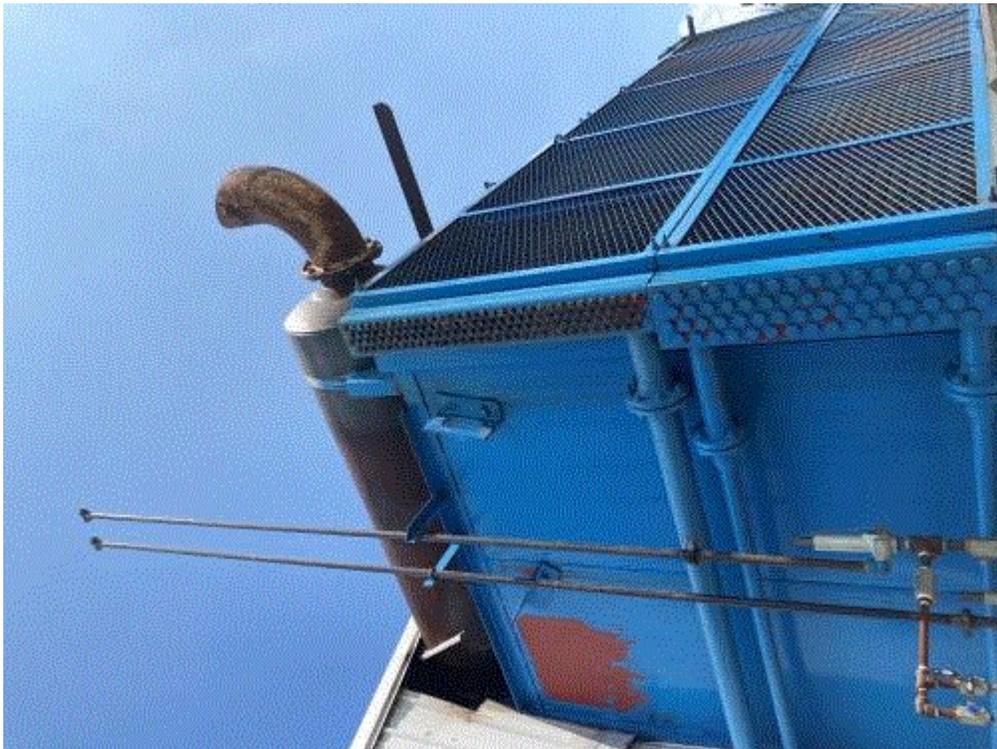
Stack is vented upwards through a muffler and appears to be at least 16 feet high or higher.

Image 4(Stack) : Caterpillar Engine Muffler and Stack
