**DEPARTMENT OF ENVIRONMENTAL QUALITY
AIR QUALITY DIVISION
ACTIVITY REPORT: Scheduled Inspection**

N298638659

FACILITY: Tecumseh Packaging Solutions, Inc		SRN / ID: N2986
LOCATION: 707 S EVANS STREET, TECUMSEH		DISTRICT: Jackson
CITY: TECUMSEH		COUNTY: LENAWEE
CONTACT:		ACTIVITY DATE: 02/16/2017
STAFF: Mike Kovalchick	COMPLIANCE STATUS: Compliance	SOURCE CLASS:
SUBJECT: Unannounced compliance inspection. No findings.		
RESOLVED COMPLAINTS:

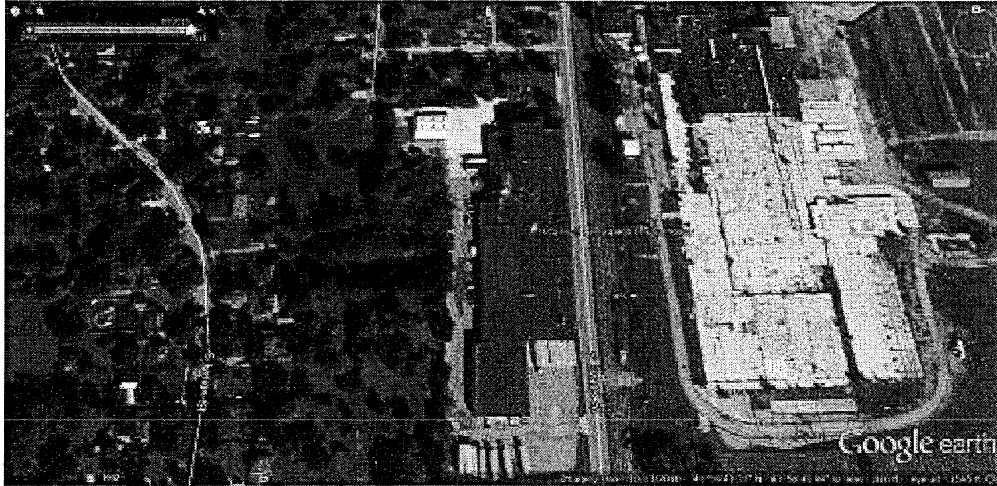
Image 1(aerial photo) : aerial photo

The facility is located near an industrial area just to the East with residential areas just to the West and North of the plant within the town of Tecumseh. See aerial photo dated October, 2016.
