**DEPARTMENT OF ENVIRONMENTAL QUALITY  
AIR QUALITY DIVISION  
ACTIVITY REPORT: On-site Inspection**

<b>FACILITY:</b> MASTER FINISH COMPANY		<b>SRN / ID:</b> N5898
<b>LOCATION:</b> 2020 NELSON SE, GRAND RAPIDS		<b>DISTRICT:</b> Grand Rapids
<b>CITY:</b> GRAND RAPIDS		<b>COUNTY:</b> KENT
<b>CONTACT:</b> Aaron Mulder , CEO		<b>ACTIVITY DATE:</b> 06/28/2022
<b>STAFF:</b> April Lazzaro	<b>COMPLIANCE STATUS:</b> Non Compliance	<b>SOURCE CLASS:</b> MINOR
<b>SUBJECT:</b> Unannounced, scheduled inspection.		
<b>RESOLVED COMPLAINTS:</b>

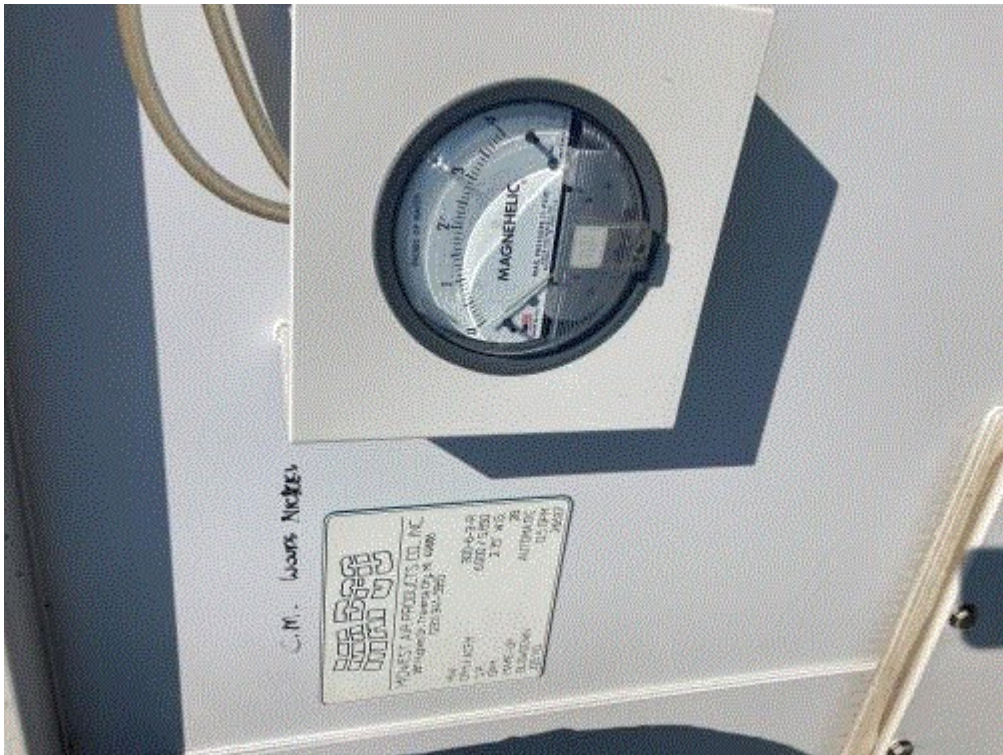
The Cyclmaster Line (PTI No. 74-94A) scrubber was visually inspected for leaks, and none were observed. This line has not operated in several months and was not operating at the time of the inspection. The pressure drop gauge had water sitting in it and was not operational. Since the line was not and has not been operating this is not considered a violation. However, the gauge must be replaced prior to operating the line. During the 2018 inspection, the inlet pressure drop gauge read 0.8" H<sub>2</sub>O and the outlet pressure drop gauge read 2.8" H<sub>2</sub>O. At the time of the 2018 inspection, the acceptable range as listed in the O&M Plan was listed as 0.04-3.0" H<sub>2</sub>O. The scrubber pressure drop in 2018 was within the parameters of the O&M Plan. During a review of the scrubber inspection log, I learned that while the company indicates they have been completing the monthly maintenance, the information associated with the inspections is not being tracked as required by the O&M Plan. As such, this is a violation of PTI No. 75-94B, Special Condition VI.2 for failure to properly implement the O&M Plan for the Cyclmaster Line scrubber. A Violation Notice will be issued. Past pressure drop readings were also requested and reviewed. Since the Cyclmaster Line has not been operated very often, limited information is available.

**Image 3(Cyclmaster Line) :** Cyclmaster Line outlet pressure drop gauge with moisture. Image should be viewed rotated one turn clockwise.
