DEPARTMENT OF ENVIRONMENTAL QUALITY
AIR QUALITY DIVISION
ACTIVITY REPORT: Scheduled Inspection

FACILITY: Lake Pleasant Recycling		SRN / ID: P0839
LOCATION: 3380 Hudson Rd., HILLSDALE		DISTRICT: Jackson
CITY: HILLSDALE		COUNTY: HILLSDALE
CONTACT: Mike Gootee		ACTIVITY DATE: 10/23/2018
STAFF: Mike Kovalchick	COMPLIANCE STATUS: Compliance	SOURCE CLASS: MINOR
SUBJECT: Inspection of an auto scrap yard.		
RESOLVED COMPLAINTS:

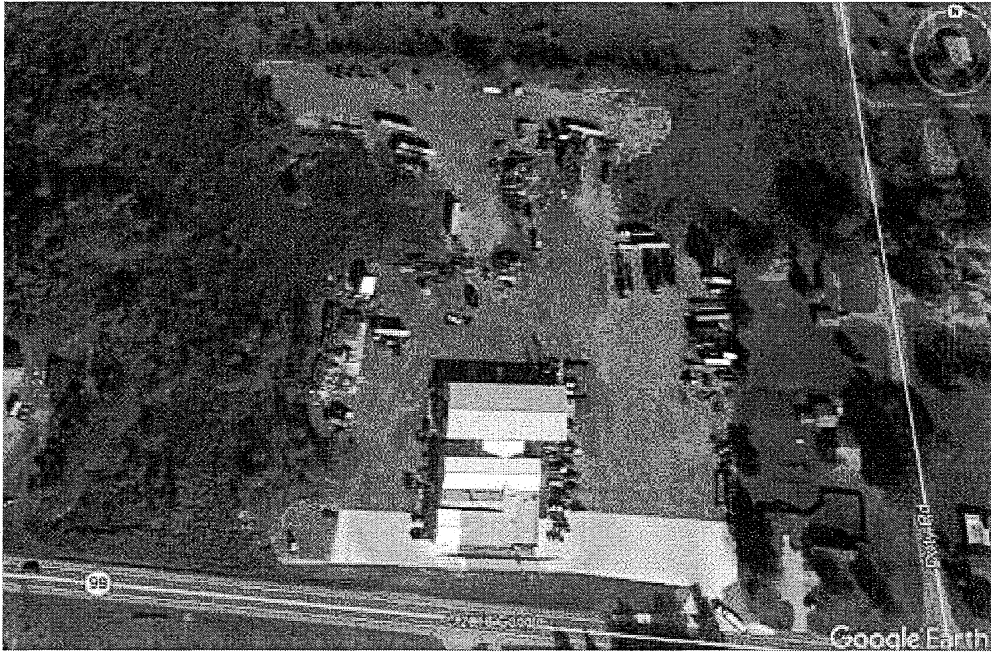
The portable auto shredder is in the process of being sold. It has not been used in 3 or 4 months. It has been disassembled into several large components. The main shredder portion of it has been moved to behind the office building where it occasionally operated to show perspective clients that it is still in working condition.

Image 9(Shredder component) : Another part of the auto shredder plant.
