DEPARTMENT OF ENVIRONMENTAL QUALITY  
AIR QUALITY DIVISION  
ACTIVITY REPORT: Scheduled Inspection

FACILITY: Cardinal Aggregates		SRN / ID: P0167
LOCATION: 3660 Carpenter Rd, YPSILANTI		DISTRICT: Jackson
CITY: YPSILANTI		COUNTY: WASHTENAW
CONTACT: Phil Eisel , Vice-President		ACTIVITY DATE: 07/26/2018
STAFF: Mike Kovalchick	COMPLIANCE STATUS: Non Compliance	SOURCE CLASS: MINOR
SUBJECT: Inspection of portable crusher on subleased land from StoneCo who leases it from Doan Companies.		
RESOLVED COMPLAINTS:

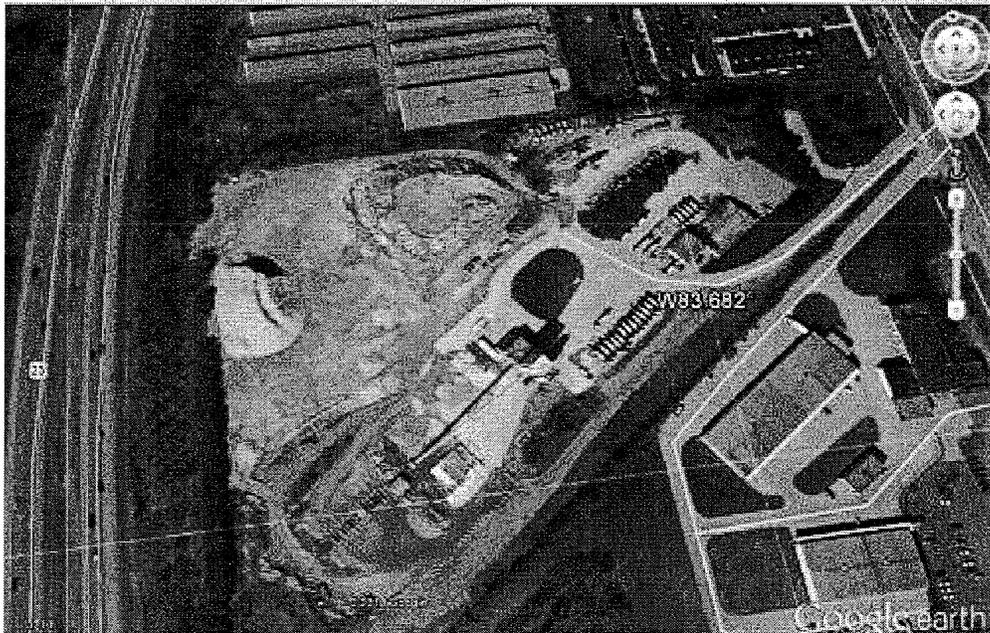
The facility is located in a commercial area in between Ann Arbor and Ypsilanti. The portable crusher is located more than 500 feet from the closest commercial or residential building. See attached aerial photo.

Image 1(Aerial photo) : Aerial photo.
