DEPARTMENT OF ENVIRONMENTAL QUALITY
AIR QUALITY DIVISION
ACTIVITY REPORT: Scheduled Inspection

FACILITY: BMC Global, LLC dba Blissfield Manufacturing		SRN / ID: A2889
LOCATION: 626 DEPOT ST, BLISSFIELD		DISTRICT: Jackson
CITY: BLISSFIELD		COUNTY: LENAWEE
CONTACT: Rebecca Parott , Quality Auditor		ACTIVITY DATE: 04/27/2017
STAFF: Mike Kovalchick	COMPLIANCE STATUS: Compliance	SOURCE CLASS: SM OPT OUT
SUBJECT: Scheduled Inspection of an Opt-Out Source.		
RESOLVED COMPLAINTS:

SM Opt Out Source for HAPs. Full Compliance Evaluation (FCE) 2017

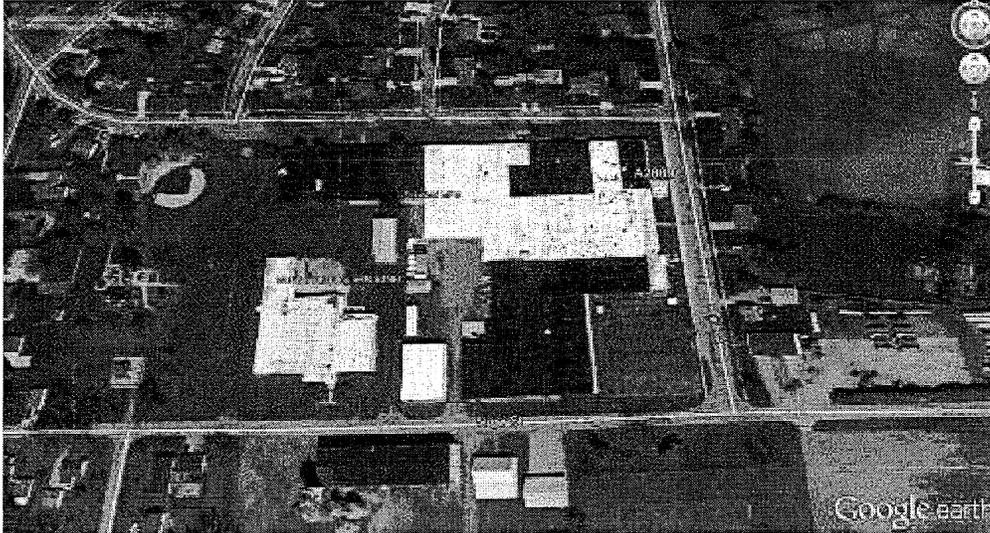
The facility is located in a mixed commercial and residential area of Blissfield. Some residential homes are very close to the facility on the North and East side of the plant and there has been historical odor complaints. See aerial photo dated October, 2016.

Image 1(Aerial photo) : Aerial photo of the facility.
