DEPARTMENT OF ENVIRONMENTAL QUALITY
 AIR QUALITY DIVISION
 ACTIVITY REPORT: Scheduled Inspection

FACILITY: Ervin Amasteel Division		SRN / ID: B1754
LOCATION: 915 TABOR ST., ADRIAN		DISTRICT: Jackson
CITY: ADRIAN		COUNTY: LENAWEE
CONTACT: Richard Payne , Plant Engineer		ACTIVITY DATE: 08/01/2019
STAFF: Mike Kovalchick	COMPLIANCE STATUS: Compliance	SOURCE CLASS: MAJOR
SUBJECT: FCE of a secondary steel mill. The facility is in compliance.		
RESOLVED COMPLAINTS:

Major Source for CO-Area Source for HAPs-Full Compliance Evaluation (FCE)

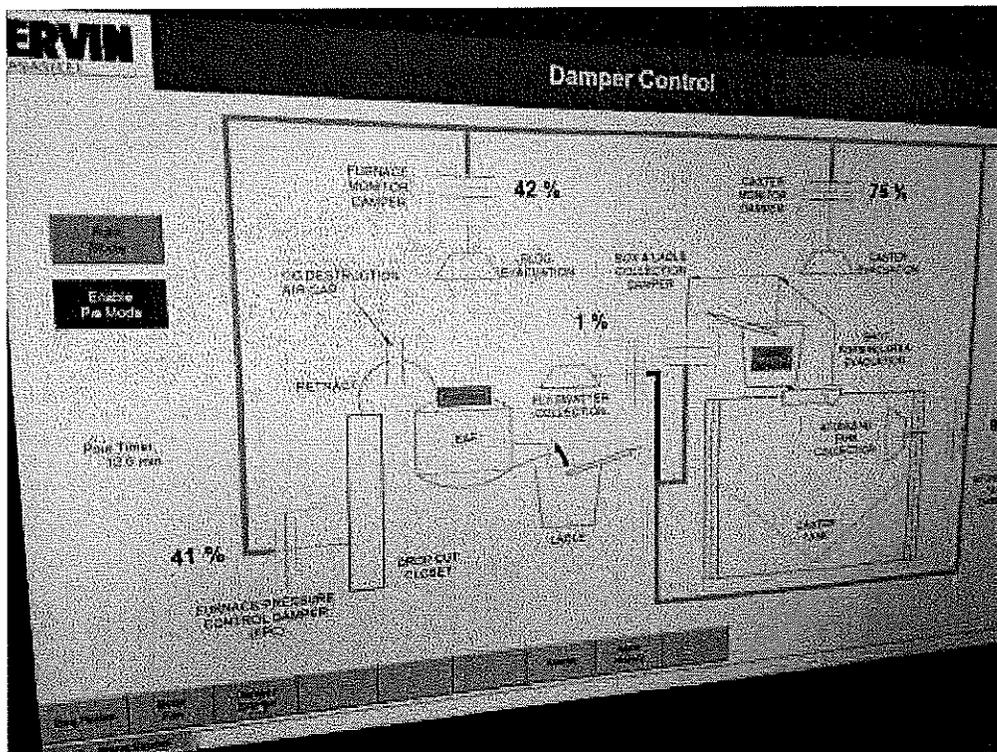
Image 10(EAF Control Screen 2) : EAF Control Screen Overview
