DEPARTMENT OF ENVIRONMENTAL QUALITY
AIR QUALITY DIVISION
ACTIVITY REPORT: Scheduled Inspection

| FACILITY: FINISHING SERVICES INC | | SRN / ID: N2474 |
| SUBJECT: Unannounced compliance inspection of a small electroless plating facility. | | |

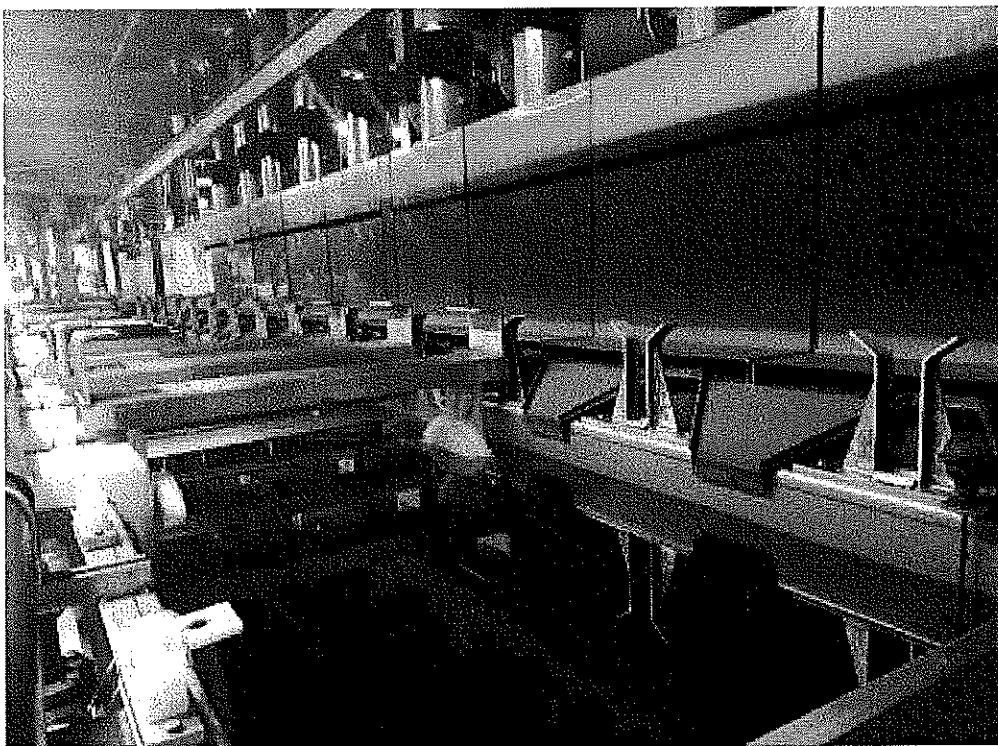
EUSYSTEM2. It was idle but tanks were full. No odors. Noted the pressure drop of the associated packed bed scrubber was reading 0.6" of water. The recirculation water was very foamy; so much so that it was spilled out the tank. See attached photo.

Image 7(Foam recirculation) : Foam coming from the scrubber water recirculation tank for the newer nickel line.
