DEPARTMENT OF ENVIRONMENTAL QUALITY AIR QUALITY DIVISION ACTIVITY REPORT: Scheduled Inspection

| 2001001101 | | |
|---|---|---|
| FACILITY: OWOSSO WASTEWATER TREATMENT PLANT | | SRN / ID: B5549 |
| SUBJECT: Scheduled Inspecti | on of the Owosso Wastewater Treatment Plant | |

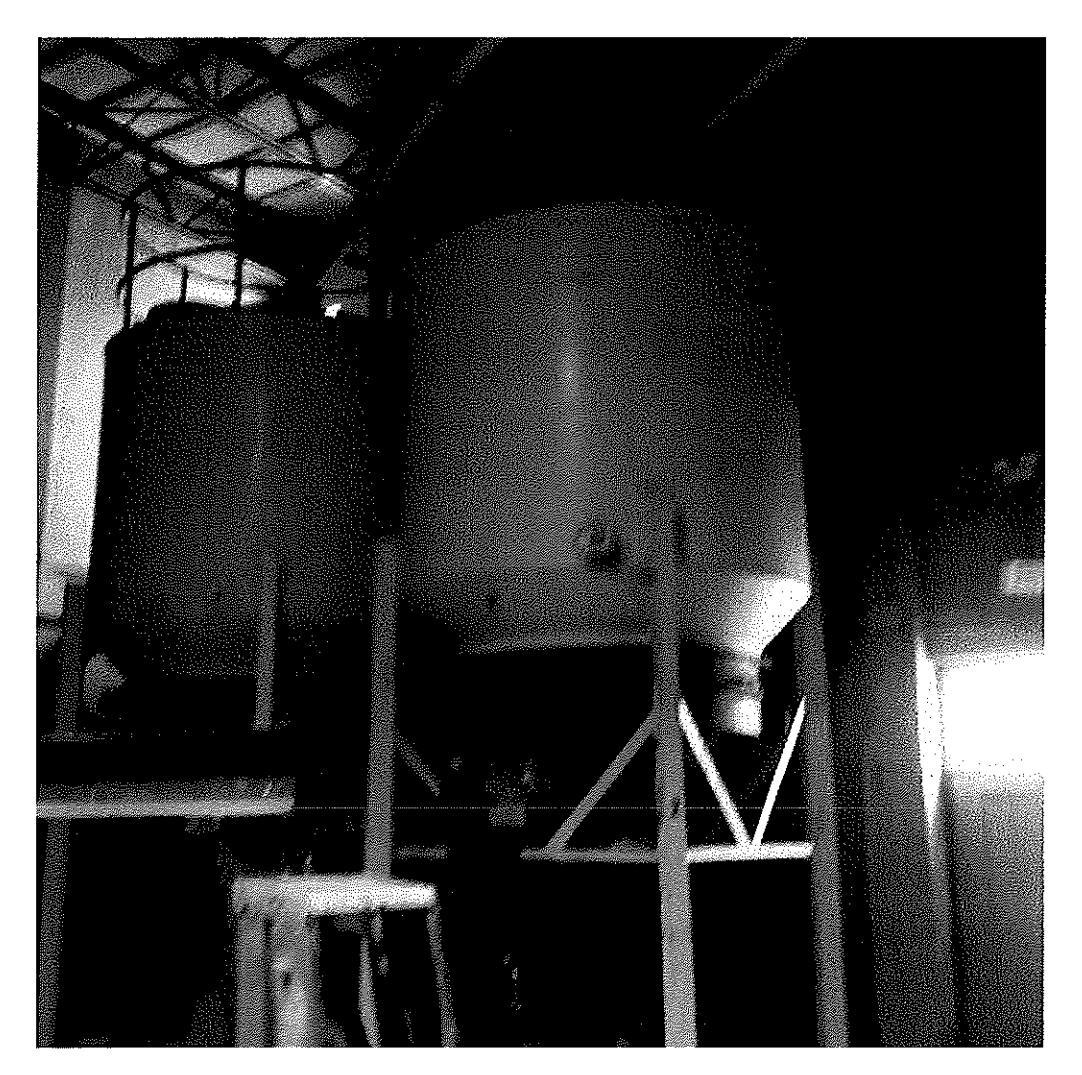
Image 1(Lime Storage Silos) : Part of the lime storage system

Sludge produced from the biological process is dewatered in a large centrifuge and dropped into a dumpster which goes to a landfill. The old filter press, lime storage silos and old sludge incinerator are non-functional. Plans are in place to remove the equipment for the lime process, and old sludge incinerator.

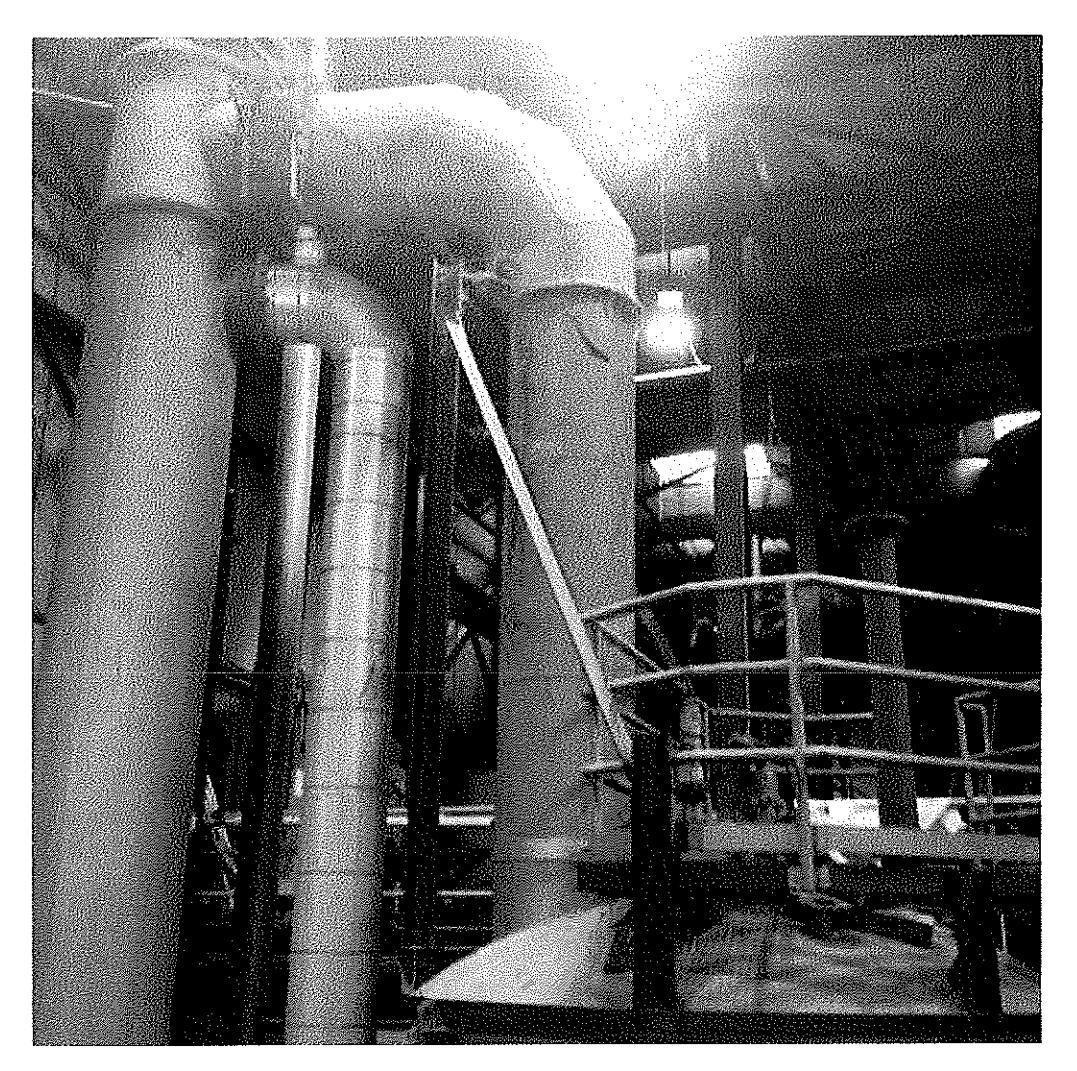
Image 2(Sludge Incinerator) : Disconnected sludge incinerator - to be removed.

PTI 228-71 and PTI 1008-84 were voided on November 16, 2016 as the equipment is no longer in service, and/or in various stages of being dismantled and removed.

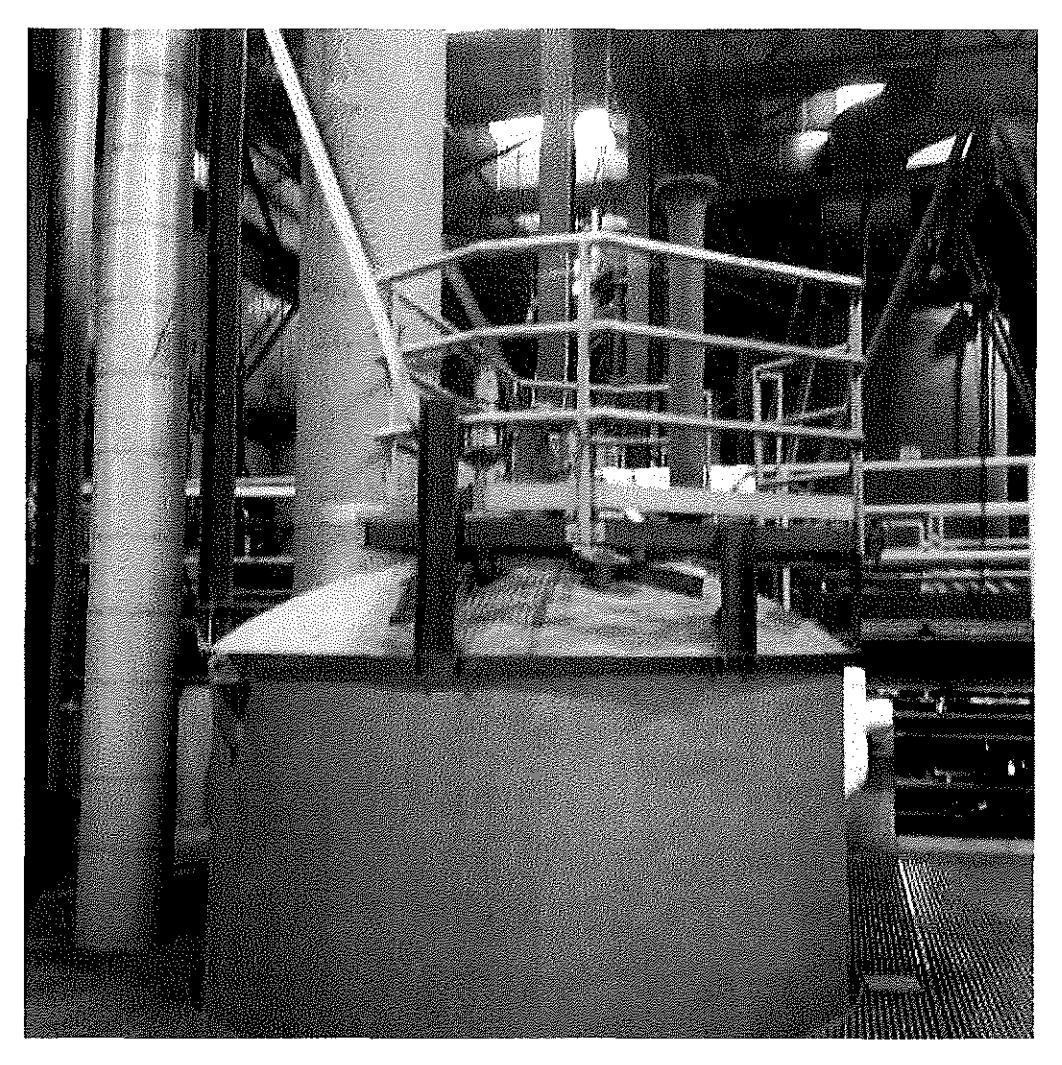
Image 3(Sludge incinerator) : Old sludge incinerator
