DEPARTMENT OF ENVIRONMENTAL QUALITY AIR QUALITY DIVISION ACTIVITY REPORT: Scheduled Inspection

FACILITY: LEADING EDGE FIBERGLASS POOL		SRN / ID: N7982
LOCATION: 3090 W COOK RD, GRAND BLANC		DISTRICT: Lansing
CITY: GRAND BLANC		COUNTY: GENESEE
CONTACT: Scott Hoover , President		ACTIVITY DATE: 07/20/2020
STAFF: Julie Brunner	COMPLIANCE STATUS: Compliance	SOURCE CLASS: SM OPT OUT
SUBJECT: Scheduled Inspection to determine compliance with PTI 53-08B		
RESOLVED COMPLAINTS:

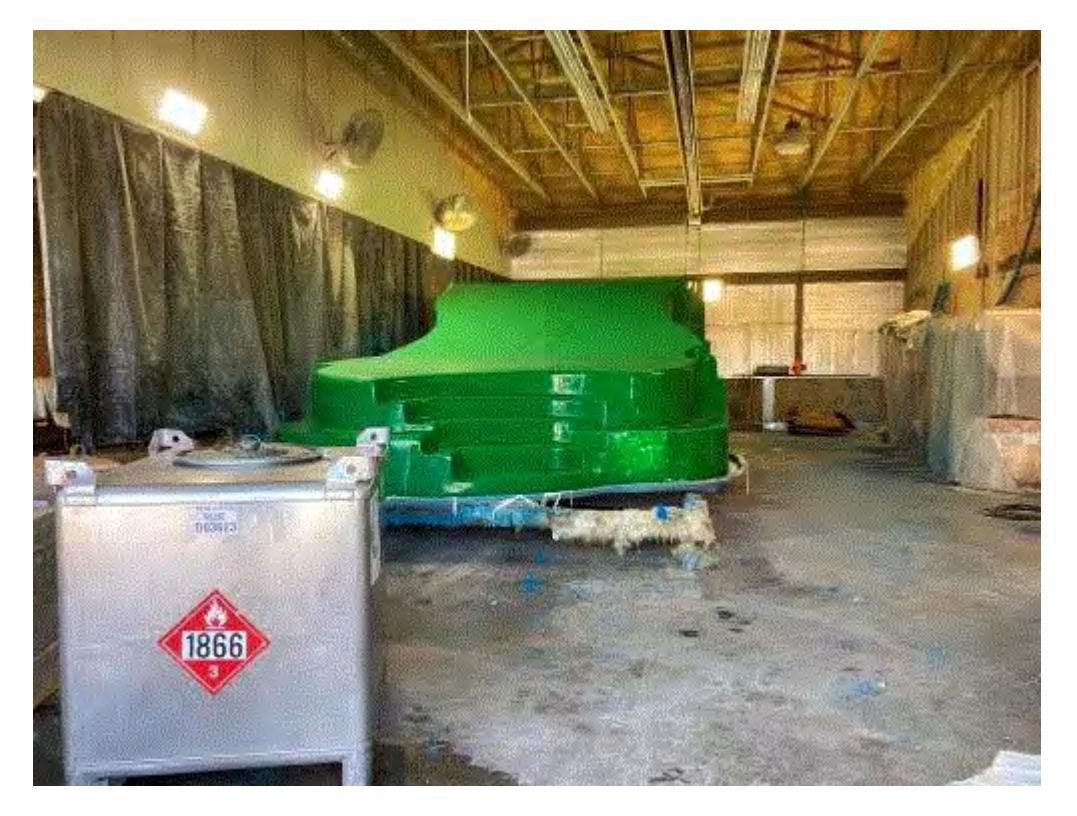
Image 1(007) : Bay 2

During the inspection, the process was operating but materials were not being sprayed. Generally, one person sprays, and up to 4 people roll the materials. PPE (Tyvek, respirators, gloves, and covered safety toed shoes) are worn by the operators when laying up a pool. The permit allows for the installation of two lay-up bays and the use of atomized applicator(s). Only one bay is currently used. The second bay is used to store pool molds, but the fabric filter system is still in place. Due to the number of pool orders, new equipment as been ordered for Bay 2 which hasn't been used in a while.

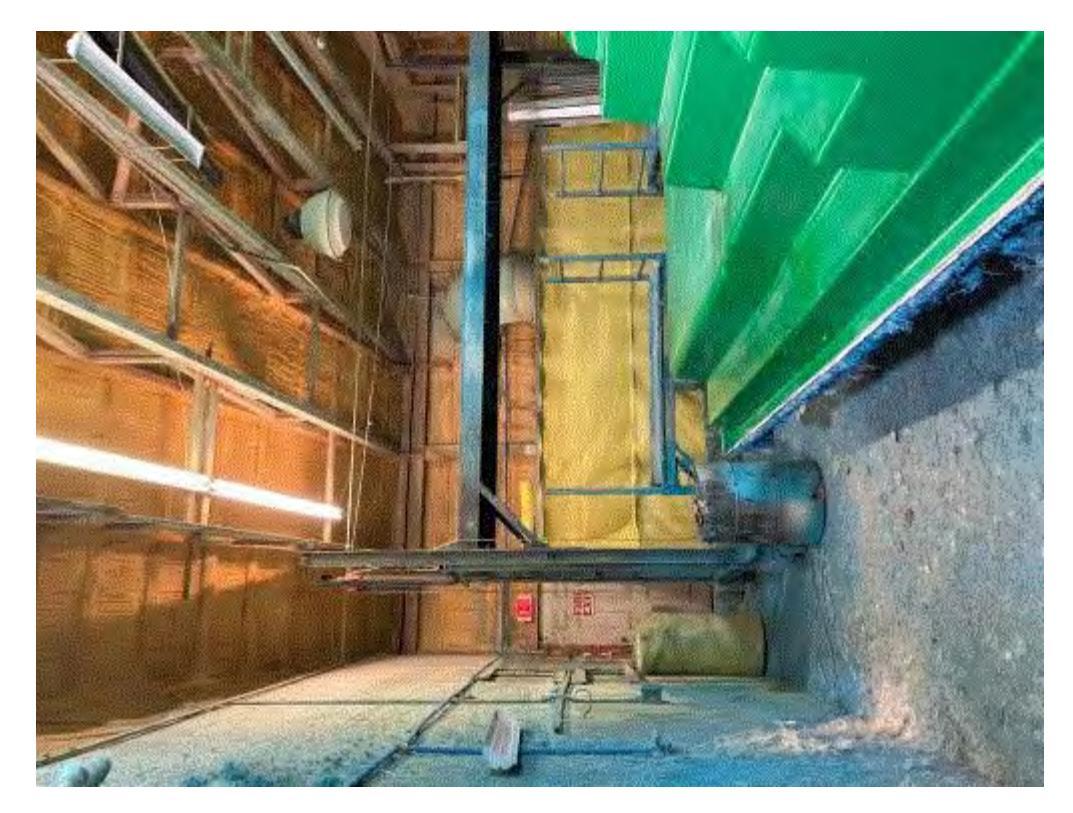
Image 2(0009) : Fabric filters in Bay 1

The exhaust system appeared to meet the restrictions in the permit and the filters were in good shape. The filters are changed about once a month based on whether airflow through the filter system is restricted. Assuming 2 to 3 pools are built a week then 8 pools are made before a filter change is needed. They aren't building many new pool molds so they aren't sanding as much which increases how often the filters need to be changed.

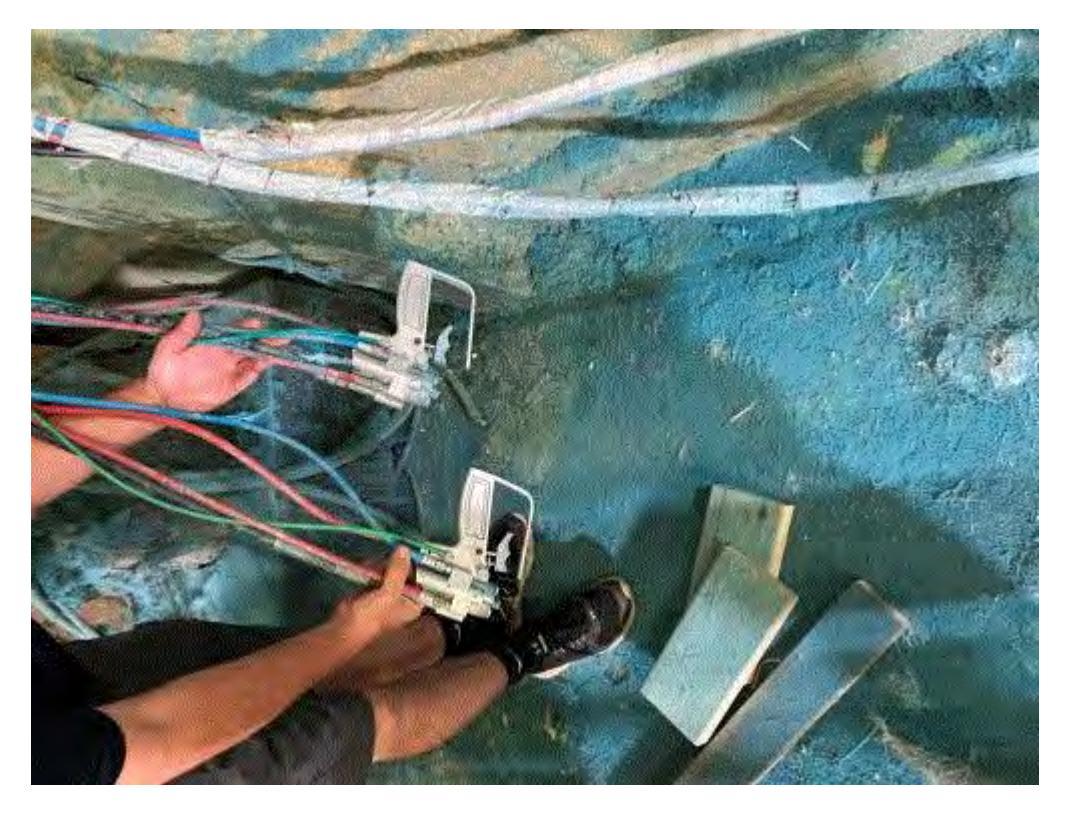
Image 3(0011) : Spray applicators

Resin and gelcoat material is pumped directly from barrels in the coating room to the spray guns. The

coating delivery system has a material measurement device, and is located right beside the bay. The gelcoat guns used are external mix and the chopper guns used are internal mix. Scott is looking into a new chopper gun that is external mix and an automated "memory" robotic system for spraying both gelcoat and resin.

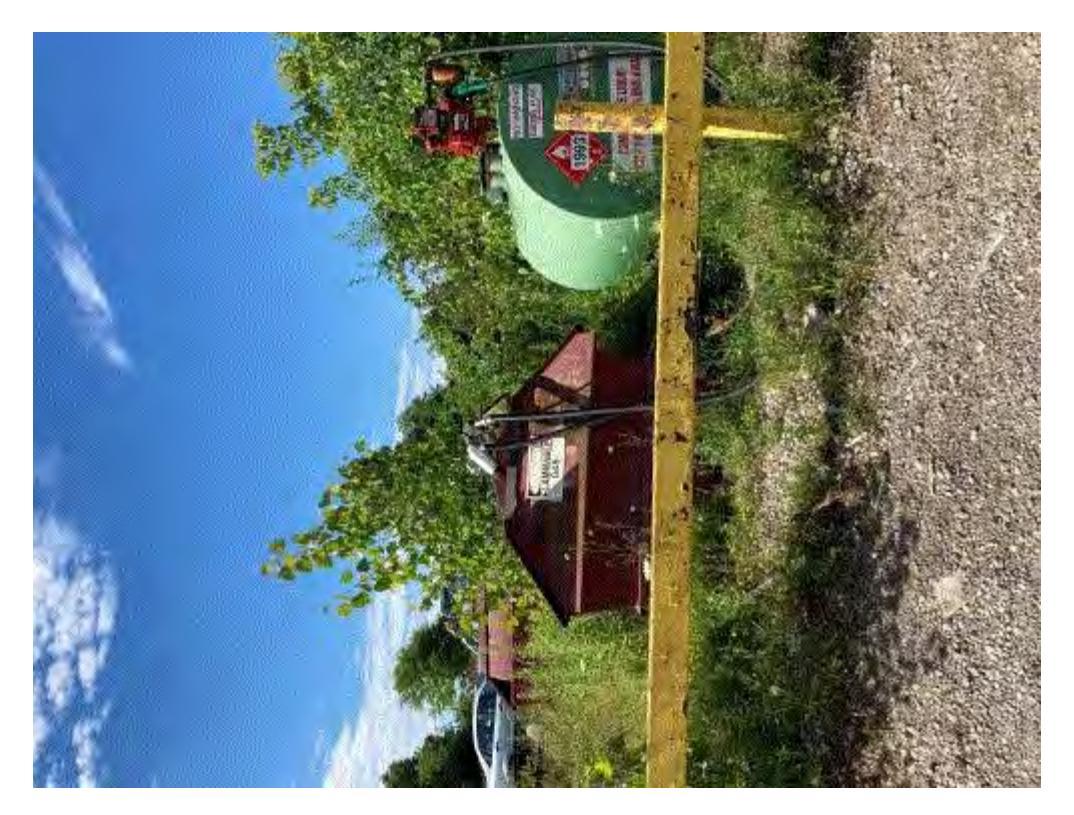
Image 4(0012) : Fuel storage tanks exempt per Rule 284(2)(g)
