DEPARTMENT OF ENVIRONMENTAL QUALITY AIR QUALITY DIVISION ACTIVITY REPORT: Scheduled Inspection

Lanutin Same	
FACILITY: ADM Grain Company - Webberville		
LOCATION: 2700 N. STOCKBRIDGE RD, WEBBERVILLE		
CITY: WEBBERVILLE		
CONTACT: Beth York , Area Environmental Manager		
COMPLIANCE STATUS: Compliance	SOURCE CLASS: MINOR	
inced inspection to determine compliance with PTI's 6	614-81, 766-83, and the NSPS Subpart DD.	
	y - Webberville IDGE RD, WEBBERVILLE vironmental Manager COMPLIANCE STATUS: Compliance inced inspection to determine compliance with PTI's (

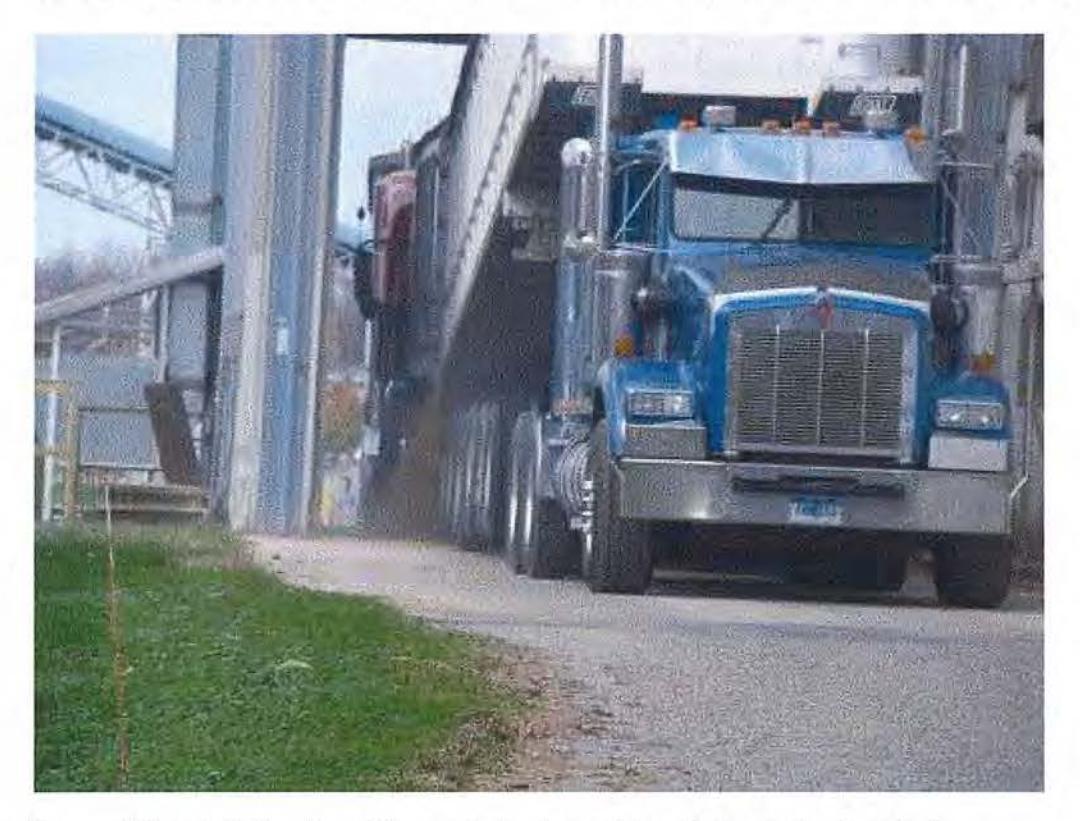
During the inspection J. Huber, T. Butcher and I watched several trucks unload in both unloading pits. One or two trucks caused no dust with the grain being unloaded (it was explained to me that the quality of the grain has bearing on how much dust there will be), while the majority of the trucks created dust that escaped the truck unloading area at what appeared to be greater than 20% opacity. See attached photos. I brought this to J. Huber and T. Butcher's attention and explained that although I was not going to conduct an official Method 9 opacity testing on the truck unloading pits that day, based on my experience with Method 9 opacity readings in the past, the opacity appeared to be greater than 20%. I proposed a few options to J. Huber, T. Butcher and Beth York in order to address the opacity issue:

Image 1(Truck Unloading #1) : south truck receiving pit. Dust clouds noted

- Discuss and find solutions for the excessive fugitive dust from pits
 - o Adjusting baghouse fan speed
 - o Installing dampers into the pits to slow down falling grain
- Demonstrate via certified Method 9 readings, that the opacity is under 20%, but only if the Method 9 is conducted during a period of high truck unloading operations, similar to the conditions during the inspection

I have given ADM until November 29th to provide a response with regard to addressing the opacity from the truck unloading pits.

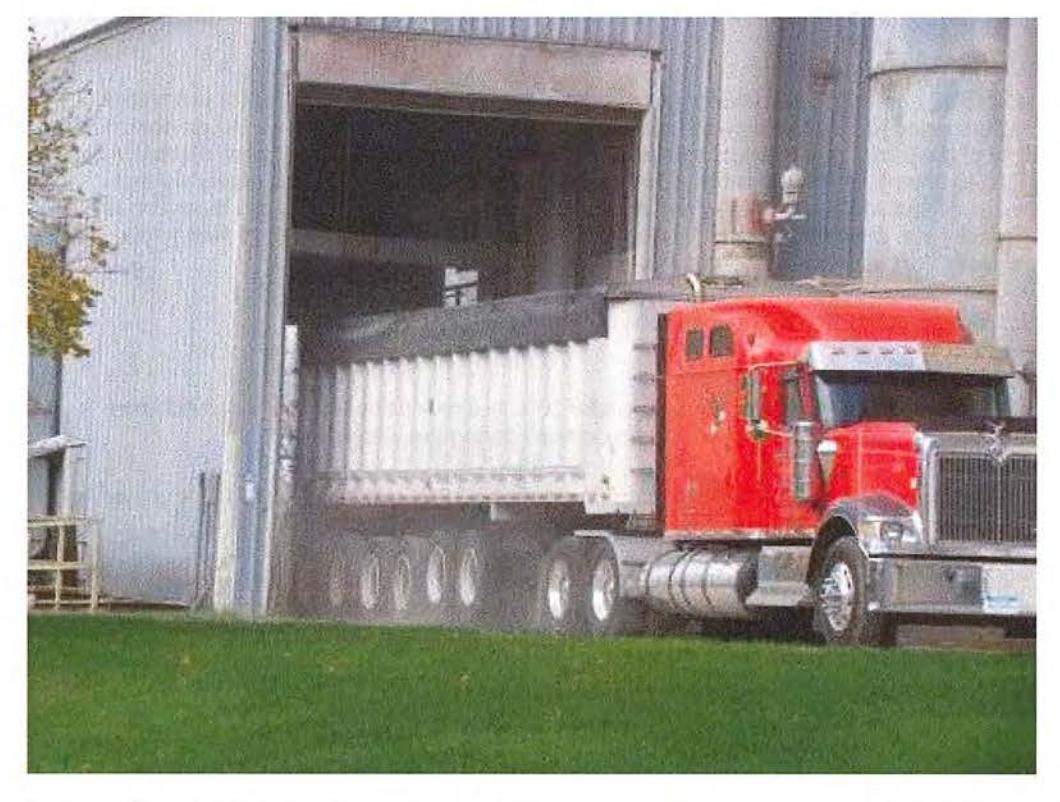
Image 2(Truck Unloading #2) : South dump pit, additional dust from another truck unloading

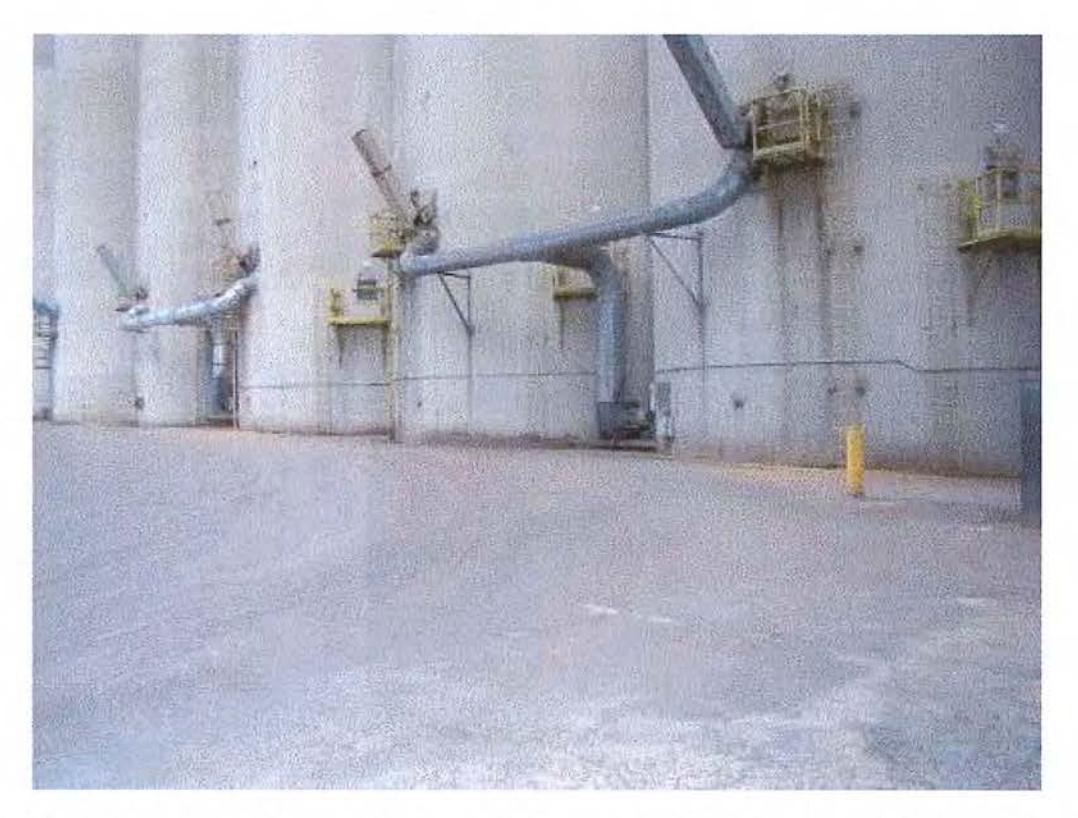
While walking through the grain elevator I noted that there were some beeswings on the ground, but the facility was predominantly well-kept and clean. I noted that none of the beeswings appeared to be outside of the property line and therefore believe that best housekeeping practices have been achieved.

ADM is required to load trucks and railcars with the loading spout below the level of the top of the truck or railcar. I did not observe any truck or rail loading during the inspection, but J. Huber and T. Butcher stated that the loadout spouts for the trucks may or may not sit below the level of the top of the truck, depending on how high the trucks are. The rail loadout spout they said does not sit below the level of the top of the railcar. ADM plans to void PTI 614-81 and operate under exemption Rule 285(2)(p); therefore, the spout drop distance requirement will no longer apply.

Image 3(Truck load-out spout) : Located on south side of silos. Note minimal beeswings near the silo bases.

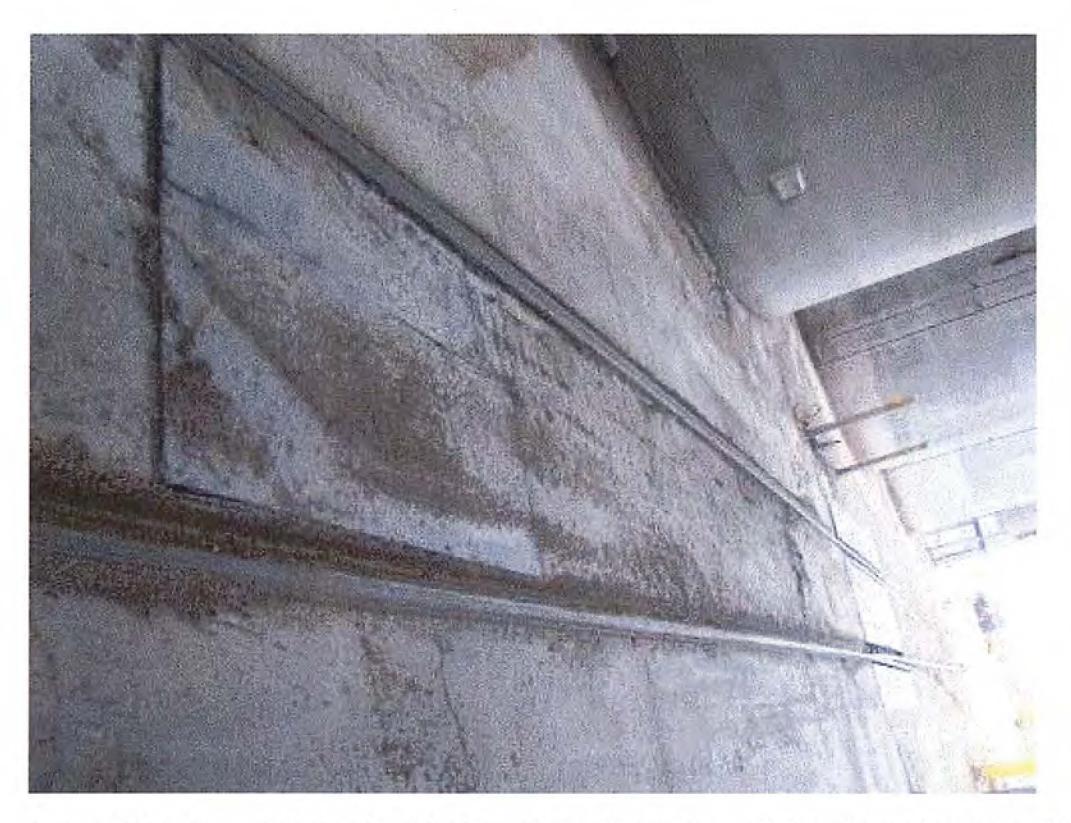
The permit also requires that the outside grain storage conveyors not have a free fall distance greater than 2 feet. During the inspection I noted that all conveyors are enclosed, except for the conveyor that is located above the railcar loading/unloading area. The conveyors, except for the unenclosed conveyor, were operating during the inspection and I saw no signs of opacity from these pieces of equipment, regardless of drop height, largely due to the conveyors being enclosed. ADM plans to void PTI 614-81 and operate the conveyors under exemption Rule 285(2)(p); therefore, the free fall distance requirements will no longer apply.

Image 4(Railcar unloading) : unloading pit located underneath the plywood in the middle of the tracks
