DEPARTMENT OF ENVIRONMENTAL QUALITY AIR QUALITY DIVISION ACTIVITY REPORT: On-site Inspection

| P1300/2900 | | |
|--|---|---|
| FACILITY: BURTON EXCAVATING INC | | SRN / ID: P1388 |
| SUBJECT: Targeted Inspection FY24 | | |

Burton Excavating is an excavation and construction company based out of Sault Ste. Marie, MI. The company operates a portable nonmetallic crusher plant throughout the Upper Peninsula of Michigan. The facility conducts its crushing operation under PTI No. 89-23A.

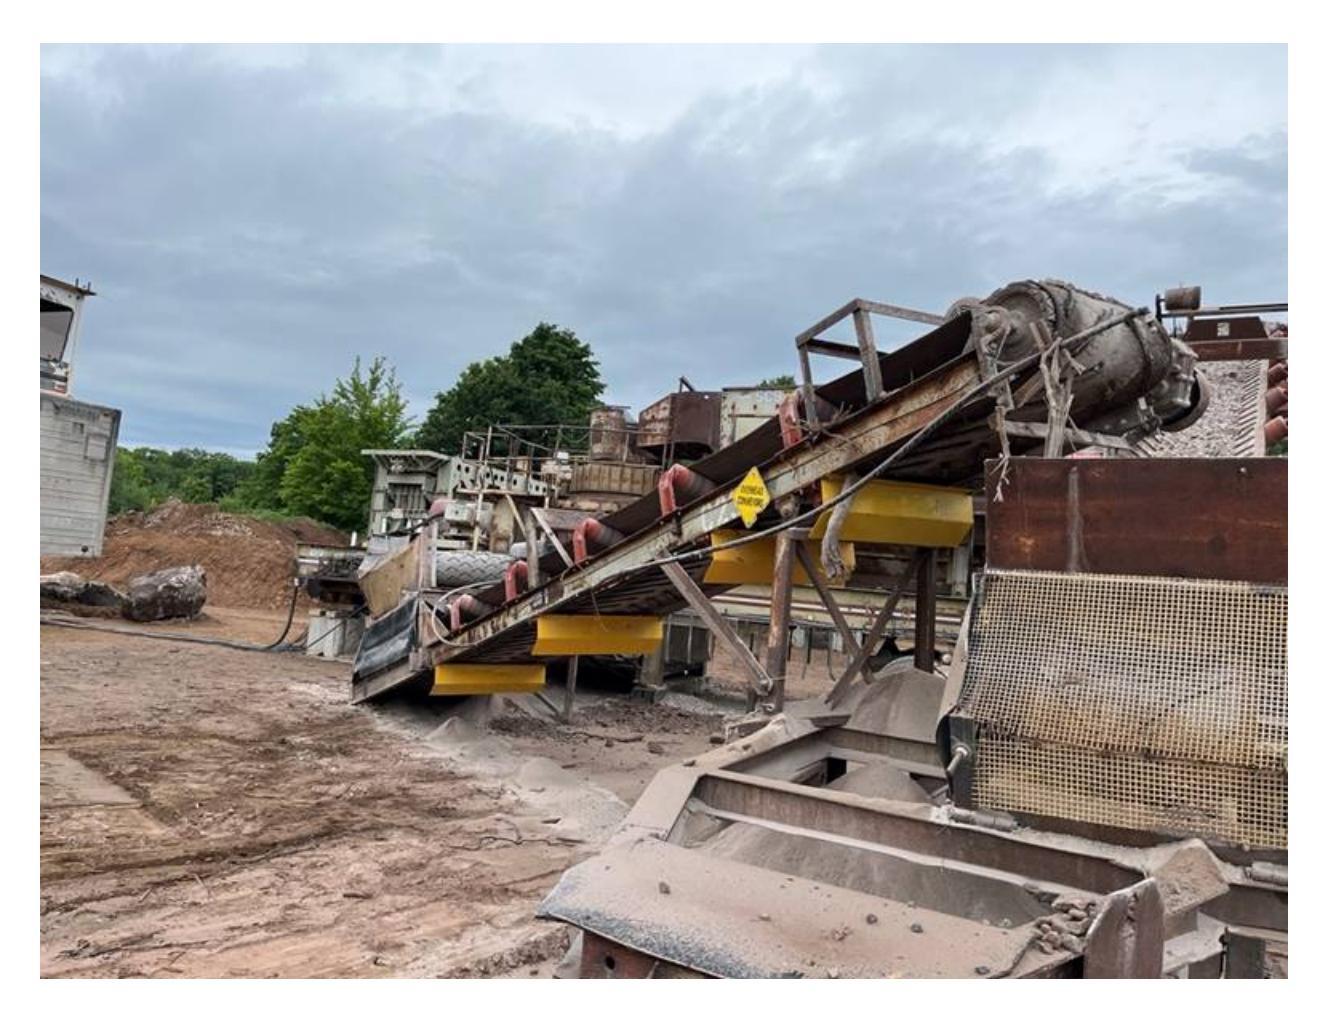
During the tour, two unpermitted recycle conveyors were observed on-site, labelled ROCK1 and ROCK2. The facility explained that they had initially considered the recycle conveyors to be included as part of the permitted Gyrasphere Cone Crusher (CR4004). AQD staff explained that the conveyors are considered separate equipment, and a new PTI application would need to be submitted to include the conveyors.

First of two unpermitted recycle conveyors (ROCK1)

Based on this inspection and the records reviewed, Burton Excavating Inc. appears to be in compliance with PTI No. 89-23A and all other applicable air pollution control rules and federal regulations. It was conveyed to the facility that the two recycle conveyors needed to be included in the permit, and all equipment needed to be properly labelled. Records review indicated that the issues were quickly handled. It was also conveyed that going forward, record of dust suppression activities must be maintained.

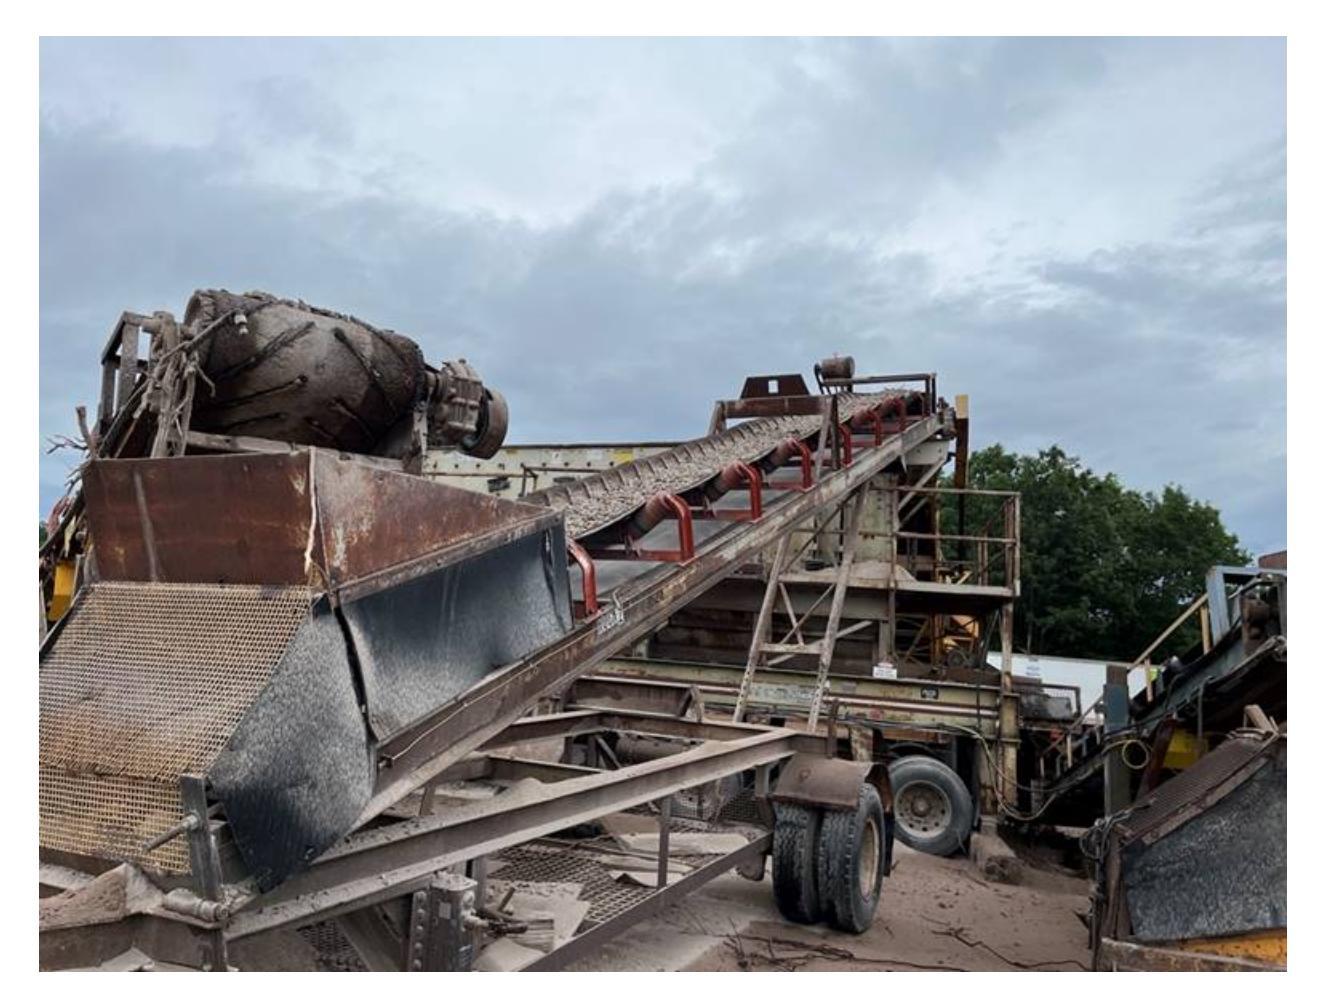
Second of two unpermitted recycle conveyors (ROCK2)

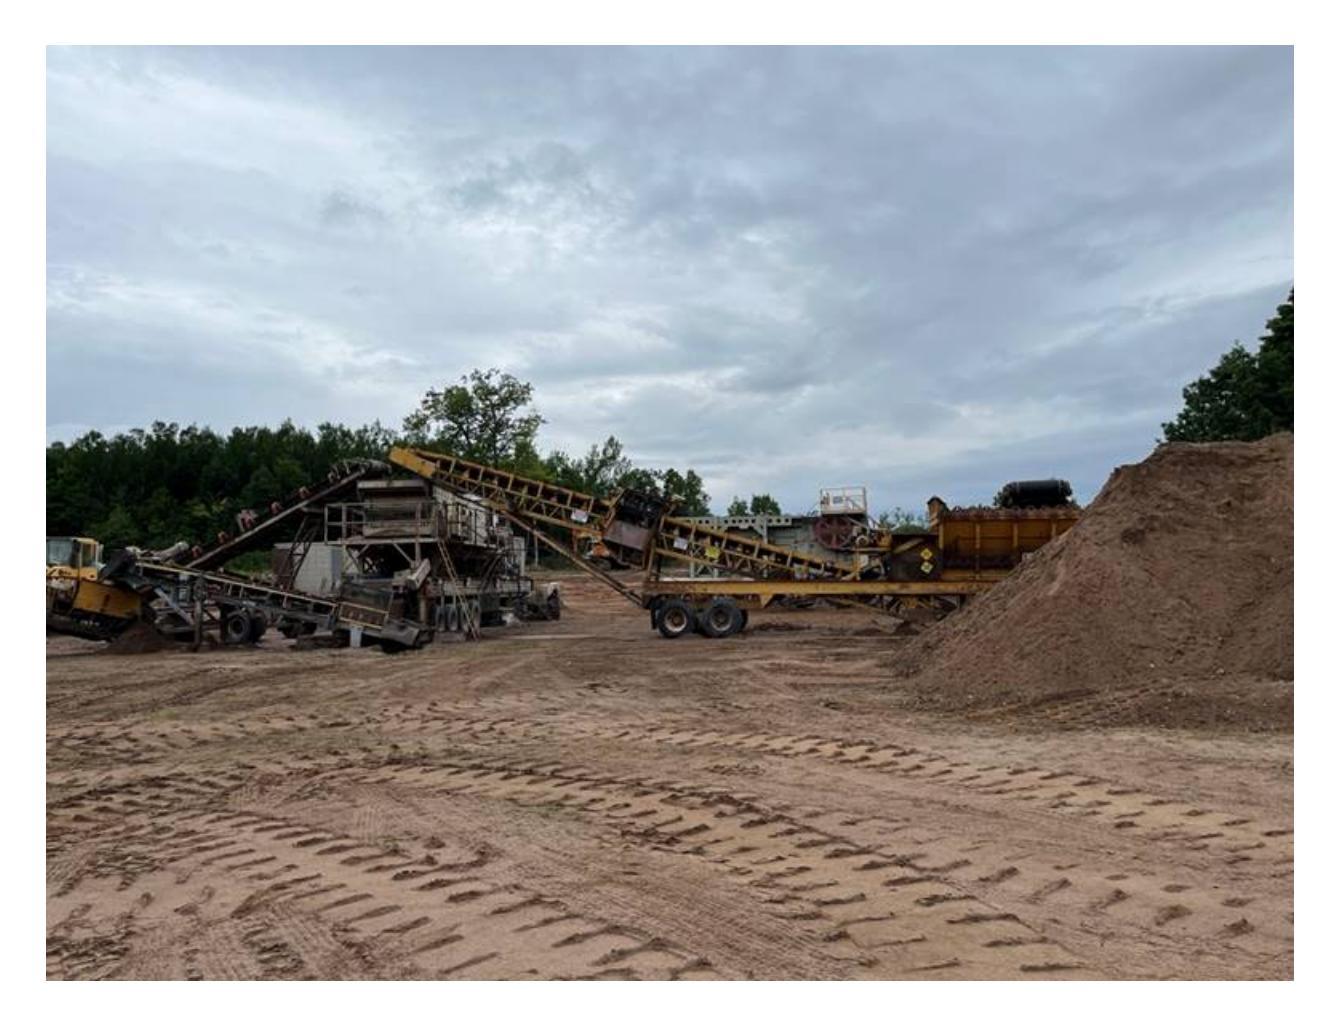
On July 23, 2024, AQD staff (Drew Yesmunt and Michael Conklin) conducted a targeted inspection of Burton Excavating. The facility's crusher plant was operating in the 15 Mile Pit located at 5996 E 15 Mile Rd, Barbeau, MI. At the time of inspection, the facility had not yet sent in a relocation notice as the crusher plant had only operated at the 15 Mile Pit since the facility's permit was issued. AQD staff arrived at the facility and met with Rob Thompson, the facility's compliance contact. It was explained that the purpose of the inspection was to ensure compliance with PTI No. 89-23A and all other applicable air pollution control rules and federal regulations. A tour of the facility was then provided. AQD staff observed that all permitted equipment was present onsite. No equipment was operating during the time of inspection. It was explained to AQD staff that although the crushing season had started, the Telesmith Jaw Crusher (CR4002) on-site was jammed with material, causing a temporary shutdown. It was observed by AQD staff that the facility's second transfer conveyor (TRANSFER #2) was not properly labelled as per special condition 1.11. It was conveyed to the facility that all equipment needs to be labelled as per the permit conditions. The facility responded stating that the conveyer would be labelled as soon as possible.

The facility's second transfer conveyor (TRANSFER #2)

Following the inspection, AQD staff sent a records request to the facility. The records requested included material processing records for all sites for 2023 and 2024, a photo demonstrating that TRANSFER #2 has been properly labelled, and for a new PTI application to be submitted to include the recycle conveyors. Material processing records were provided and showed the facility produced 37,443 tons of material in 2023 and 4,115 tons in 2024, under the facility's 12-month rolling limit of 1,000,000 tons. The facility also provided an updated PTI application to include the recycle conveyors. It was also noted by AQD staff that records of Method 9 visible emissions testing for all equipment, including the two recycle conveyors, were available and kept on file.
