DEPARTMENT OF ENVIRONMENTAL QUALITY AIR QUALITY DIVISION ACTIVITY REPORT: On-site Inspection

Facility: Grede, LLC – Iron Mountain (B1577)

Location: 801 South Carpenter Avenue, Kingsford, MI 49802

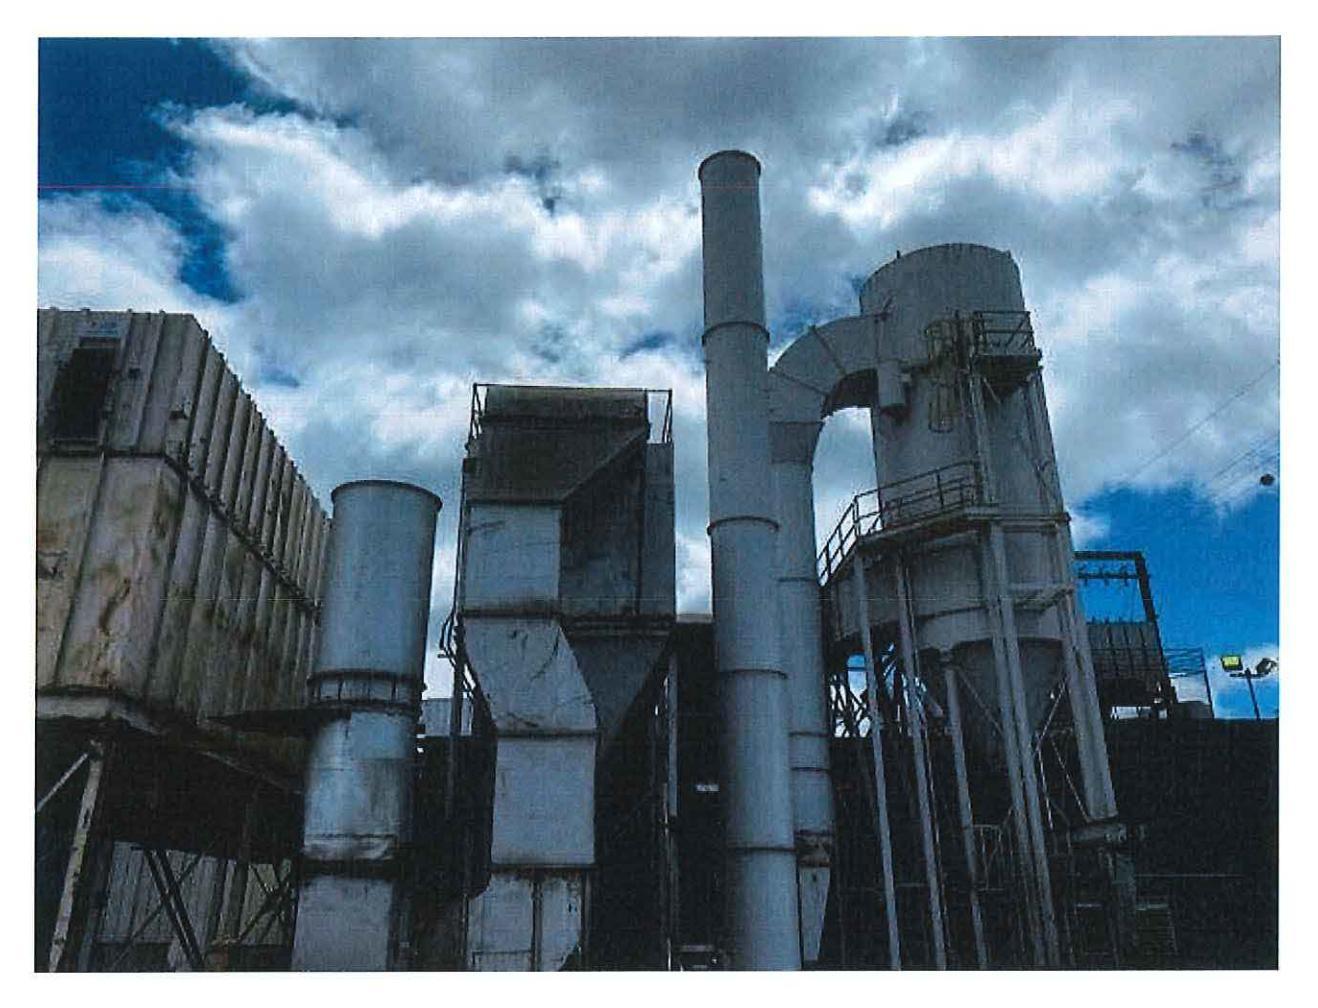
The Linsmeyer and Torrit #1 baghouses were operating at the time of the inspection. No visible emissions were observed. The Linsmeyer baghouse stack measured 23.1 feet and the Torit #1 baghouse stack measured 60.4 feet. According to the ROP, the minimum stack height for the Linsmeyer baghouse is 30 feet. Based on the measurements taken, the Linsmeyer baghouse is not meeting the minimum stack height requirement.

Image (1) Linsmeyer baghouse stack.

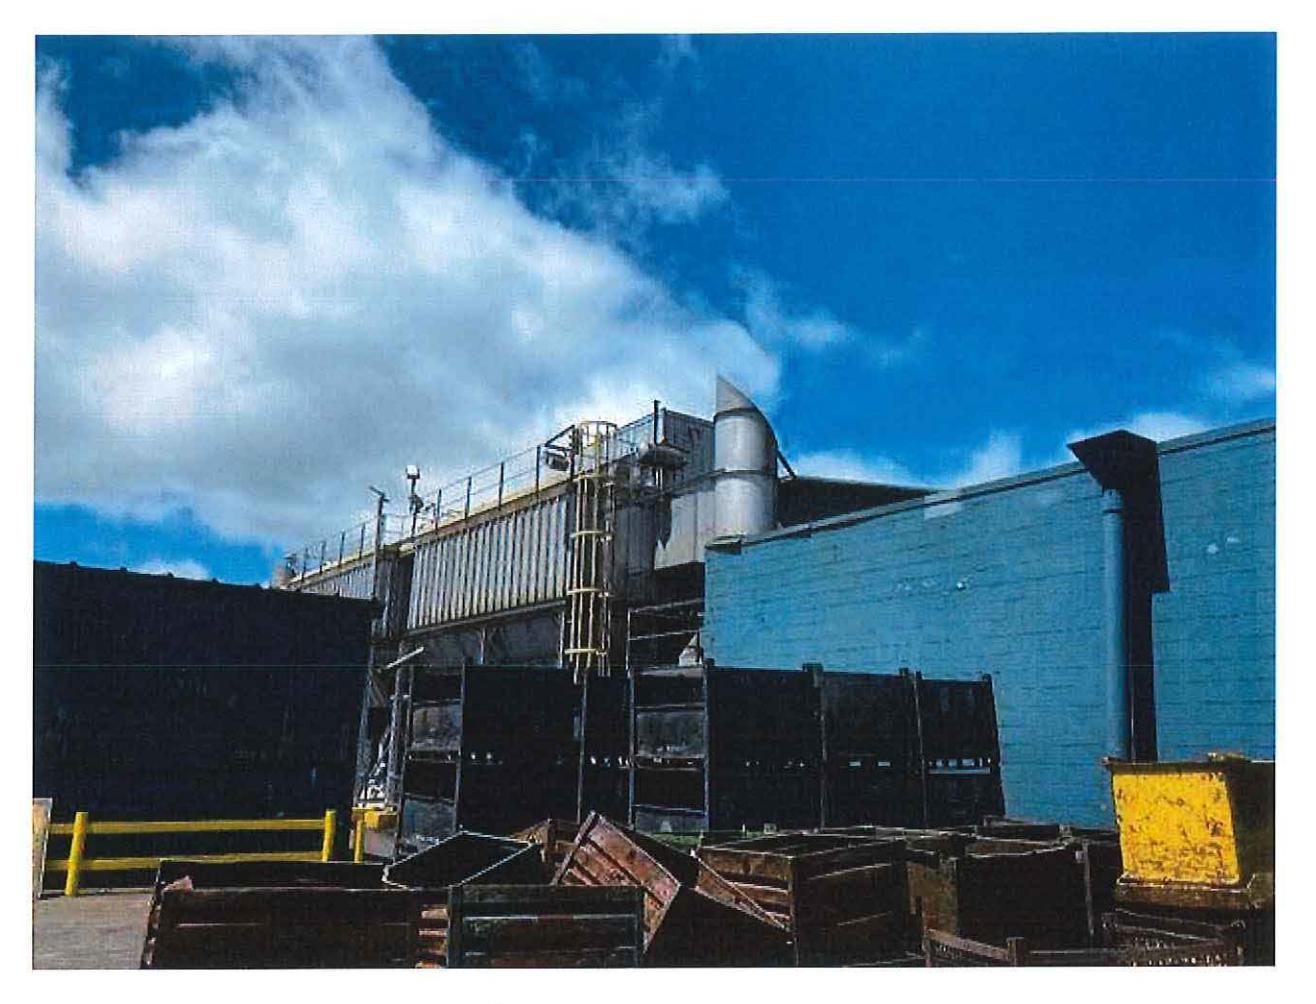
After collecting the monitoring parameters data, we proceeded outside of the facility to inspect the Steelcraft, West Fuller, and East Fuller for visible emissions and verify stack heights with the rangefinder. At the time of the inspection, all three baghouses were in operation and no visible emissions were observed. The Steelcraft baghouse measured 45.5 feet, which meets the minimum height requirement of 44 feet. The East and West Fuller baghouse stacks are cut on a 45-degree slant. Measuring at the bottom point of the stack results in a measured height of 25 feet for both West and East Fuller. Measuring at the higher point, results in a measured height of 29 feet. Since exhaust emissions can be emitted at the lowest point in the stack, the minimum height must be compared to the permitted limit. In doing so, the West and East Fuller baghouses are not meeting the minimum height requirement of 27 feet. If the stacks were raised to the high point in the slant, then the stacks would meet the minimum height requirement.

Image (2) East Fuller baghouse stack.

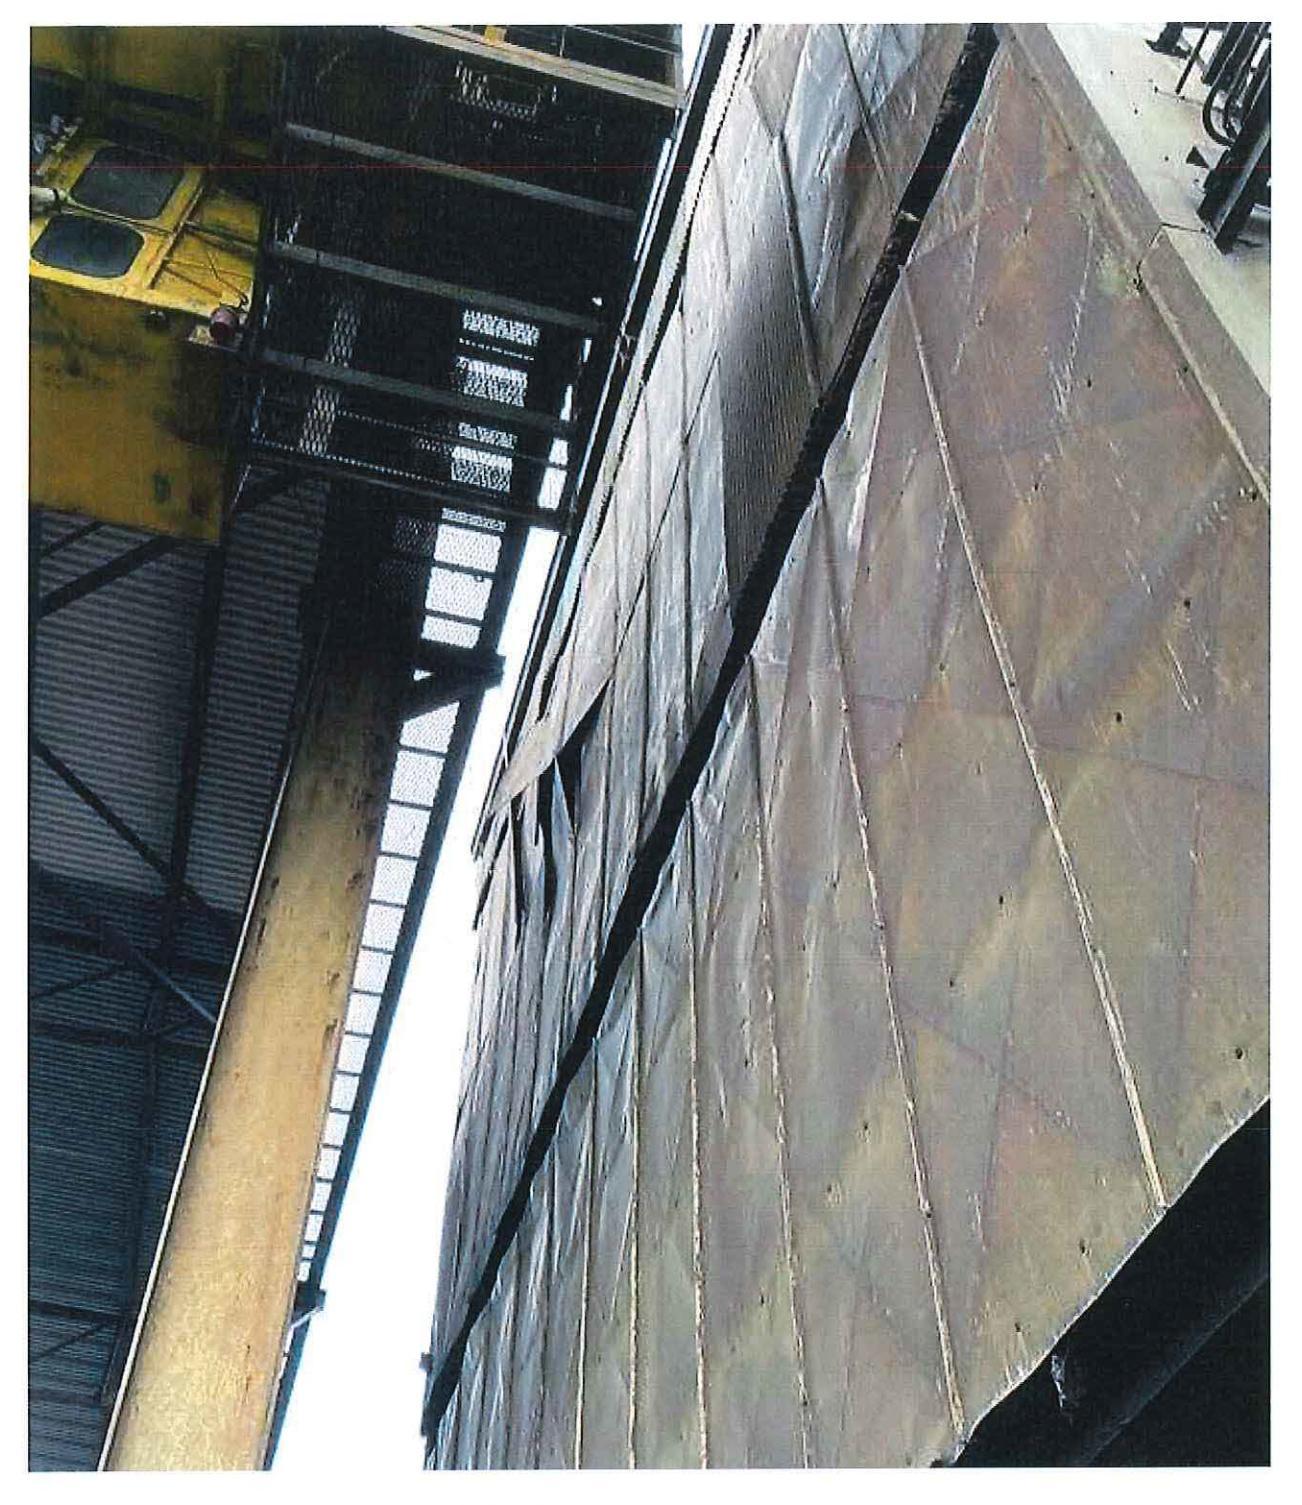
The baghouse was inspected for visible emissions, proper operation, overall condition, and stack height. During the inspection of the baghouse, it was observed panels on the south facing side were not intact and were blowing outwards. Since the baghouse is a positive pressure unit, the exhaust appeared to also be exiting some at the point where the housing is not intact. The panels are being blown outward indicating emissions are being vented at this point. A range finder was used to measure the height at which the panels were shown not intact. A height of 42.6 feet was measured.

Based on observations of the baghouse, the integrity of the structure did not appear to be well maintained and was causing exhaust leaks at a point where it should not be emitting.

Image (3) Gaps observed in cupola baghouse structure.

Rule/Permit	
Process Description	Condition Violated	Comments
EU-P009 Cupola	Special Condition III.1	Panels on the south facing side of the baghouse were not intact and blowing outwards.
FGMACTEEEEE	Special Condition IV.1	Maintenance on the baghouse did not appear to be following the Operations and Maintenance Plan based on gaps observed in the baghouse structure.
FGMACTEEEEE	Special Condition VII.4 and 5	The facility has not been certifying compliance explicitly with 40 CFR Part 63, Subpart EEEEE when submitting the ROP compliance and deviation reports.

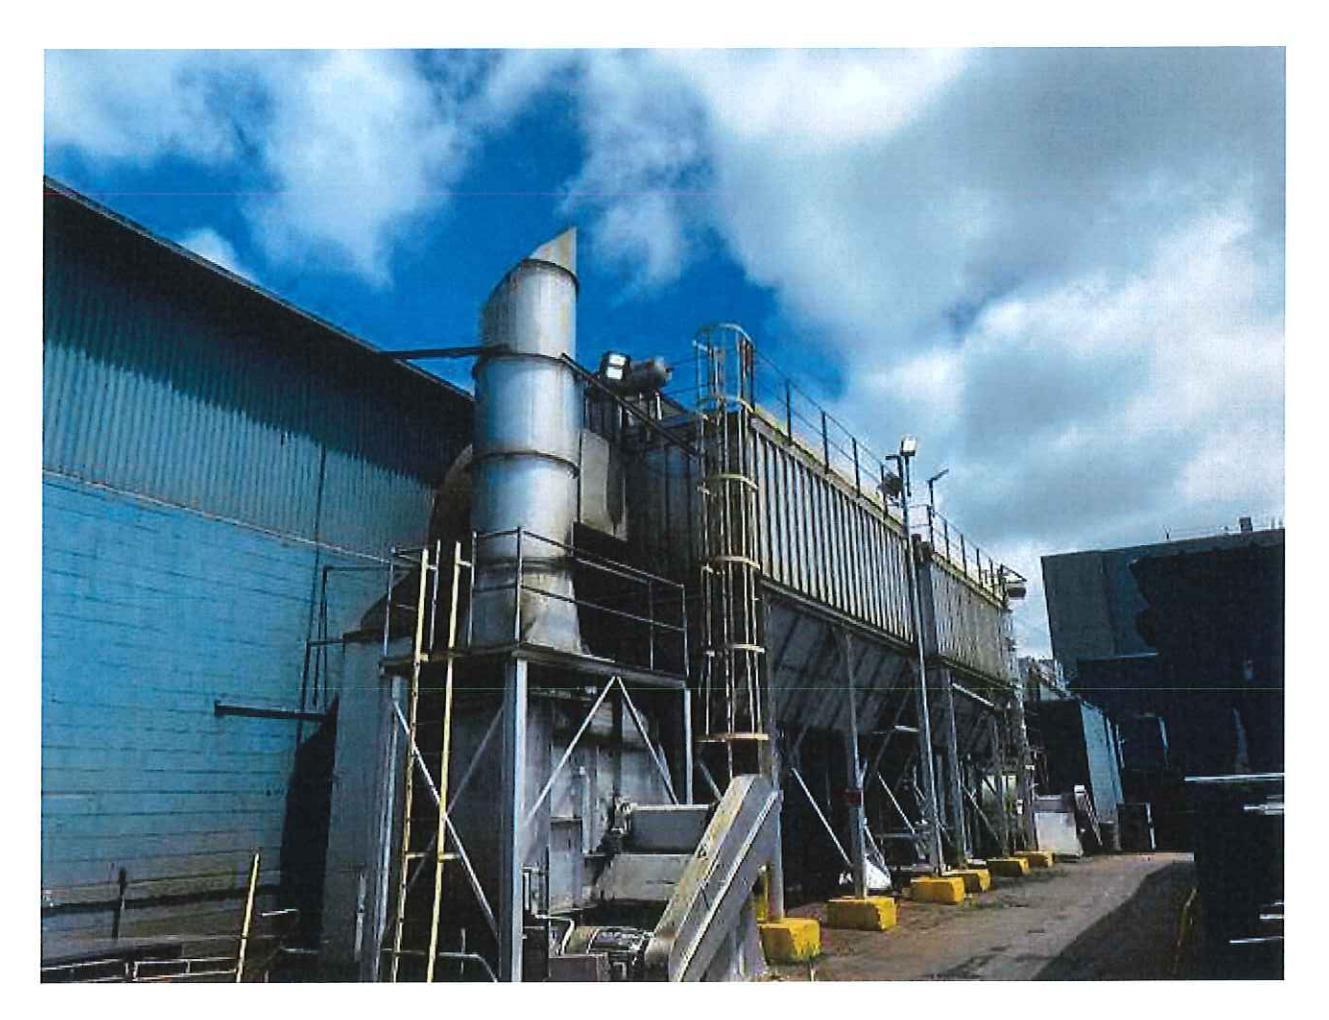
Image (4) West Fuller baghouse stack.
