#### DEPARTMENT OF ENVIRONMENTAL QUALITY AIR QUALITY DIVISION ACTIVITY REPORT: On-site Inspection

Facility: Bacco Construction Co Plant 12 (SRN: B6451)

## Location: N3676 US-2, Iron Mountain, MI 49801

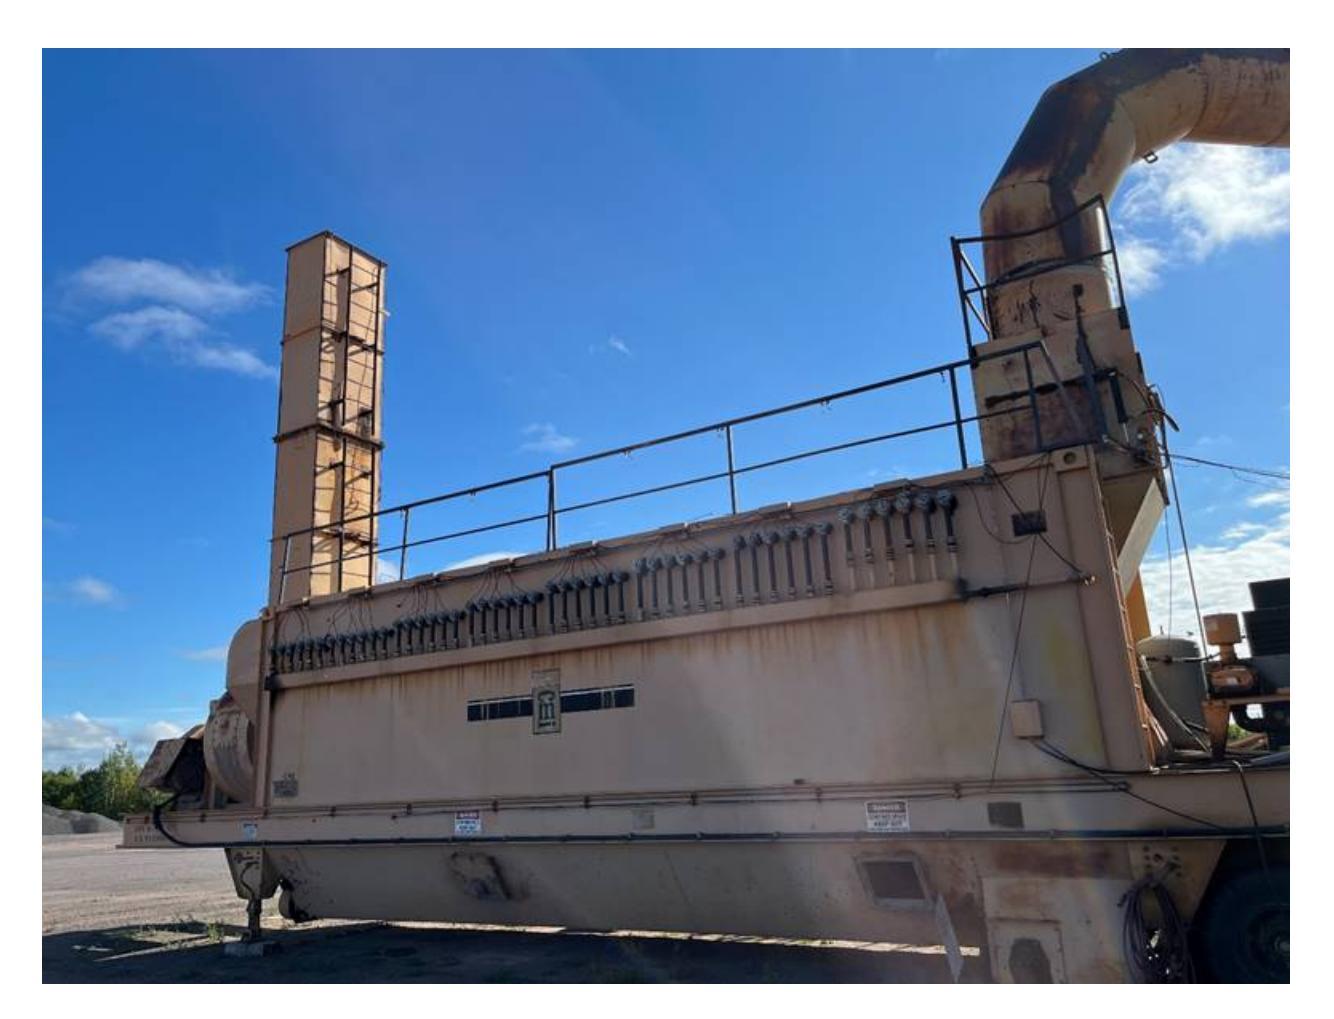
Baghouse and stack connected to Bacco Construction Co. Plant 12

The facility operates a CMI Unitized Drum Mix asphalt plant. AQD staff observed that the facility's baghouse was properly installed and connected to the drum dryer. The baghouse was also equipped with a high temp alarm. The main exhaust duct from the dryer to the baghouse appeared to be in good condition with no gaps in the structure. No excess material was observed around transfer points of the collected material from the baghouse, and no holes were observed in the structure. The collection system appeared to be well sealed. Areas around the feed bins were inspected for excess spillage of aggregate material. AQD staff also did not observe any excess fugitive dust from the plant yard or roadways during the inspection. The facility stated that water is applied during each operating day to control dust.

AQD staff then conducted a Method 9 visible emissions observation on the baghouse stack. Particulate emissions were detected during operation, but the emissions remained below the facility's permitted limit of 20 percent opacity. During the observation, a visible haze was briefly observed downwind of the stack before dissipating. Following the Method 9 observation, AQD staff alerted the facility to the presence of the visible emissions as a potential indicator of baghouse malfunction or failure. The facility responded stating that the plant foreman would be coming to the site in the coming days and would inspect the baghouse for any malfunctions.

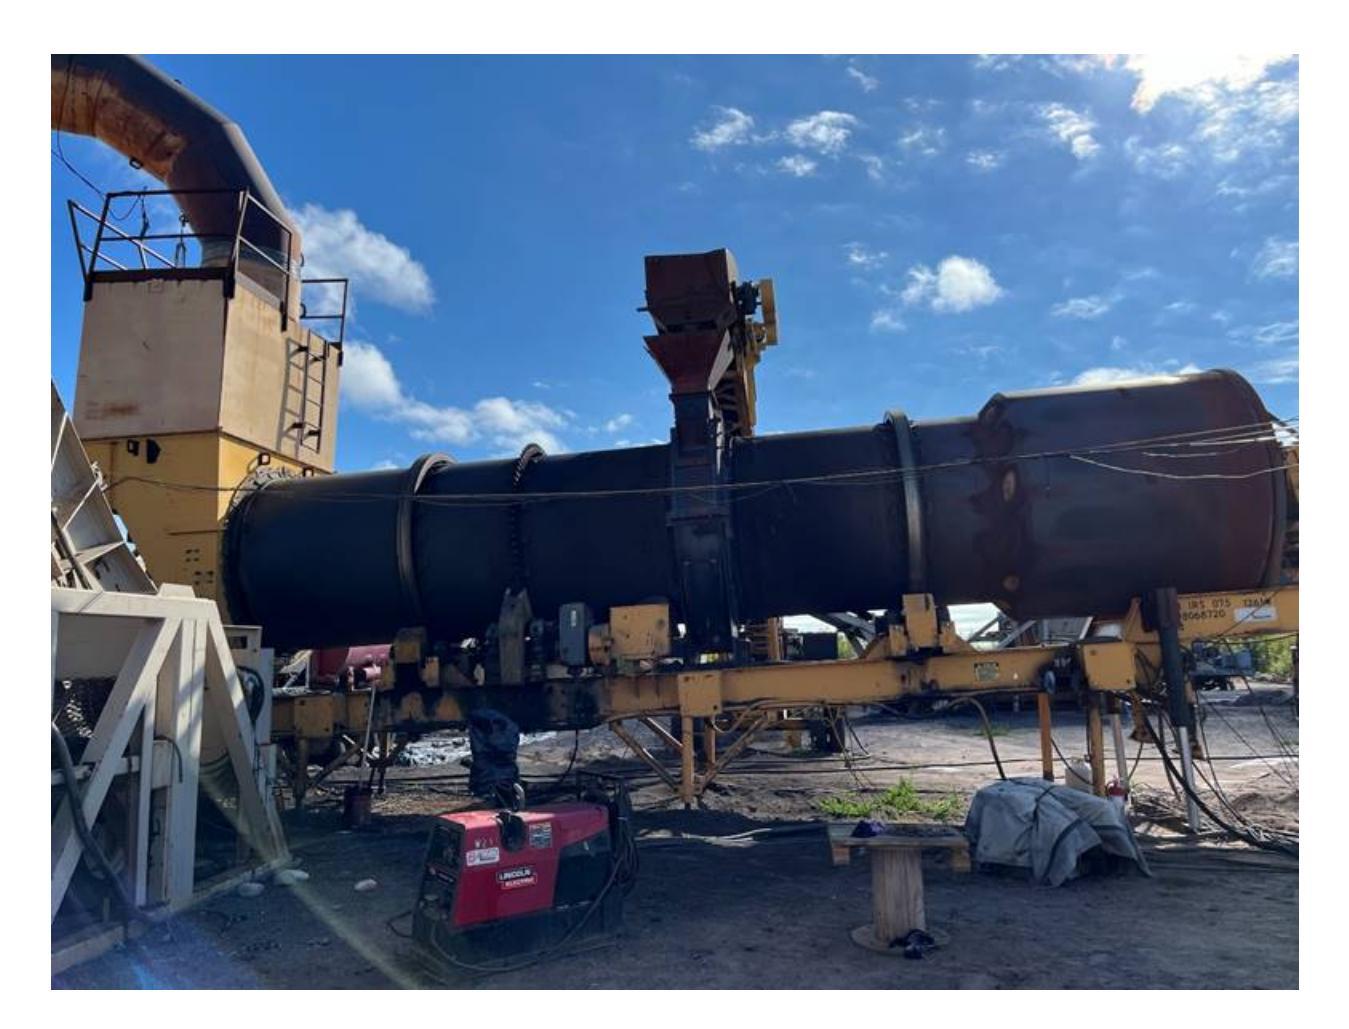
Drum dryer
