**DEPARTMENT OF ENVIRONMENTAL QUALITY
AIR QUALITY DIVISION
ACTIVITY REPORT: On-site Inspection**

B164658044

FACILITY: RIETH RILEY CONSTRUCTION CO., INC.	SRN / ID: B1646
LOCATION: 4150 S. CREYTS RD., LANSING	DISTRICT: Lansing
CITY: LANSING	COUNTY: EATON
CONTACT: John Berscheit , Technical Services Manager	ACTIVITY DATE: 05/13/2021
STAFF: Michelle Luplow	COMPLIANCE STATUS: Non Compliance
SOURCE CLASS: SM OPT OUT	
SUBJECT: Partial compliance evaluation inspection conducted as part of a full compliance evaluation.	
RESOLVED COMPLAINTS:

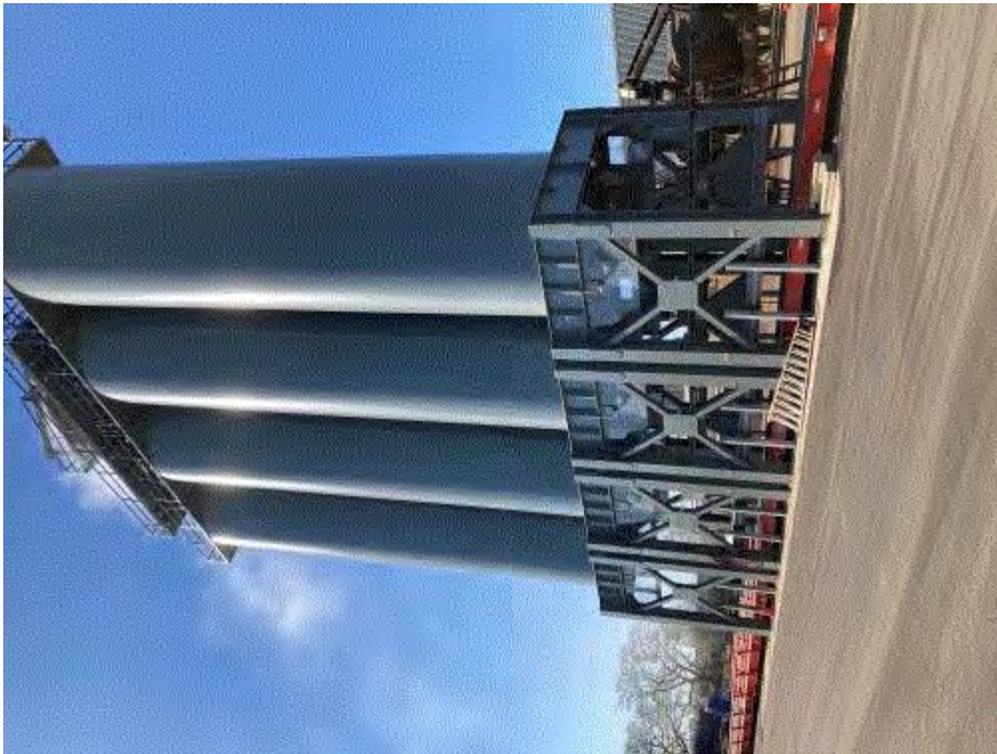
EUSILOS	<p>Four 300-ton finished-product storage silos all installed in 2020. Coils in the bottom of each silo are heated with heat transfer oil to keep the finished product at a working temperature.</p>
EUYARD	<p>Fugitive dust sources:</p> <ul style="list-style-type: none"> -all plant roadways -plant yard -material storage piles -material handling operations
Boiler	<p>2 MMBtu/hr Natural gas-fired for heating heat transfer oil exempt under Rule 282(2)(b)(i)</p>

Image 2(New Silos) : 4 new 300-ton silos with new loadout tunnel

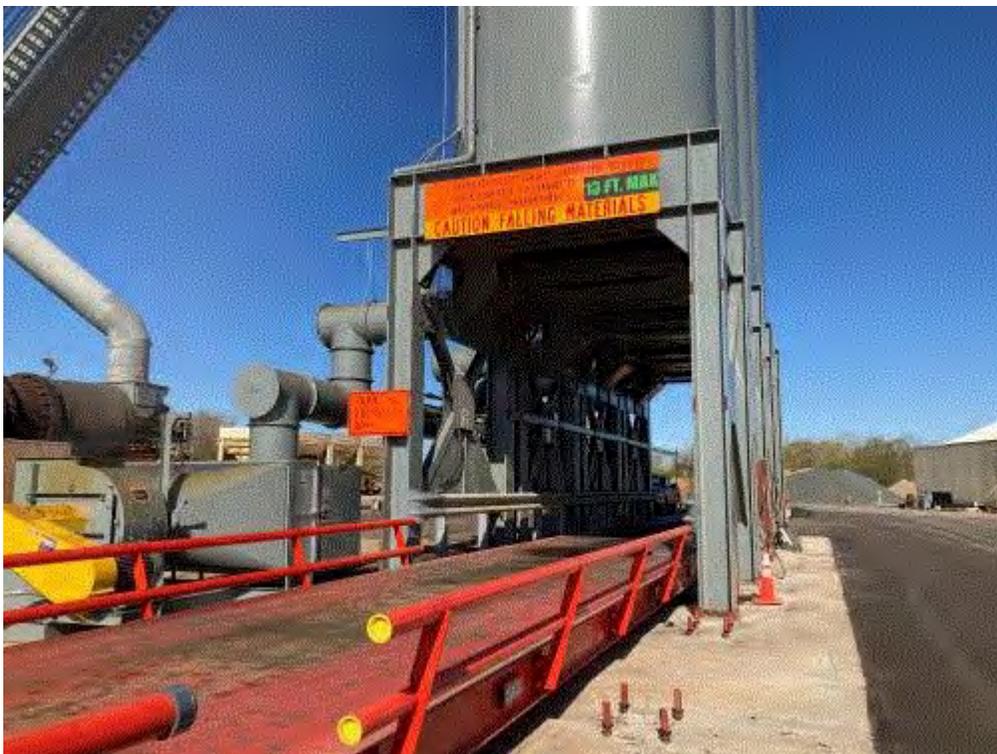
The asphalt odors/smoke from loadout, as well as from the loadout silos are captured via a new control system, which J. Berscheit had described as "paper filters." J. Berscheit provided me with additional information on these filters, which he said work in tandem: a Camfil Farr 30/30 High Capacity Pleated Panel Air filter and a Camfil

Image 3(Loadout Tunnel) : New loadout tunnel with new control device

Durafil ES2 (microfiber) Final filter. I have requested an exemption demonstration for the replacement of the previous control device with these two filters.

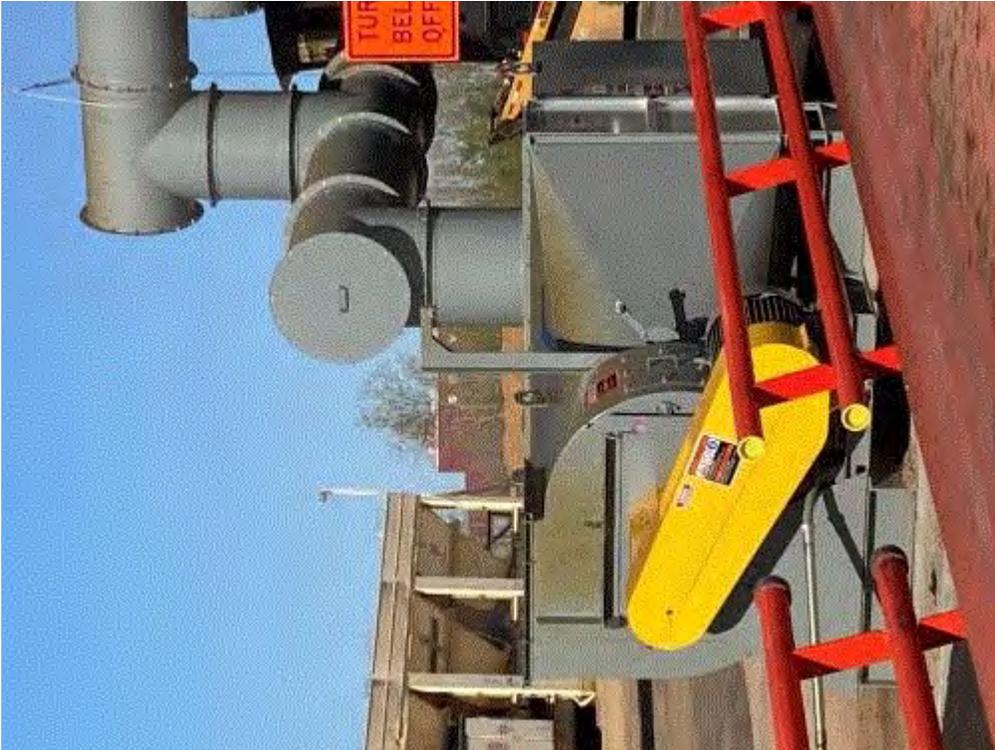
During the inspection, I watched the loading of a few trucks through the loadout area and did not see any signs of opacity (nor did I detect any odors, but I was standing upwind of the loadout at that time) from unloading nor from the blue smoke control device. The loadout area is required to be completely enclosed. The previous silos have been replaced with 4 new 300-ton silos, as well as the structure that supports the silos and which also is part of the loadout tunnel. The new loadout tunnel is not fully enclosed. There are panels on either side of the loadout tunnel that allow for egress from the truck drivers in the event of an emergency: the bottom of the panels line up with the top of the truck beds. Further internal discussions will be had to address whether this set up meets the intent of the requirement, in light of newly permitted asphalt plant permit requirements.

Image 4(Loadout Control) : New control system close-up. No opacity seen from unit during loadout activities.

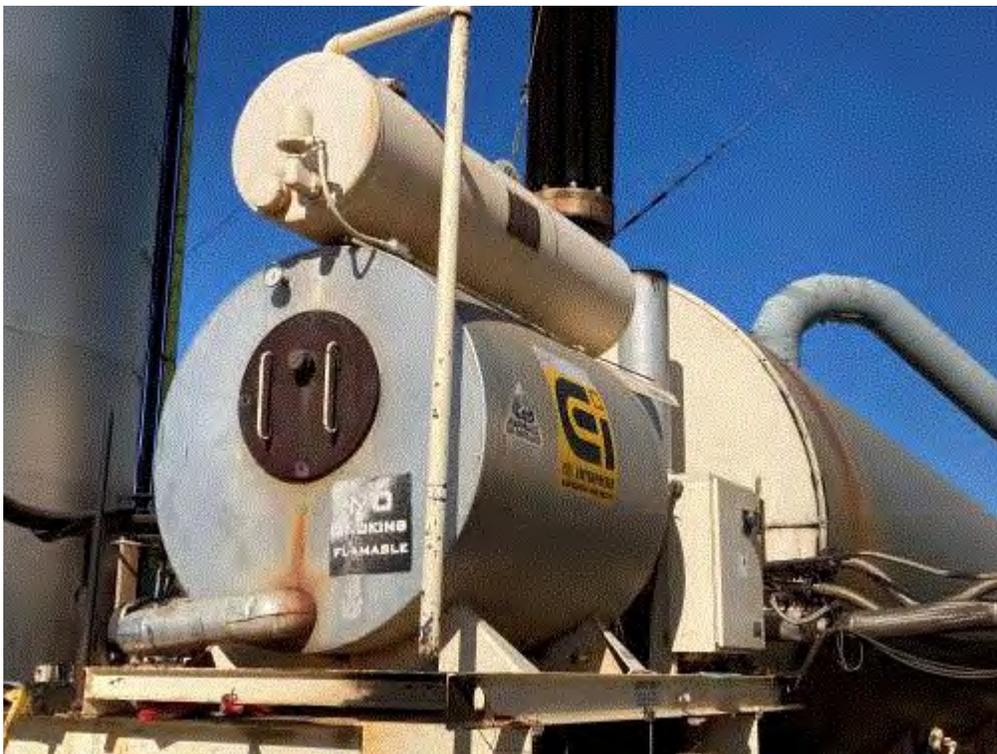
Image 5(Gas-fired boiler) : Natural gas-fired boiler used to heat the heat transfer fluid for warm the AC tanks and silos.

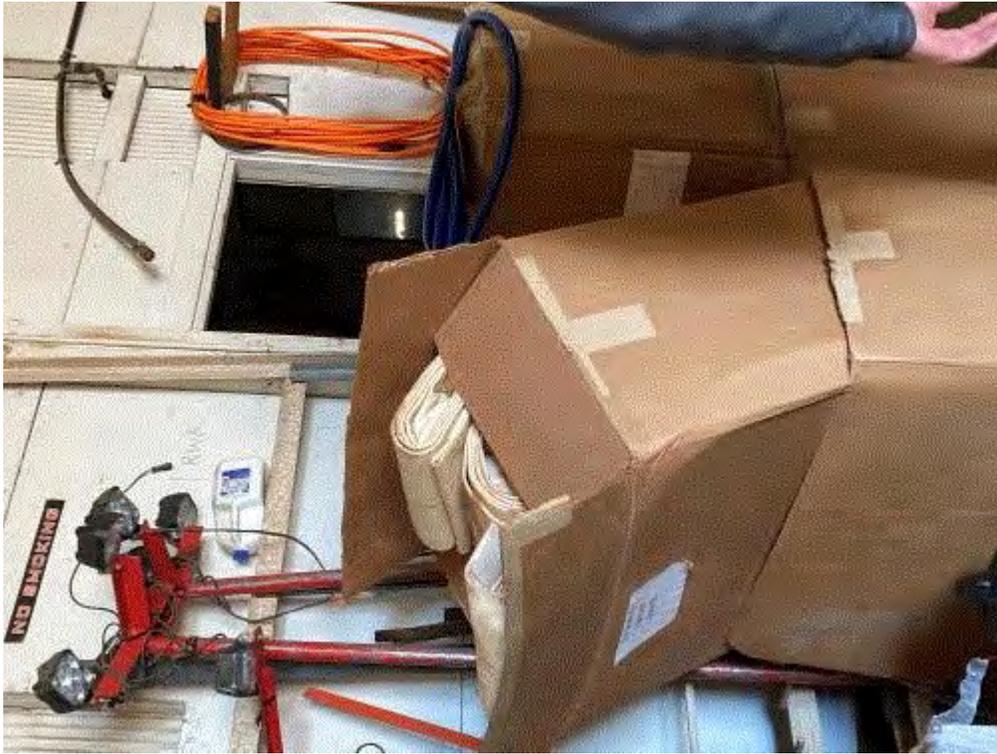
A minimum of 15 fabric filter bags are required to be maintained in inventory onsite at all times. J. Berscheit, D. Larson and I confirmed onsite that there were at least 4 boxes (25 bags per box) of filter bags in inventory onsite.

Image 6(baghouse filters) : 4 boxes of new baghouse filters kept in inventory

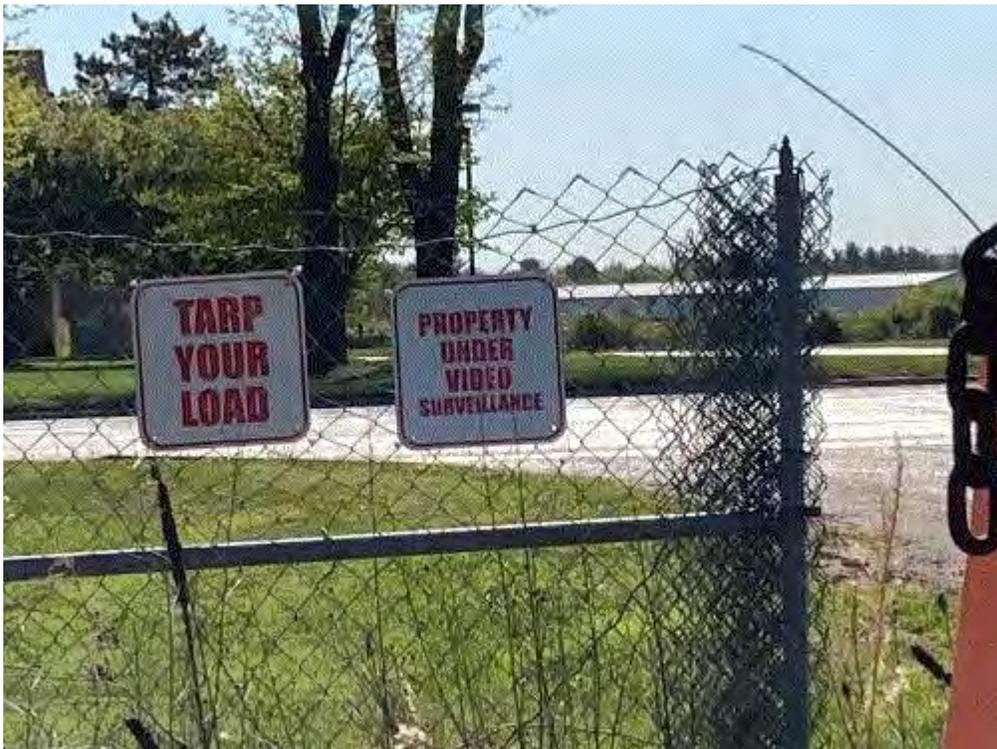
All trucks entering the site to deliver loads and all trucks leaving the site with HMA paving materials are required to cover their loads. A sign for the trucks leaving the site is also required to remind them to tarp the loads prior to leaving the site. D. Larson, J. Berscheit and I walked to the exit gate and verified that signs had been installed reminding truck drivers to cover their loads. Additionally, they installed a sign to alert truck drivers that they are under surveillance. All trucks exiting the site covered their loads prior to leaving the property boundary.

Image 7(Exit signs) : Cover load sign prior to exiting facility.

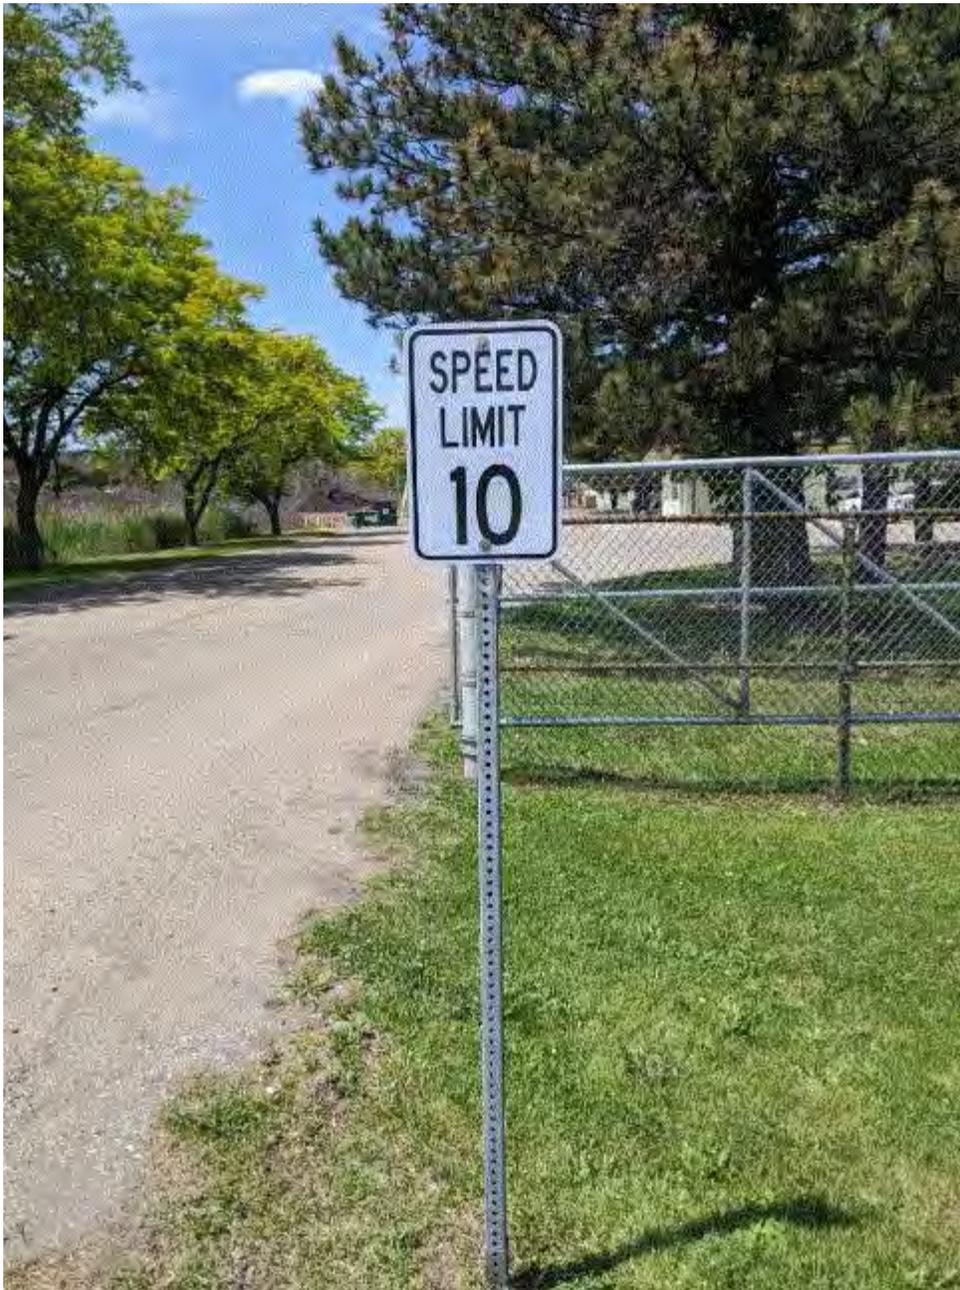
Image 9(New Speed Limit sign) : Photo credit: Dan Larson, Rieth-Riley. New sign posted to replace faded sign.

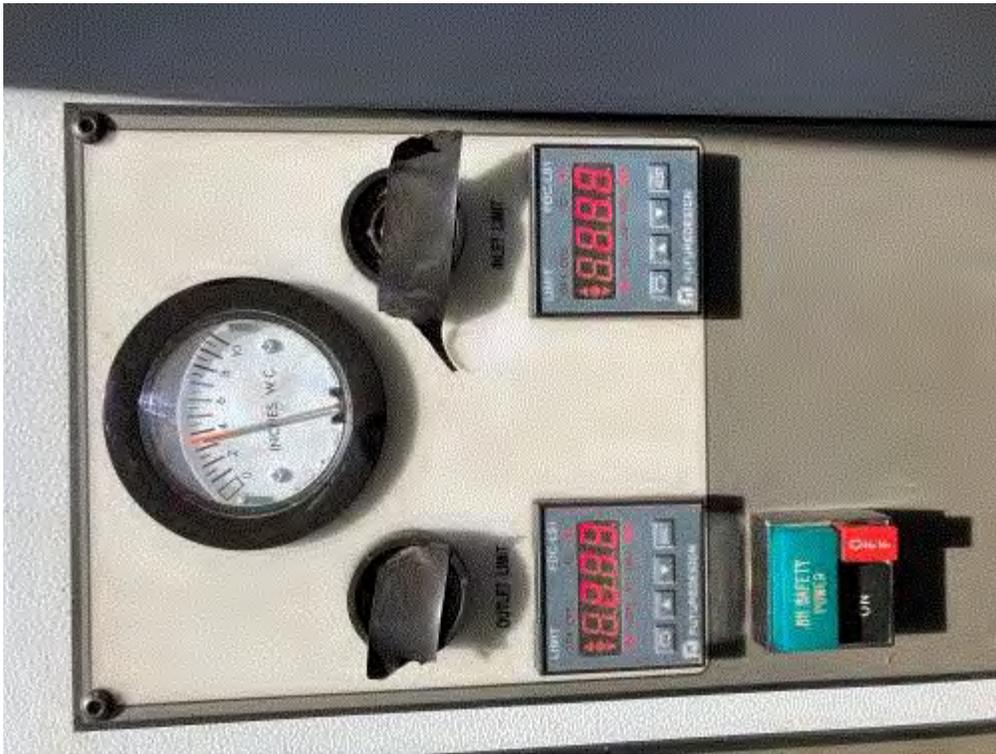
J. Berscheit, per my request, provided me with April & May 2019, and April & May 2021 pressure drop records. Pressure drops ranged from 3 "H₂O to 7 "H₂O. Early season pressure drop records were requested to learn/understand what pressure drops look like early on in the season, prior to larger production periods. All appeared to be in compliance with the 2-8 "H₂O permitted range.

Image 10(Baghouse dP) : Pressure drop monitor for baghouse control. Photo credit: John Berscheid, Rieth-Riley

Rieth-Riley is required to install, maintain and operate a device to monitor the pressure drop across the baghouse, and must be calibrated on an annual basis in accordance with manufacturer's instructions. J. Berscheit said that the gauge is always replaced on an annual basis because the cost to do conduct a calibration exceeds the cost to operate a factory-calibrated gauge. He said that the gauge was replaced in the spring of 2021.

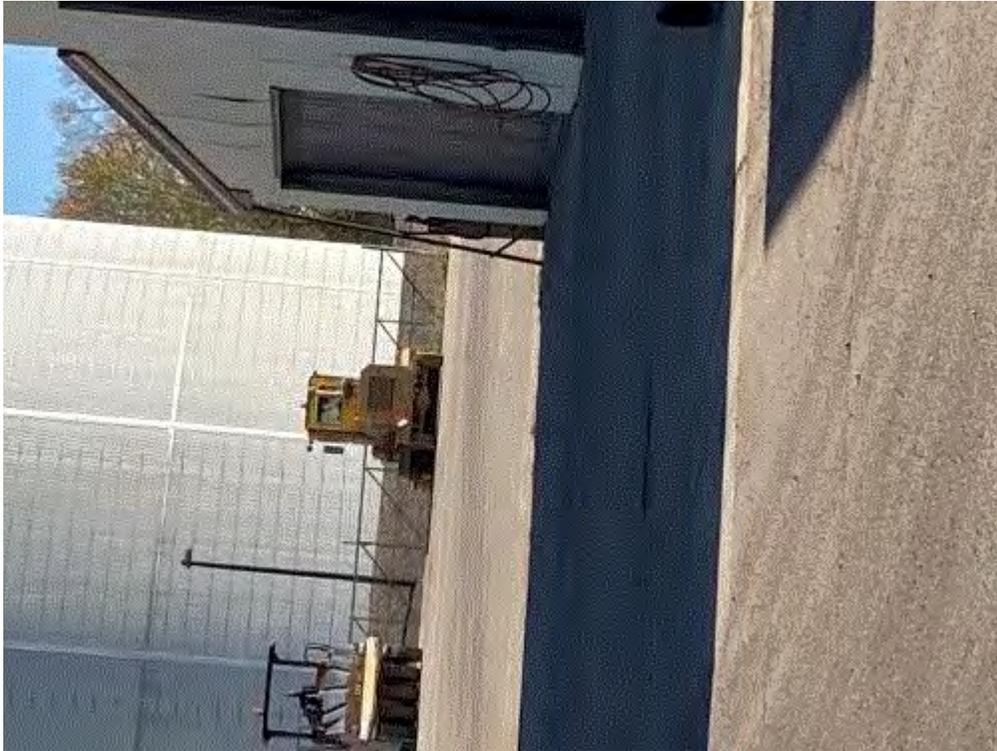
D. Larson said that Rieth-Riley uses a water truck and a mechanical broom with water to maintain fugitive dust on paved surfaces.

Image 12(Sweeper Truck) : Sweeper truck to be used in conjunction with water truck.
