DEPARTMENT OF ENVIRONMENTAL QUALITY
AIR QUALITY DIVISION
ACTIVITY REPORT: Complaint Investigation

FACILITY: ReConserve of Michigan, Inc.		SRN / ID: N8081
LOCATION: 170 ANGELL STREET, BATTLE CREEK		DISTRICT: Kalamazoo
CITY: BATTLE CREEK		COUNTY: CALHOUN
CONTACT: Kevin Kowalchuk , Transportation Manager		ACTIVITY DATE: 05/09/2023
STAFF: Amanda Cross	COMPLIANCE STATUS: Non Compliance	SOURCE CLASS: SM OPT OUT
SUBJECT:		
RESOLVED COMPLAINTS:

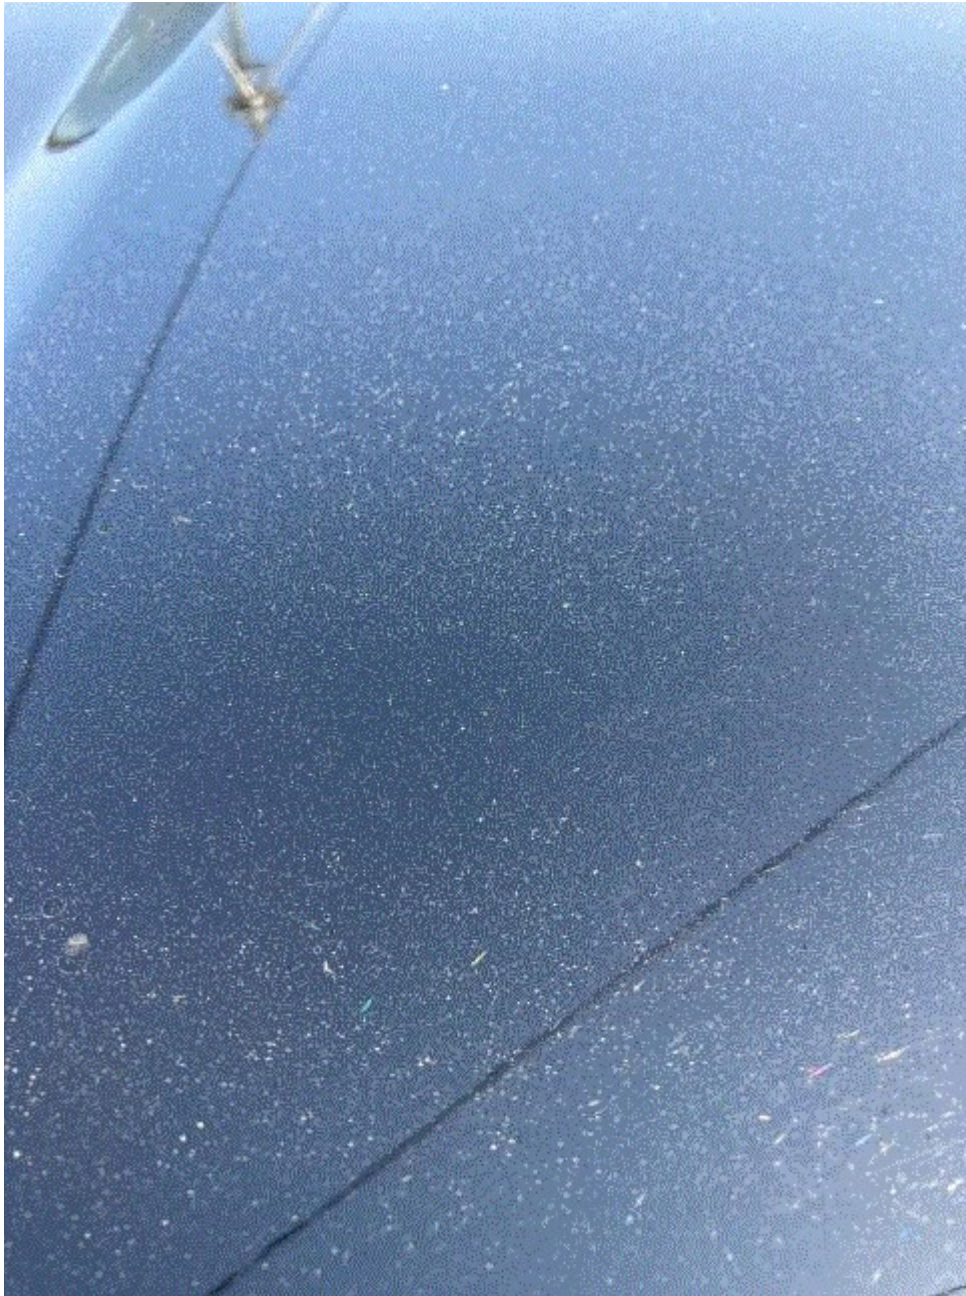
Mr. Ticknor accompanied staff outside to document the dust accumulated on the cars. The cars parked outside appeared to have a coating of dust on them. Since the dust was not wet, it could be removed with a finger however it's been previously noted that the dust gets very sticky if left on the vehicles and it becomes difficult to remove. AQD staff took photos of the dust on two vehicles parked outside the facility. The owner of one of the vehicles said it had been washed that morning. He also said that he washes his vehicle a few times a week to combat ongoing dust accumulation while it's parked on site.

Image 1(Dust on Vehicle Hood) : Dust on Vehicle Hood

We discussed speaking to the drivers and manager of that area about making sure the doors are closed during loading. I also informed him that a violation notice will be written for the violation of Rule 901 since the complaint was verified on site and this has been a recurring issue. The stack associated with the cyclone does not appear to be the origin of the dust for this complaint. Photos of the truck with dust are included with the report.

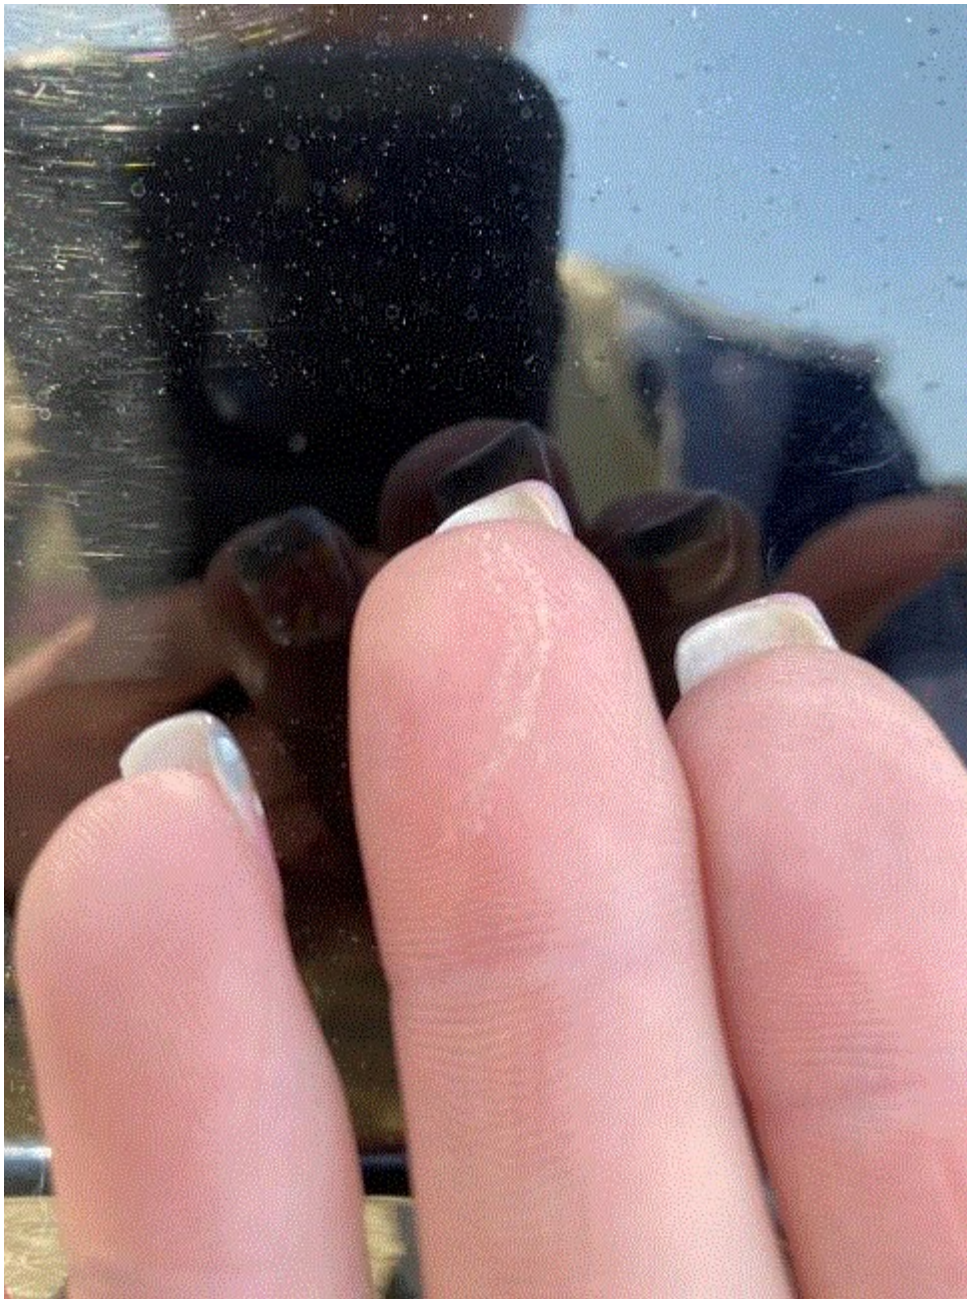
Image 2(Dust on Finger) : Dust accumulation on finger to demonstrate quantity of dust present.
