DEPARTMENT OF ENVIRONMENTAL QUALITY
AIR QUALITY DIVISION
ACTIVITY REPORT: On-site Inspection

FACILITY: STATELINE CRUSHING	SRN / ID: P0622
LOCATION: 7061 Dexter Ann Arbor Rd, DEXTER	DISTRICT: Jackson
CITY: DEXTER	COUNTY: WASHTENAW
CONTACT: John Thompson , Owner Operator	ACTIVITY DATE: 07/06/2022
STAFF: April Lazzaro	COMPLIANCE STATUS: Non Compliance
SUBJECT: Unannounced, self-initiated inspection.	SOURCE CLASS: MINOR
RESOLVED COMPLAINTS:

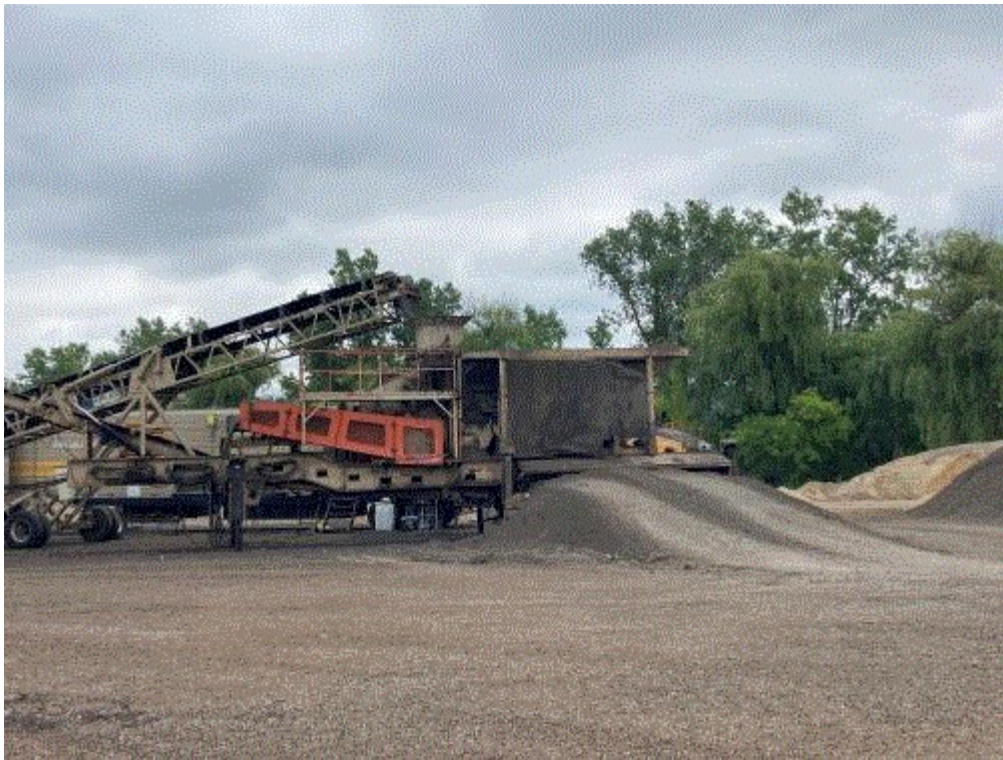
Image 1(KPI JCI 4250) : 500 tph primary jaw crusher

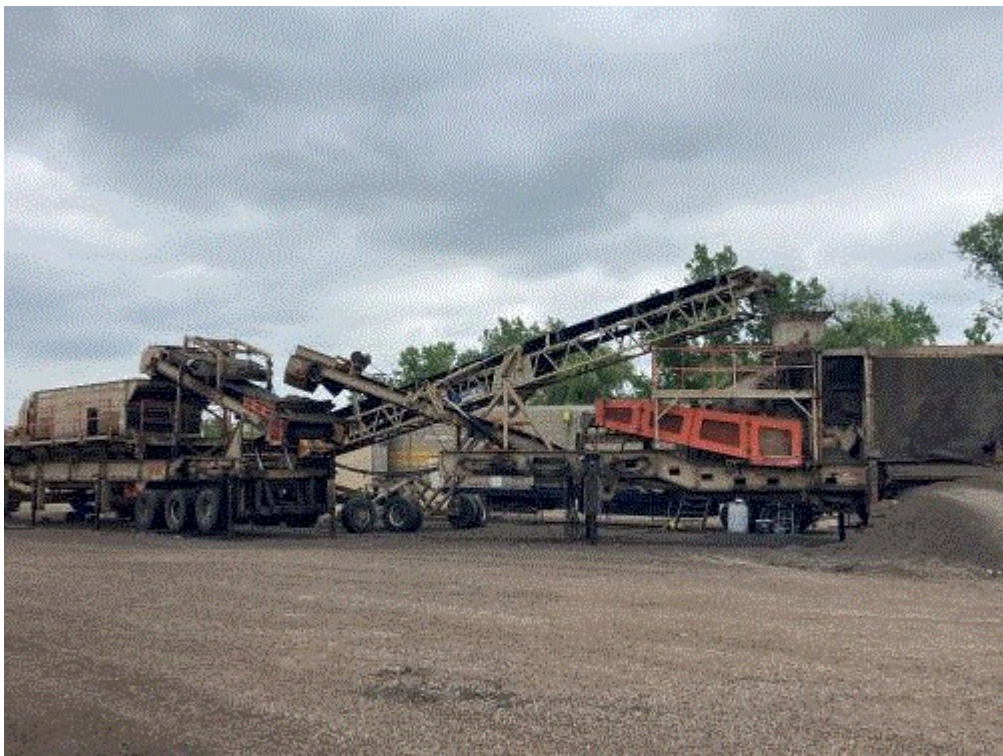
At the time of my inspection, no water was being used on the crushing plant. The crushing plant was not equipped with appropriate spray nozzles, no hoses were attached, and the water truck which was parked a few hundred feet away from the crushing plant was empty. As indicated, opacity was in the 10-20% range, however due to the short duration of observed operation, a 6-minute average of opacity readings were not obtained.

Image 2(KPI JCI plant) : KPI JCI nonmetallic mineral crushing plant

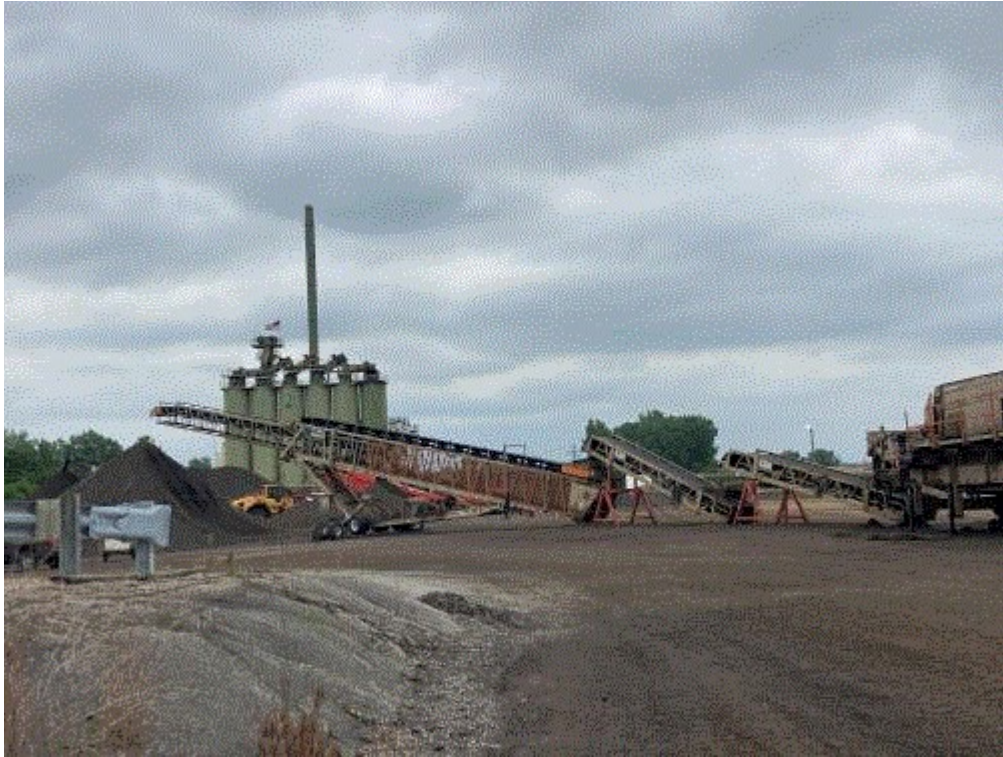
Image 3(KPI JCI) : KPI JCI nonmetallic mineral crushing plant. Asphalt plant in background.

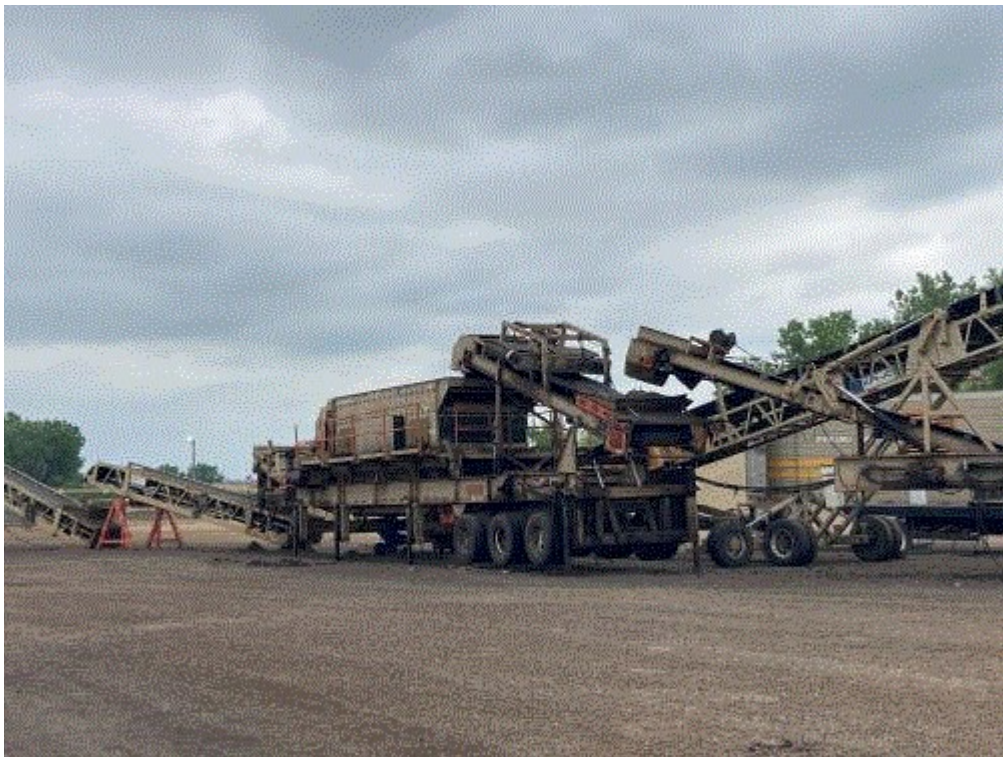
As indicated above, a review of the 2021 MAERS submittal was conducted to calculate the correct emissions for the facility. During that review, it was identified that the facility was not reporting emissions associated with the 796 hp Volvo diesel engine/generator set. Per AQD MAERS guidance, and assuming the facility is using the Rule 285(2)(g) exemption for internal combustion engines, emissions should be reported to MAERS because it is larger than 300 hp, and they have not been.

Image 4(KPI JCI) : KPI JCI screen with Volvo engine/gen set in background.

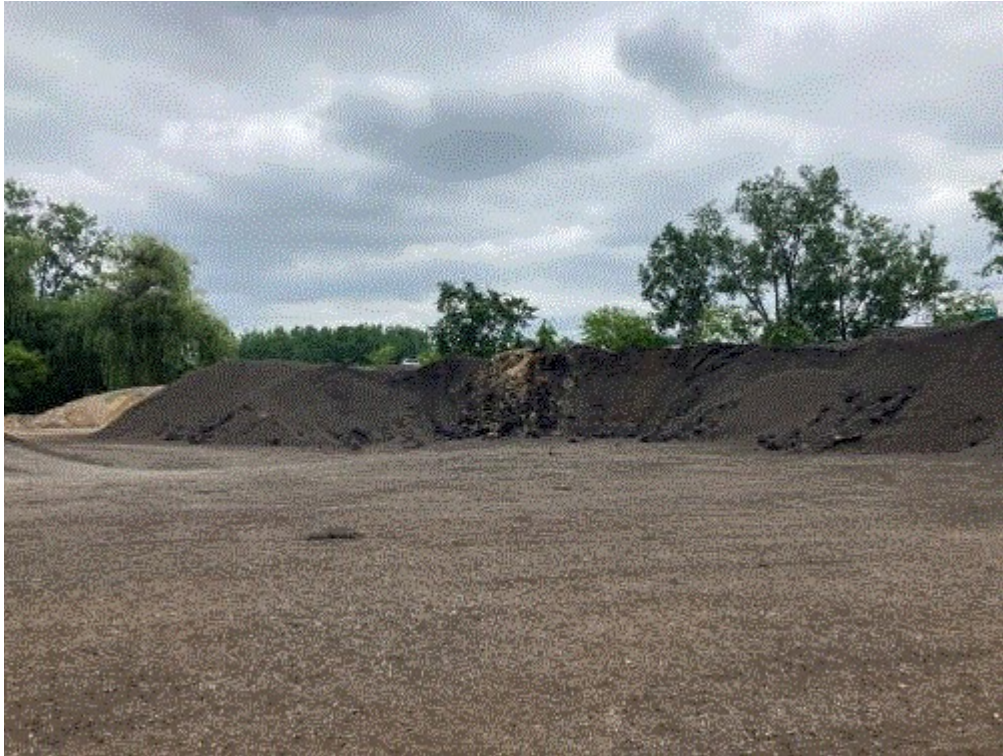
AQD staff considered that they chose the EF for tertiary crushing for the recycled asphalt paving (RAP) because some of the material is already reduced in size before they crush it. However, the AP-42 goes into detail how the crushing process works, and it specifies that tertiary crushing is to further reduce materials that come out of a secondary crusher at a size of 1-4". Photos of the stockpile they were pulling from to feed the crusher were taken, and while some of the material is certainly in the 1-4" size, there is also larger pieces of RAP which are a foot or more in diameter, and as such is not considered tertiary crushing. (see attached photo of stockpile)

Image 5(Feed Pile) : KPI JCI nonmetallic mineral crusher recycled asphalt paving feed pile.
