DEPARTMENT OF ENVIRONMENTAL QUALITY
AIR QUALITY DIVISION
ACTIVITY REPORT: On-site Inspection

FACILITY: BACCO CONSTRUCTION CO PLANT PUC-10250		SRN / ID: P0781
LOCATION: N3676 US 2, IRON MOUNTAIN		DISTRICT: Marquette
CITY: IRON MOUNTAIN		COUNTY: DICKINSON
CONTACT: Kyle Fortier , Project Superintendent		ACTIVITY DATE: 09/20/2023
STAFF: Lauren Luce	COMPLIANCE STATUS: Compliance	SOURCE CLASS: SM OPT OUT
SUBJECT: On-site Inspection FY23		
RESOLVED COMPLAINTS:

Facility: Bacco Construction Company (SRN: P0781)

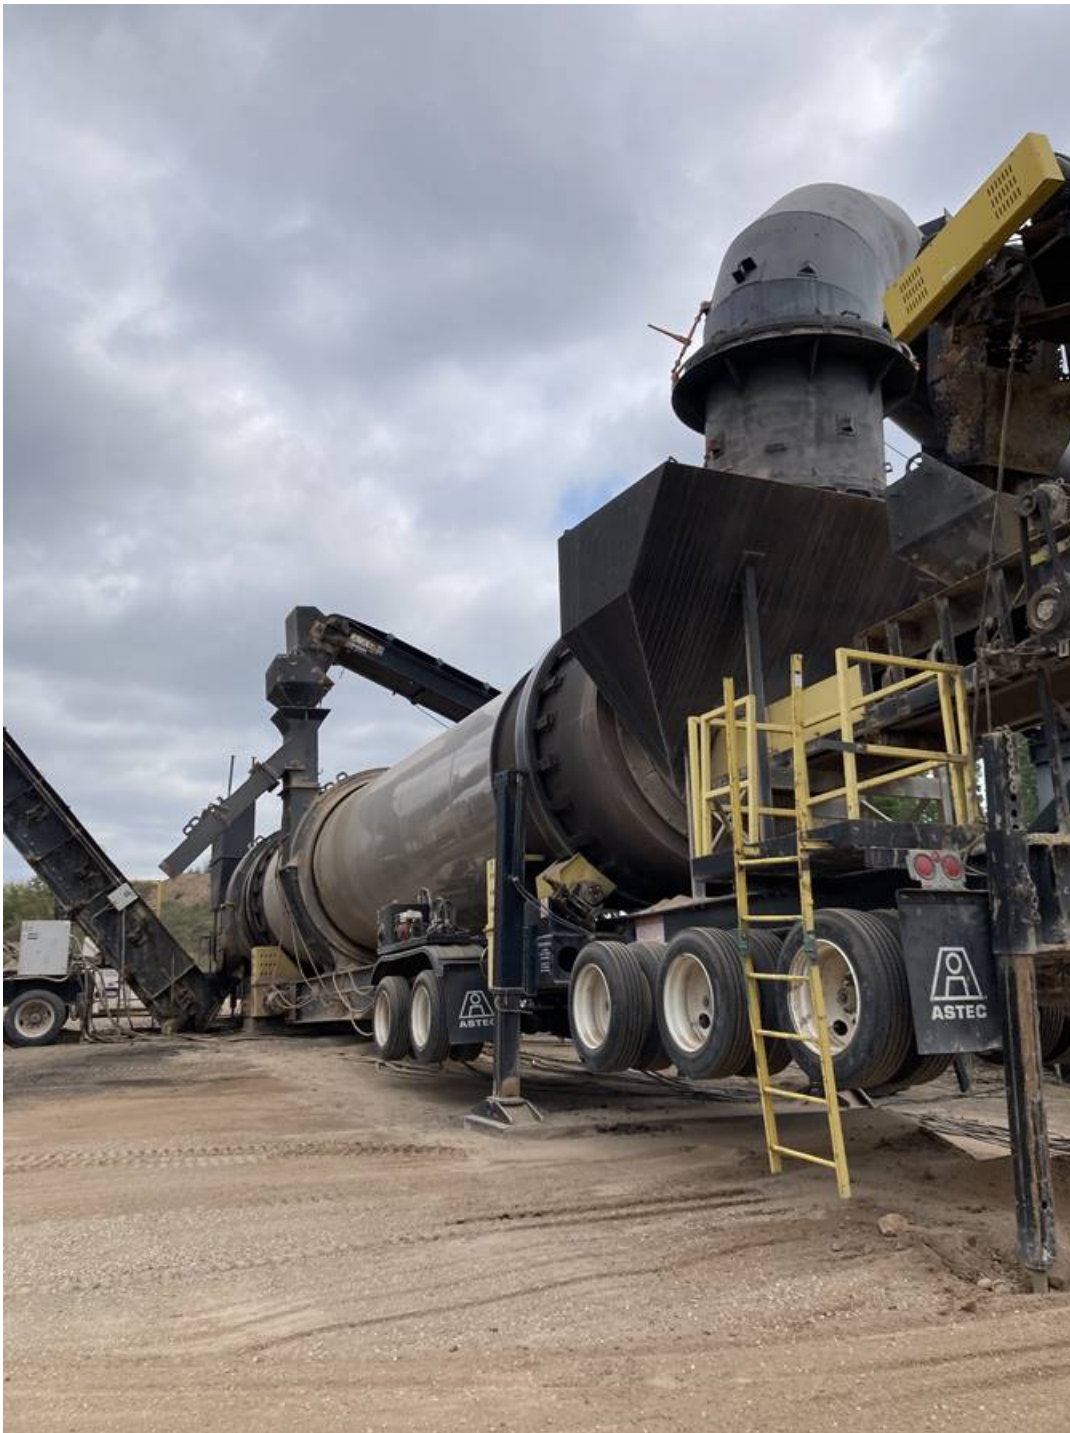
Image 1: EUHMAPLANT

This emission unit consists of one Hot Mix Asphalt (HMA) facility, consisting of aggregate conveyors and a counterflow drum mixer with a fabric filter dust collector baghouse.

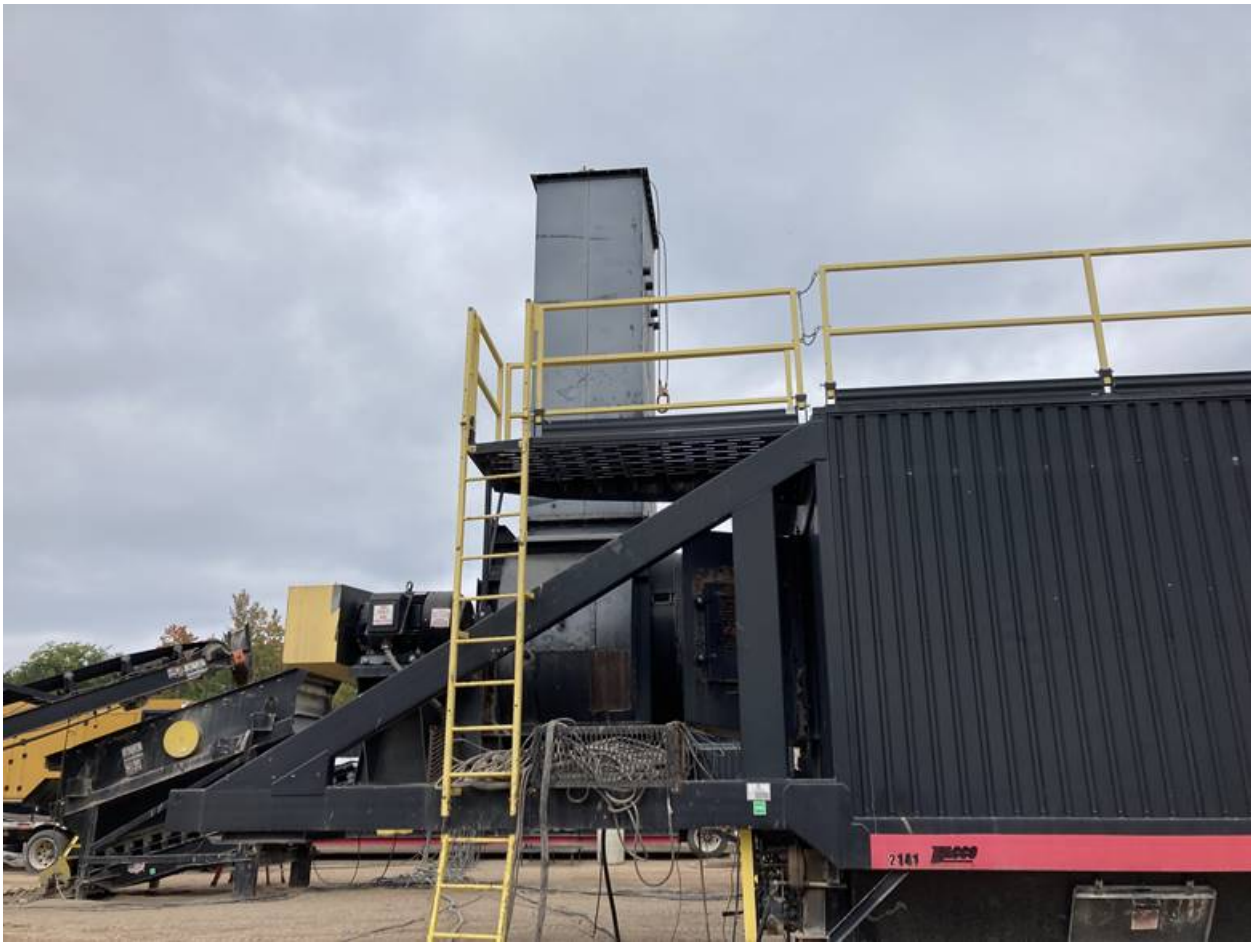
Image 2: Baghouse and stack

The baghouse is installed and operating properly. Additional bags are located on-site. At the date of inspection at 12:12PM, the pressure drop was 3.94 inches WC.

Stack height was not verified but appeared to be at least 22 feet above ground.
