**Re: Response to Violation Notice dated October 26, 2023
Louis Padnos Iron & Metal – Padnos Wyoming Recycling (SRN: P1410)**

Louis Padnos Iron & Metal (“Padnos”) submits this letter responding to the October 26, 2023 violation notice (“VN”) from the Air Quality Division (“AQD”) concerning Padnos’ recycling facility located at 500 44th Street SW in Wyoming, Michigan.

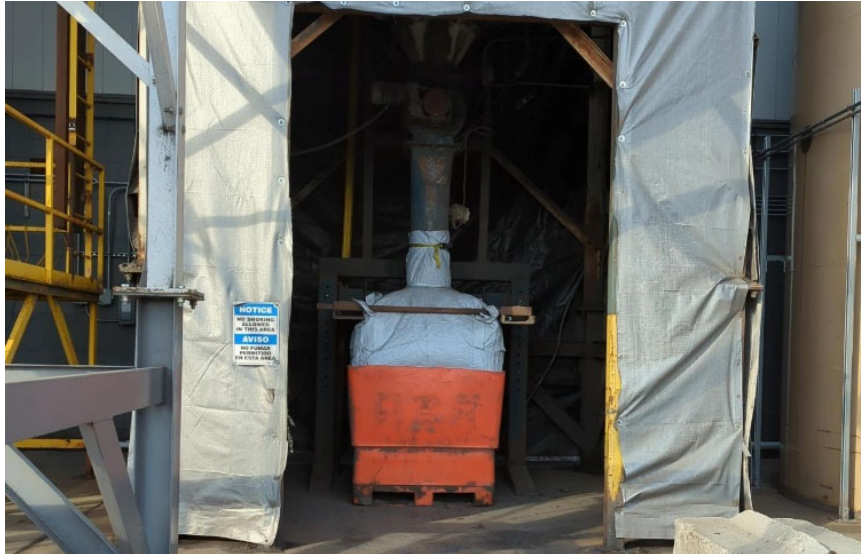
Figure 1. Current Shredder 1 Baghouse Dust Storage Area

That said, Padnos recognized the opportunity to improve its handling of this small plastic material in these dropout areas, especially compared to what AQD observed on October 10. For example, Padnos has taken action to improve the storage area for the Shredder 1 baghouse dust collection system. Since the inspection, Padnos implemented the use of a flexible supersack to store the plastic material as well as a “cinch” that connects the supersack to the discharge tube (and air lock) below the baghouse. This improved setup is shown in Figure 1 below.

Similarly, Padnos has already ordered equipment to create a similar enclosed connection for Shredder 2. Specifically, after the Thanksgiving holiday, Padnos is scheduled to install a connection to link up the baghouse dust container for Shredder 2 with the dropout chute (and air lock) that follows the associated baghouse system. Padnos plans to send you a photograph of that enclosed connection for Plastic Shredder 2 once it is completed.
