DEPARTMENT OF ENVIRONMENTAL QUALITY
AIR QUALITY DIVISION
ACTIVITY REPORT: On-site Inspection

FACILITY: Sagola Hardwoods		SRN / ID: U222402066
LOCATION: N10640 State Highway M95, Sagola		DISTRICT: Marquette
CITY: Sagola		COUNTY: DICKINSON
CONTACT: Steve Shirkey , Mill Manager		ACTIVITY DATE: 03/19/2024
STAFF: Lauren Luce	COMPLIANCE STATUS: Compliance	SOURCE CLASS:
SUBJECT: Self-initiated Inspection FY24		
RESOLVED COMPLAINTS:

Facility: Sagola Hardwoods (U222402066)

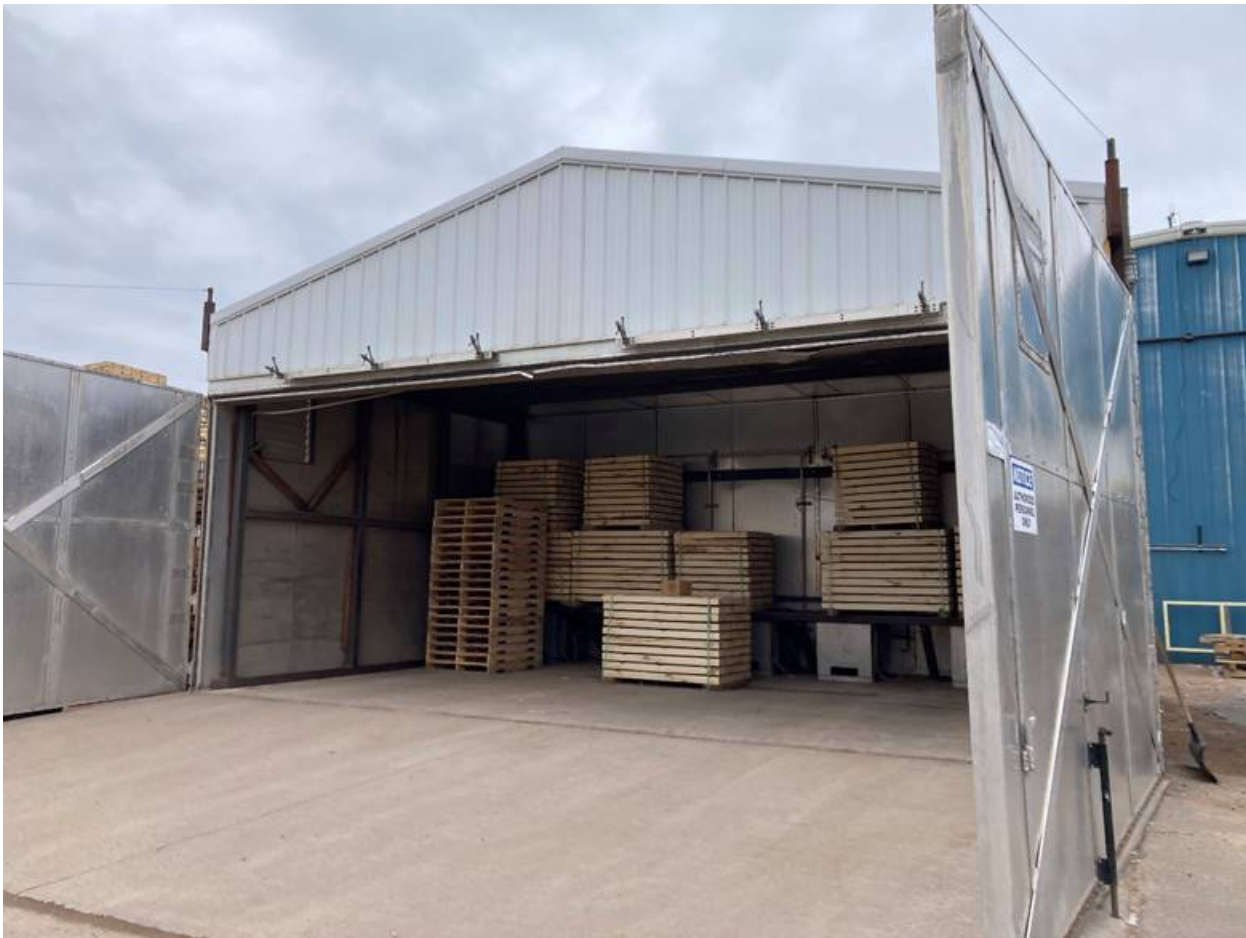
Pallet and crating lumber is then dipped in a water based fungicide tank before proceeding to the heat treater. A 20,000 board feet capacity heat treater is used to remove any pests or pathogens in the wood. The facility estimates this heat treater was installed in 1998/1999. The heat treater for pallet lumber is direct heated and must reach a temperature of 140°F for 30 minutes. Direct heat is provided by a natural gas fired 2 MMBtu/hr Temp-Heat THP-2000 direct heater. This unit appears to be exempt per Rule 282(2)(b)(i). The pallets are assembled on-site and sold to various customers.

Image 1: Heat treater

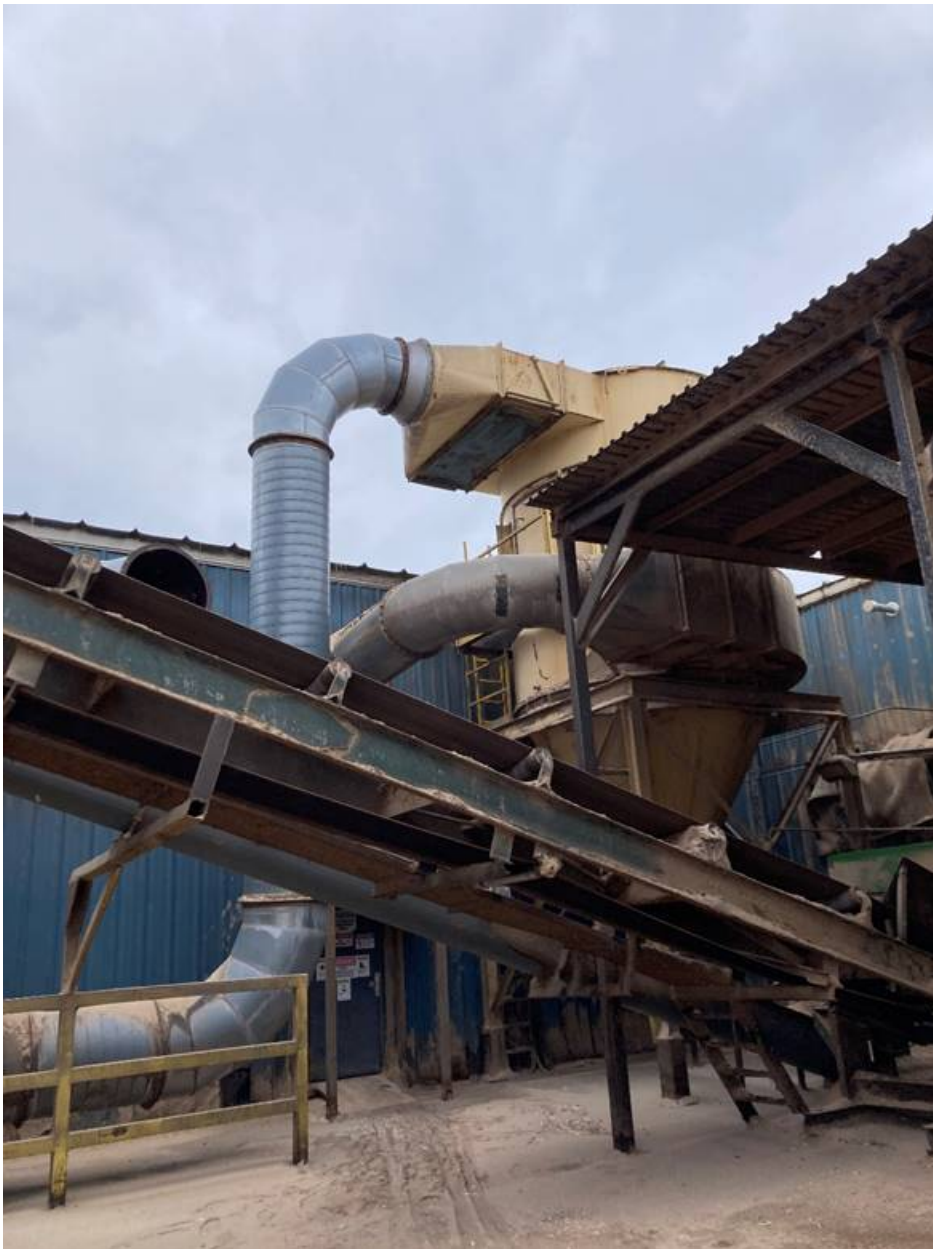
The inspection began by touring the facility and observing the different wood processing operations. The process begins with incoming logs going through the de-barker and then proceeding to saws depending on the size of the log. The scragg mill is the larger of the two mills and produces pallet and crating lumber using mixed hardwoods and Aspen. Sawdust conveyed through the pneumatic handling system from the scragg mill is controlled by a pulse-jet baghouse equipped with 144 bags and exhausts out a horizontal vent. No visible emissions were observed from the vent and the baghouse appeared to be operating properly. The baghouse also serves as waste wood product recovery system. This process appears to be exempt per Rule 285(2)(l)(vi)(C).

Image 2: Scrag mill baghouse

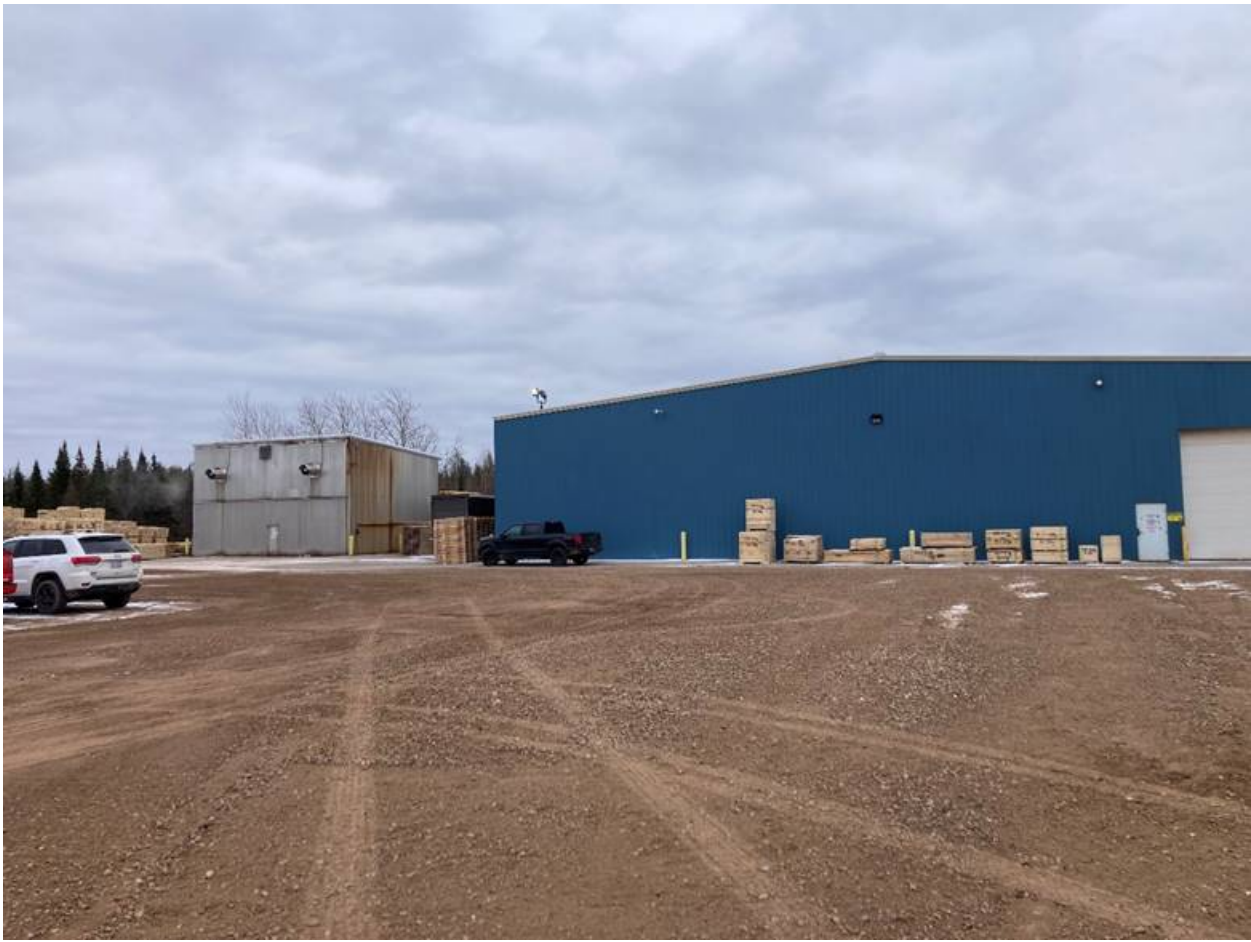
The grade mill produces dimensional lumber using primarily hard maple. Lumber from this mill is kiln dried in a 70,000 board feet capacity kiln. The kiln is indirect heated by a 1.5 MMBtu/hr natural gas-fired Columbia boiler. The boiler appears to be exempt per Rule 282(2)(b)(i). Each batch of lumber is dried for approximately 7 days at 160 degrees Fahrenheit. This kiln was installed in approximately 2002/2003. Based on the capacity of the kiln, batch drying time, and wood species of the lumber, the potential VOC emissions from the kiln are less than 5 tpy. Using a factor of 1.44lb VOC/1,000 BF (*Estimated VOC losses during the drying of six eastern hardwood species*, Forest Products Journal), the drying time of seven days, and the batch capacity of 70,000 board feet, the potential emissions are estimated at 2.6 tpy of VOCs. This process is believed to be exempt per Rule 291(2).

Image 3: Kiln and pallet assembly building
