**DEPARTMENT OF ENVIRONMENTAL QUALITY
AIR QUALITY DIVISION
ACTIVITY REPORT: On-site Inspection**

FACILITY: Gerdau Special Steel North America - Jackson Mill		SRN / ID: B4306
LOCATION: 3100 BROOKLYN RD, JACKSON		DISTRICT: Jackson
CITY: JACKSON		COUNTY: JACKSON
CONTACT: Chris Hessler , Regional Environmental Manager		ACTIVITY DATE: 04/14/2021
STAFF: Mike Kovalchick	COMPLIANCE STATUS: Compliance	SOURCE CLASS: MAJOR
SUBJECT: FCE. Announced inspection. Melt Shop ceased operations in June, 2020. It is not expected to restart in the foreseeable future. As such, emissions are now at a minor source level. Only the finishing operations consisting of two heat treat furnaces remain active along with some emergency generators.		
RESOLVED COMPLAINTS:

Major / ROP Source. Full Compliance Evaluation (FCE) and Inspection (PCE)

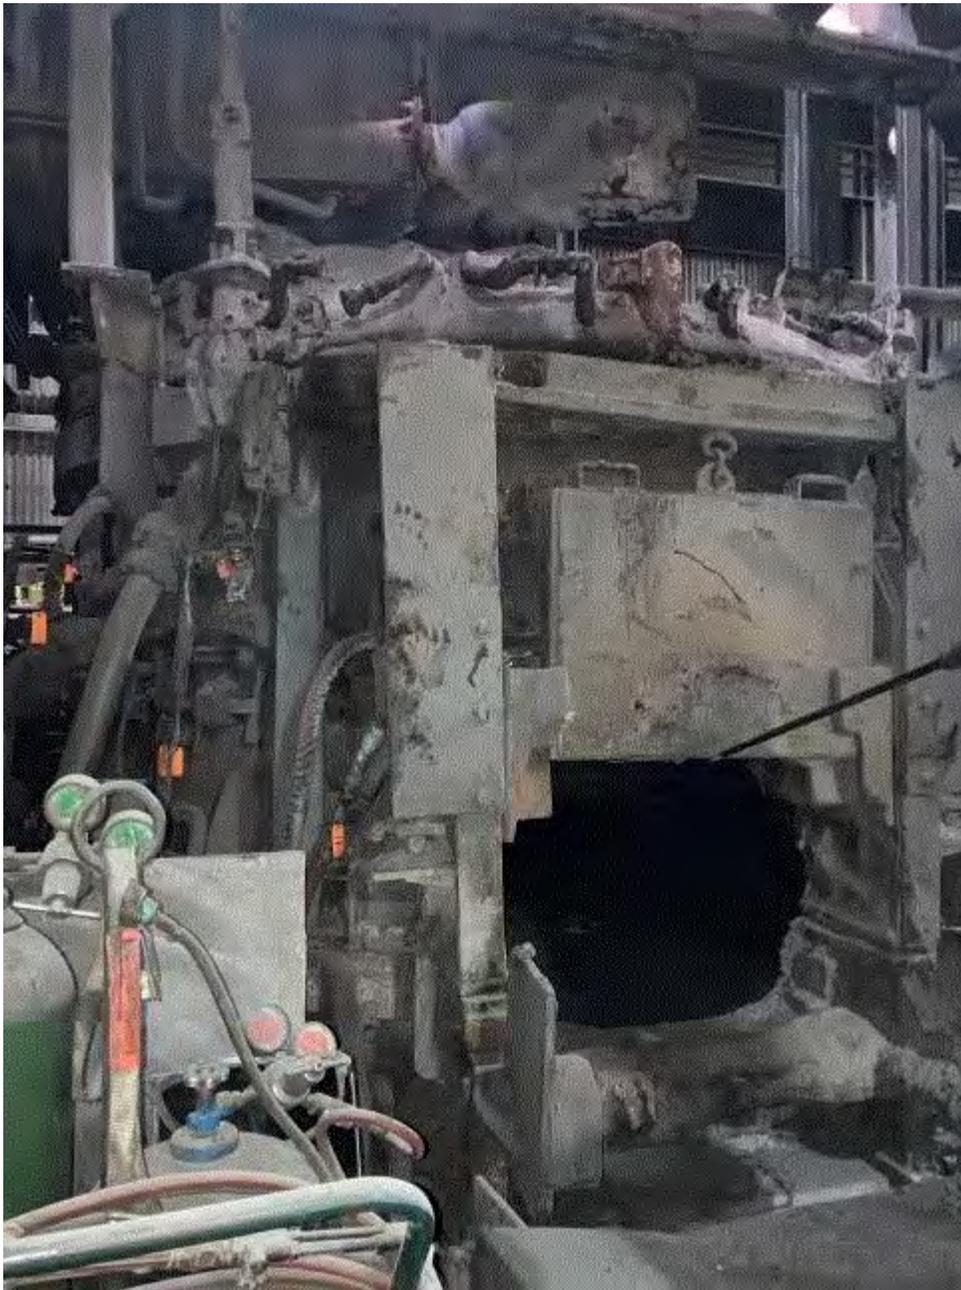
Image 1(EAF) : Photo of one of the EAFs.

We toured the Melt Shop building. The interior of the building was dark with no activity. Dust covered the ground with some pigeons flying inside. The two EAFs appeared to have been moth balled and were not being maintained in idol status. The water system to the EAFs had been cleaned/shutoff. The hydraulics systems were shutoff. The Control Room was dark. The two baghouses that controlled the Melt Shop were also off. The EAFs lacked refractory brick and appeared to be in poor condition. See attached photo of one of the EAFs. The condition of the Melt Shop supported the notion that it would take months of work for the equipment to be restarted.

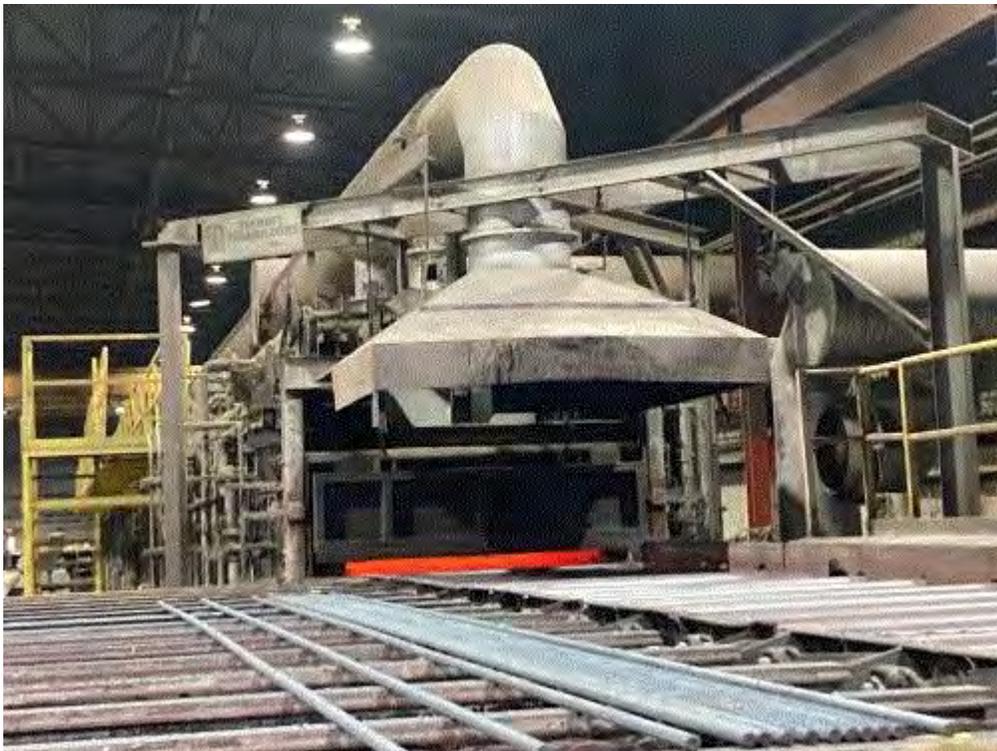
Image 3(Heat Treat) : One of the heat treat furnaces.

Emission unit includes one 60.2mmBtu/hr. annealing furnace (Furnace #1) located in the detached finishing building, which is south of the main building. (See attached photos.)

Emission unit includes one 38.4mmBtu/hr. annealing furnace (Furnace #2) located in the detached finishing building, which is south of the main building. (See attached photos.)

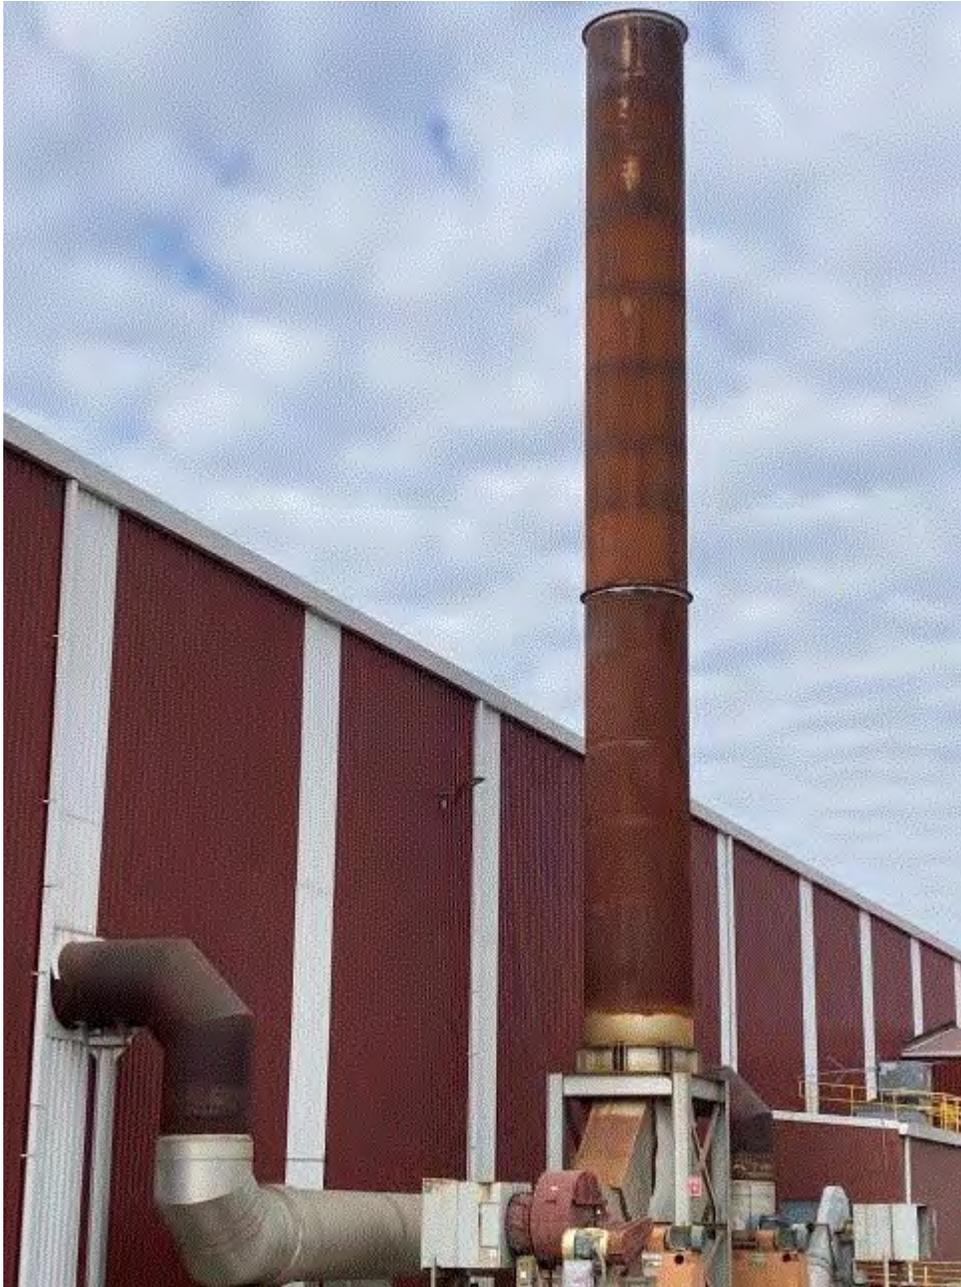
Image 4(Heat treat stack) : Heat treat furnace stack that serves both furnaces.

Prohibits direct venting of the furnace to the outside atmosphere.
