DEPARTMENT OF ENVIRONMENTAL QUALITY  
AIR QUALITY DIVISION  
ACTIVITY REPORT: Odor Evaluation

<b>FACILITY:</b> Crimson Holdings, LLC		<b>SRN / ID:</b> E8117
<b>LOCATION:</b> 1336 E MAUMEE ST, ADRIAN		<b>DISTRICT:</b> Jackson
<b>CITY:</b> ADRIAN		<b>COUNTY:</b> LENAWEE
<b>CONTACT:</b>		<b>ACTIVITY DATE:</b> 09/26/2023
<b>STAFF:</b> Brian Merle	<b>COMPLIANCE STATUS:</b>	<b>SOURCE CLASS:</b> MINOR
<b>SUBJECT:</b> Odor evaluation in response to ongoing complaints.		
<b>RESOLVED COMPLAINTS:</b>

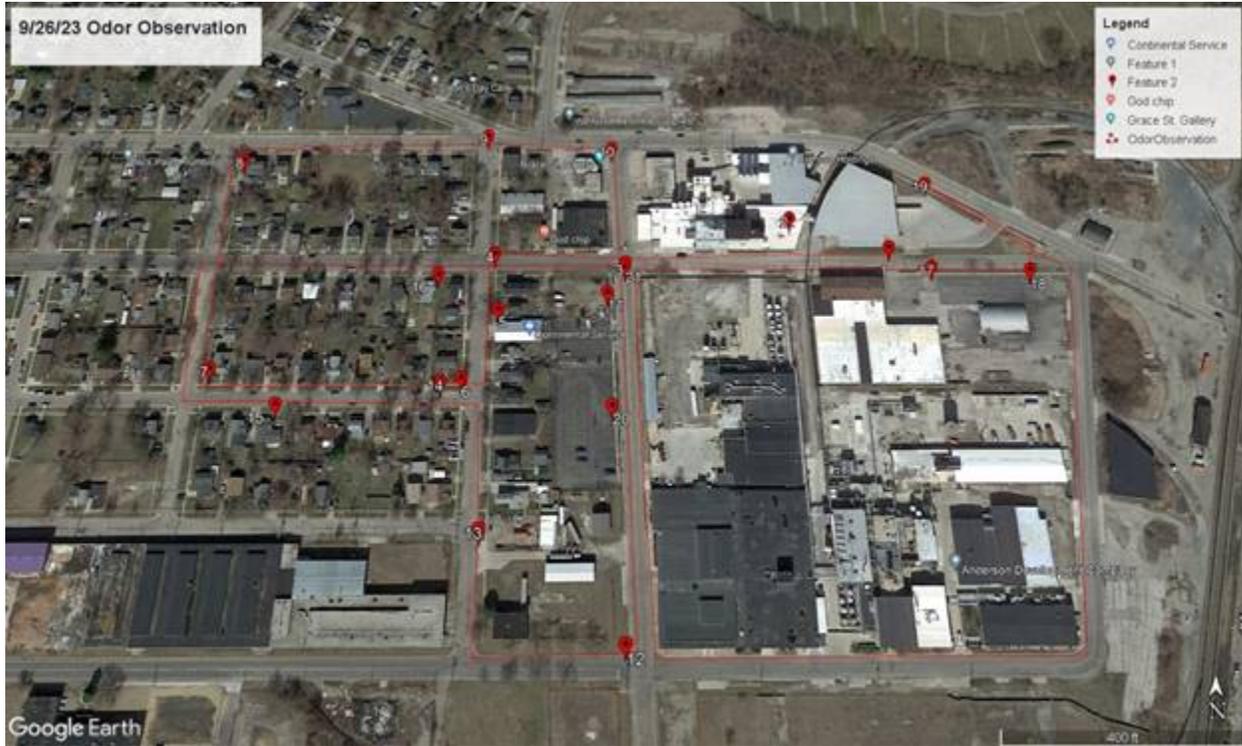
**Image 1: Route with observation locations**

Each point on the map corresponds to an odor observation, detailed below.

The worst odors were detected directly downwind of the facility, lowering in intensity the further west I headed. However, strong odors were detected near the homes surrounding the facility to the west, and individuals were observed leaving their homes during the time of my observation who would be impacted by the odors.
