DEPARTMENT OF ENVIRONMENTAL QUALITY
AIR QUALITY DIVISION
ACTIVITY REPORT: On-site Inspection

FACILITY: DELTA SOLID WASTE MANAGEMENT AUTHORITY		SRN / ID: N6035
LOCATION: 5701 19TH AVENUE N, ESCANABA		DISTRICT: Marquette
CITY: ESCANABA		COUNTY: DELTA
CONTACT: David Lundquist , Operations Manager		ACTIVITY DATE: 05/16/2024
STAFF: Lauren Luce	COMPLIANCE STATUS: Non Compliance	SOURCE CLASS: MAJOR
SUBJECT: Targeted inspection for FY 24		
RESOLVED COMPLAINTS:

Facility: Delta Solid Waste Management Authority (SRN: N6035)

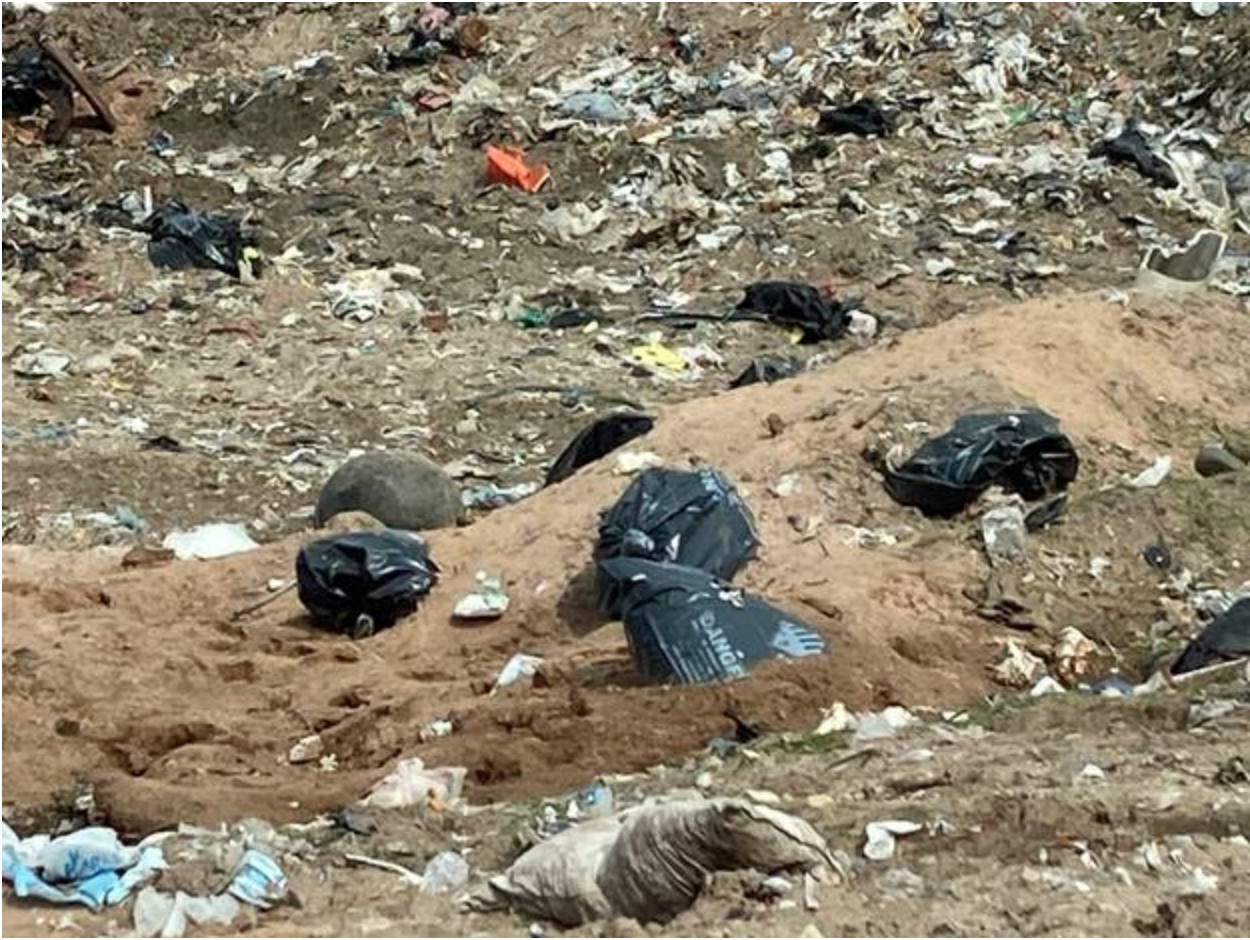
During the tour of the landfill, asbestos warning signs were observed along the perimeter and at the entrances to the landfill (SC III.1) The regulation requires that, unless meeting the no visible emissions requirement, a cover of at least 6 inches shall be applied at the end of each operating day or at least once every 24-hour period while the site is in continuous operation (SC III.1). The facility received a violation notice for not meeting this requirement during the previous inspection. During the landfill tour, bags of asbestos were visible and not covered. Waste shipment records were reviewed and asbestos was last accepted on 4/27/24. This would mean the asbestos has been uncovered for a period of over two weeks. It was relayed to landfill staff

that asbestos was uncovered during the tour which is a violation. Records on the amount and type of material used to cover the asbestos were not available (SC VI.4).

Image 1: Uncovered asbestos

Based on the inspection performed and records reviewed, Delta County Landfill does not appear to be in compliance with MI-ROP-N6035-2022. There appears to be the following violations: asbestos was not being covered at the frequency required in SC III.1.c or daily Method 22 readings for 15 minutes were not being performed and recorded (EUASBESTOS, SC III.1), and records of the amount and type of material that has been used to cover the asbestos waste and documentation that the cover material was applied in the frequency required in Special Condition III.1.c were not available (EUASBESTOS, SC VI.4.b). A violation notice will be issued in response. When conducting future quarterly SEMS, the facility will also need to include the meteorological conditions during the day of testing.
