EMISSIONS TEST REPORT

CARBON MONOXIDE (CO) DESTRUCTION EFFICIENCY

EURICE1-3

**DTE-Gas Willow Compressor Station
Ypsilanti, Michigan**

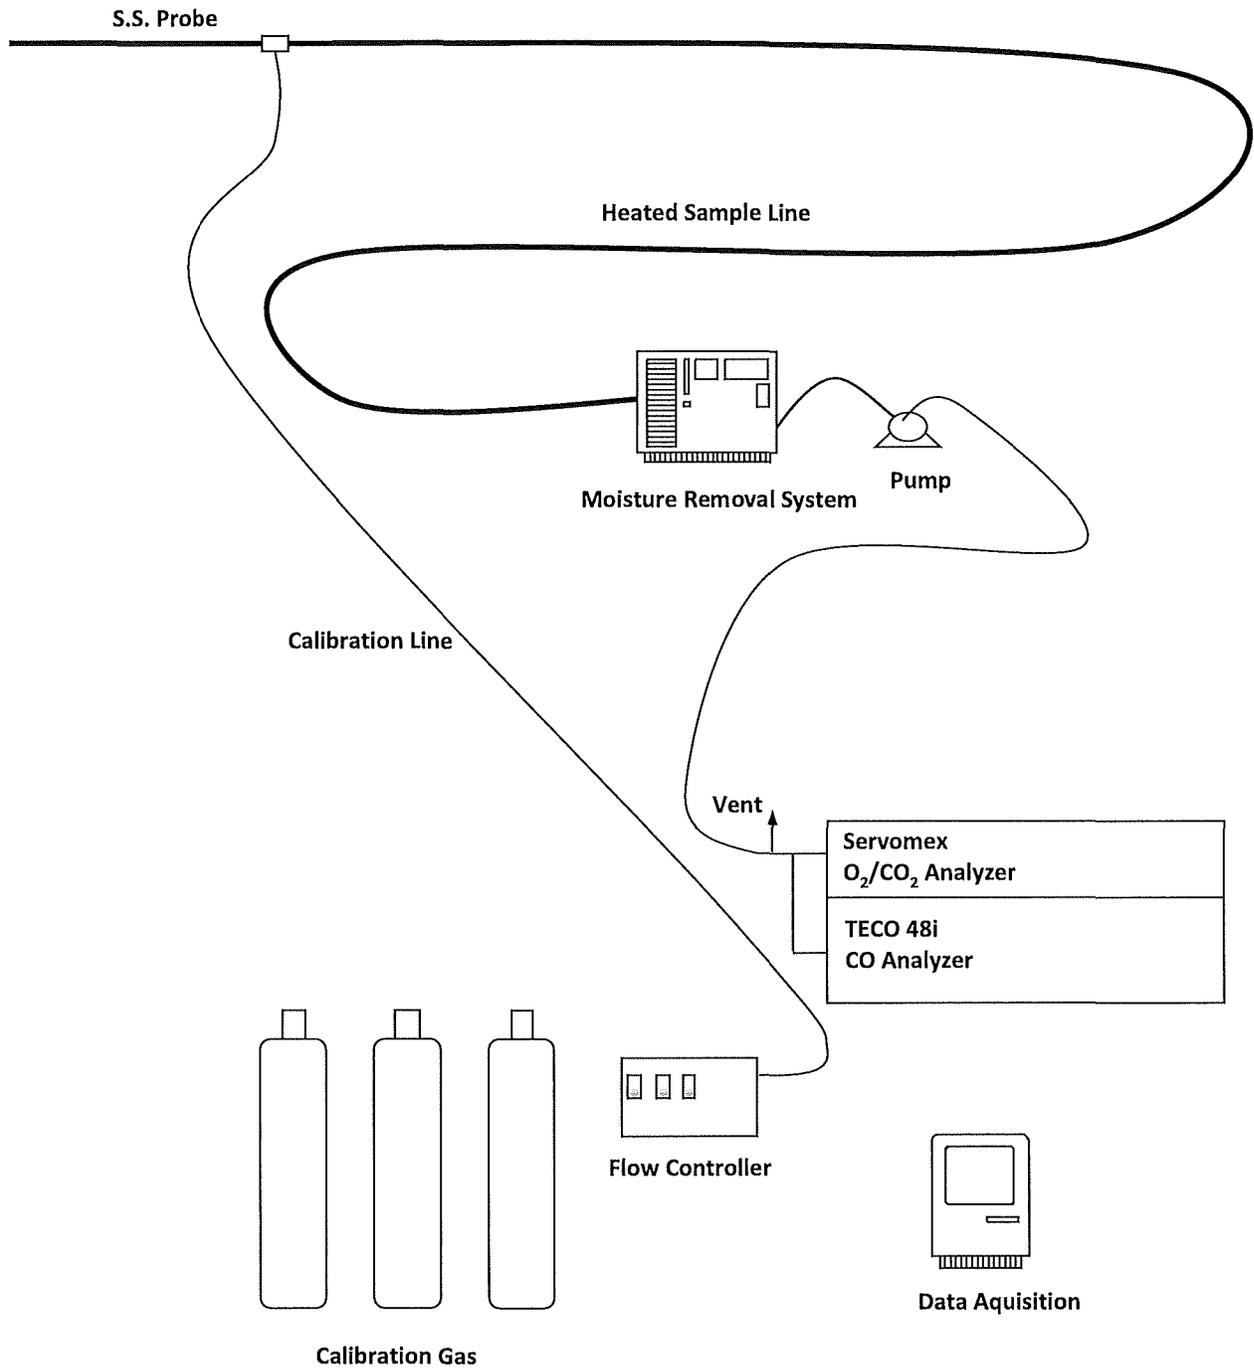
Figure 2 – EPA Methods 3A/10
Willow Run Compressor Station

- (1) Stainless-steel sampling probe
- (2) Heated Teflon™ sampling line
- (3) Gas conditioner with particulate filter
- (4) Flexible unheated Teflon™ sampling line
- (5) Servomex 1400 O₂/CO₂ gas analyzer
- (6) Appropriate USEPA Protocol 1 calibration gases
- (7) Data Acquisition System

- (1) Stainless-steel sample probe
- (2) Heated Teflon™ sampling line
- (3) Gas conditioner with particulate filter
- (4) Flexible unheated Teflon™ sampling line
- (5) TECO 48i NDIR CO gas analyzer
- (6) Appropriate USEPA Protocol 1 calibration gases
- (7) Data Acquisition System.

The EPA Method 3A sampling system (Figure 3) consisted of the following:

Two identical systems were used to measure O₂ on the inlet and the outlet of the catalyst.

The EPA Method 10 sampling system (Figure 3) consisted of the following:

Two identical systems were used to measure CO on the inlet and the outlet of the catalyst.
