DEPARTMENT OF ENVIRONMENTAL QUALITY
AIR QUALITY DIVISION
ACTIVITY REPORT: On-site Inspection

FACILITY: ENVIRONMENTAL RUBBER RECYCLING		SRN / ID: P0524
LOCATION: 6515 N. DORT HIGHWAY, FLINT		DISTRICT: Lansing
CITY: FLINT		COUNTY: GENESEE
CONTACT: Bud Dingus , Plant Manager		ACTIVITY DATE: 07/13/2022
STAFF: Daniel McGeen	COMPLIANCE STATUS: Compliance	SOURCE CLASS: MINOR
SUBJECT: Unannounced inspection of facility which was last inspected by AQD in 2006.		
RESOLVED COMPLAINTS:

On July 13, 2022, the Michigan Department of Environment, Great Lakes, and Energy (EGLE), Air Quality Division (AQD), conducted an unannounced inspection of Environmental Rubber Recycling, which had last been inspected by AQD in 2006.

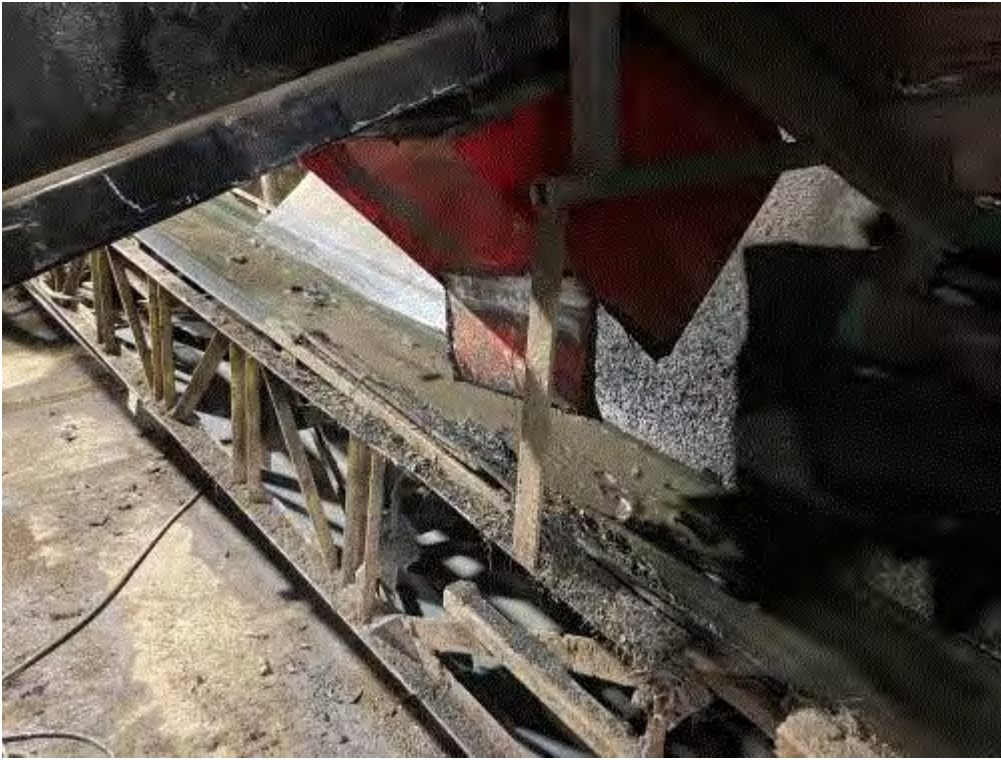
The new Raptor Manufacturing/Jomar unit is located inside the main plant. It does not exhaust to the outside air. It was operating, and no visible emissions were observed, aside from a water mist. There was a generous amount of water being applied from a hose and 6 sprayers.

1. IMG_0678.JPG, conveyor belt from underneath 2021-installed tire shredder, showing water and collected particulate.
2. IMG_0679.JPG; new shredder operating.

Image 1(1) : Underside of conveyor of 2021-installed tire shredder, showing water and collected particulate.

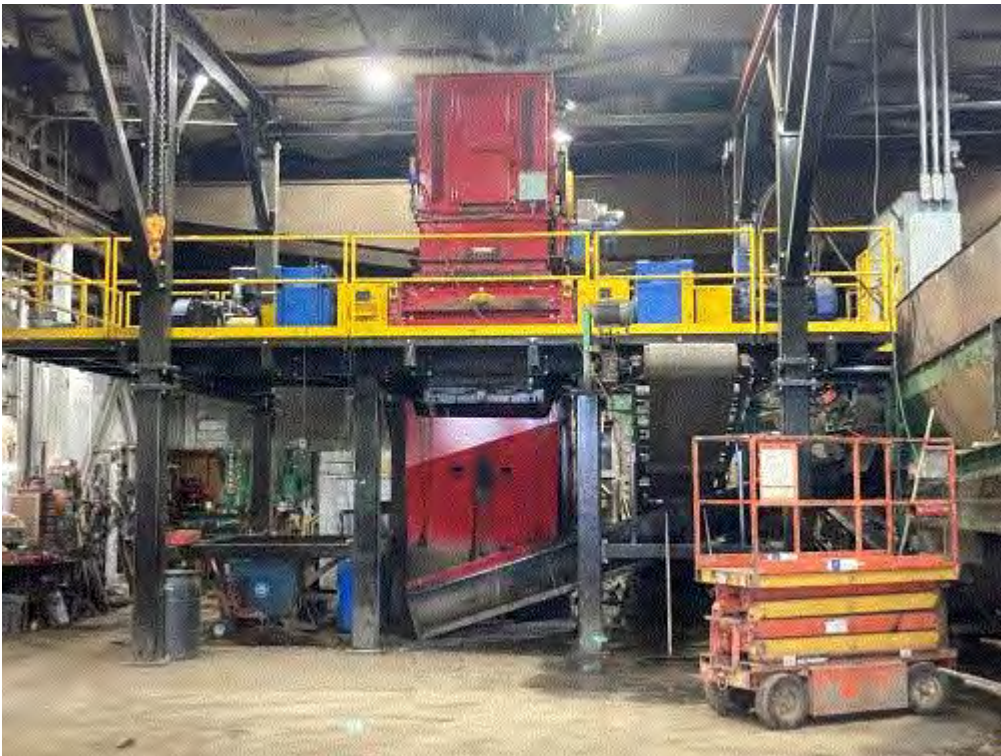
Image 2(2) : New 2021 tire shredder is at center, and original 1992 unit is at far right.

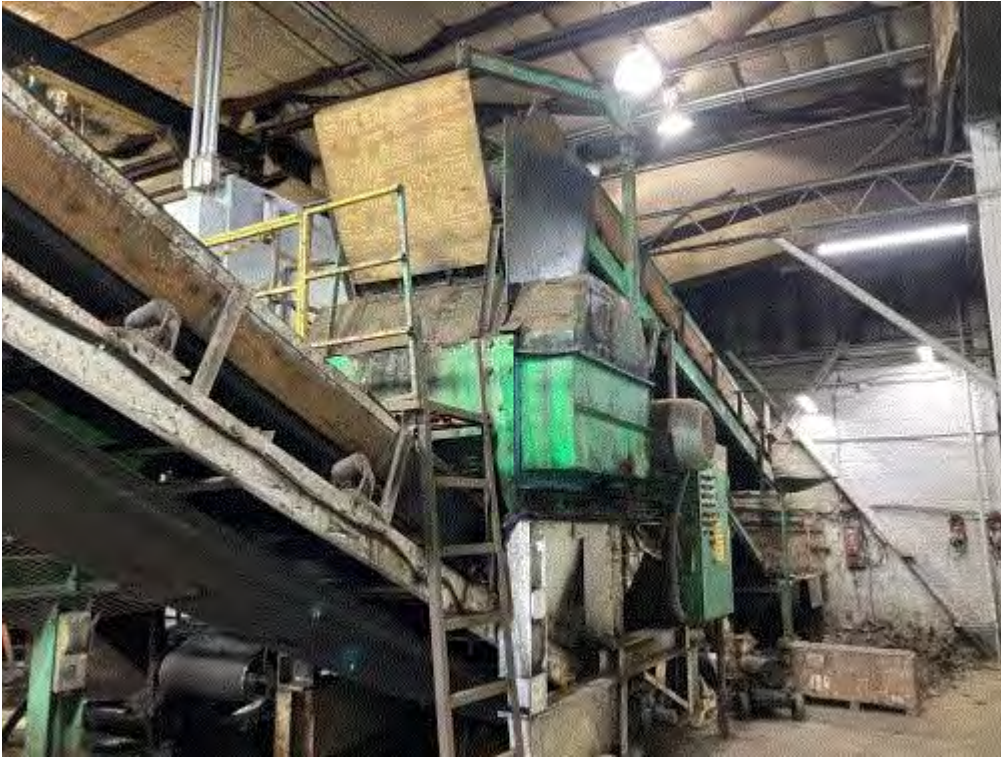
The 1992-installed Columbus-McKinnon unit is located inside the main plant. It was not operating today. It is slower and more maintenance intensive than the new unit, but they really like it, so it is kept for back up.

1. IMG_0680.JPG; original 1992-installed shredder, not running on 7/13/2022. It is kept as backup.

Image 3(3) : Original, 1992-installed tire shredder, used for backup.
