QUALITY ROASTING

Re: Quality Roasting (P1000)

This letter is in response to the violation notice (VN) issued on October 22nd, 2024 to our Reese Michigan facility. This violation notice stems from an inspection visit on September 5th, 2024 by the Department of Environment, Great Lakes, and Energy (EGLE), Air Quality Division (AQD). Please find below, Quality Roasting's responses to the received VN.

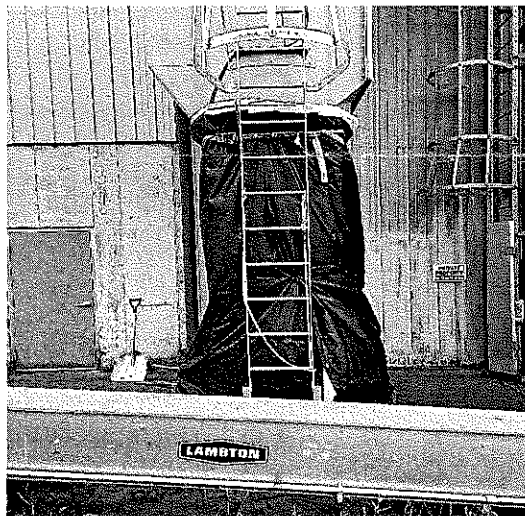
FG-Process – Meal loadout dust collector

Failed to contain the dust captured by the collector.

QR Response – Dust produced by the dust collector is currently being captured and placed in a wheelbarrow and reintroduced into the product stream. The long-term solution to the reintroduction of the meal dust is the installation of an enclosed auger system. This system has been ordered and we are awaiting its arrival. Temporarily, the dust collecting system and the wheelbarrow have been enclosed with a tarp to limit any dust from blowing in the wind.

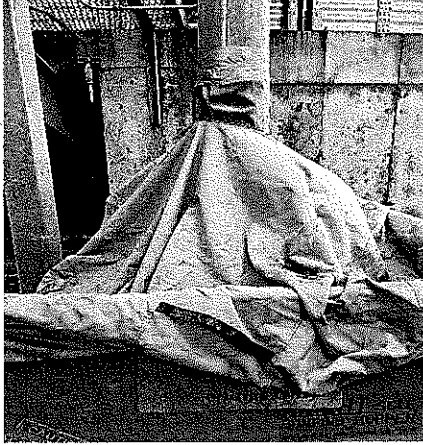
FG-Process – Screener

Collection point is an open hopper, not typically enclosed.

QR Response – Hopper has been covered with an ATV cover containing the material being removed by the cleaner. See photo.
