Subject: Fugitive Air Emissions

Carmeuse Americas Drummond Island operations located at 23311 East Haul Road, Drummond Island, Michigan received a complaint from a resident located on the south east side of the island approximately 1.5 miles from our Carmeuse Americas Drummond Island production plant . The dust complaint received by Michael Conklin EGLE Compliance officer on June 4<sup>th</sup> was sent on to Carmeuse personnel. Michael Conklin notified Christopher Martin who then arrange for an onsite meeting with plant personnel for June 8<sup>th</sup> to investigate the complaint.

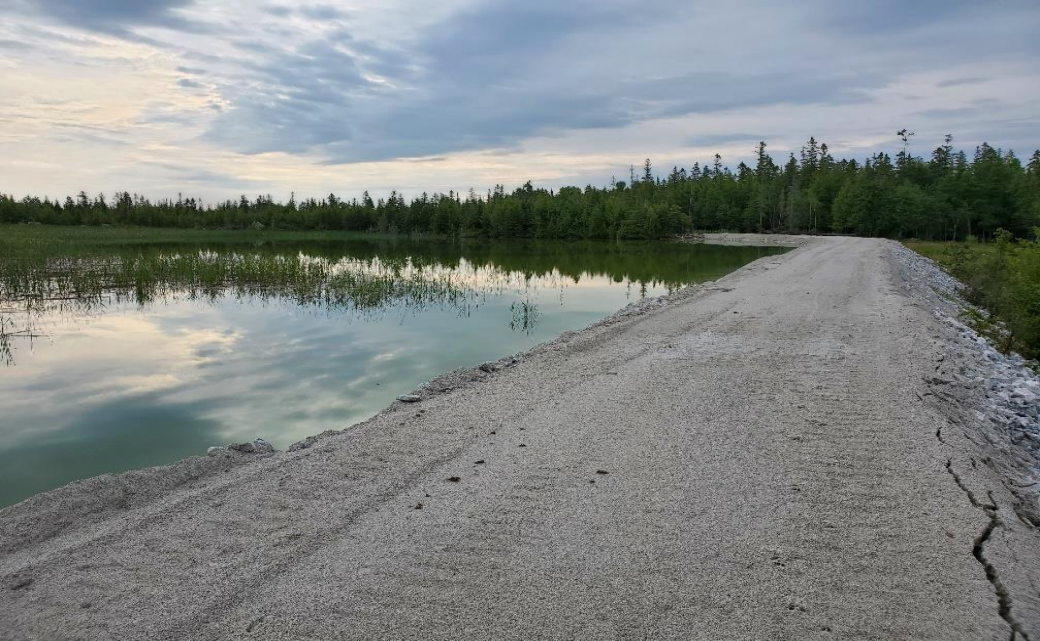
Photo #1

In speaking with Roger Nash and John Abbitt, we have determined the settling ponds were the cause of the fugitive dust that affected Mr. Coppings property during the times he had complained. We first thought it was the stockpile but after visually seeing the material being transport by the wind from the settling pond, we changed our focus to the ponds in addition to the stockpile of tailings. The facility made some repairs to the embankments to direct and hold water for much longer period of time in pond 1 and 2. This will keep them flooded and eliminate the potential of dust coming from the pond area. See photo 1 an 2.

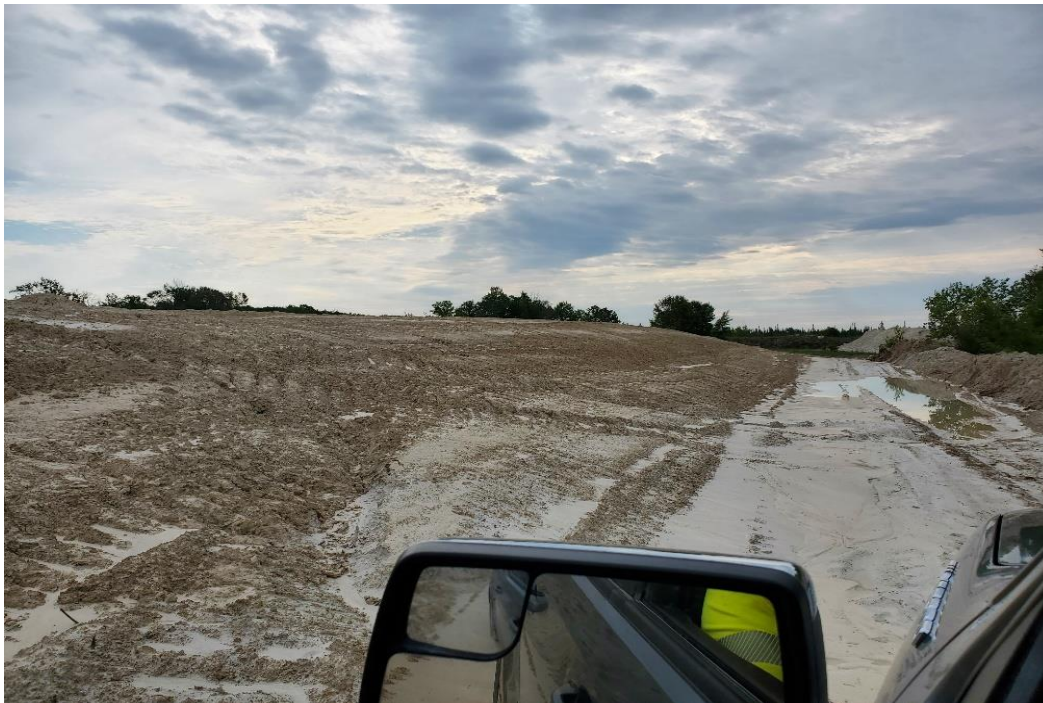
Additional, we have knocked down the original limestone fines pile that was originally thought to be contributing to the fugitive dust. Please see Photo #3
