DEPARTMENT OF ENVIRONMENTAL QUALITY
AIR QUALITY DIVISION
ACTIVITY REPORT: On-site Inspection

FACILITY: Quarrystone, Inc. dba BICHLER Concrete & Gravel		SRN / ID: D0066
LOCATION: 6851 COUNTY 426 M.5 RD, ESCANABA		DISTRICT: Marquette
CITY: ESCANABA		COUNTY: DELTA
CONTACT: Cory Pangborn , President (2018)		ACTIVITY DATE: 12/21/2023
STAFF: Drew Yesmunt	COMPLIANCE STATUS: Compliance	SOURCE CLASS: MINOR
SUBJECT: Targeted Inspection FY24		
RESOLVED COMPLAINTS:

Facility: Bichler Concrete & Gravel (SRN: D0066)

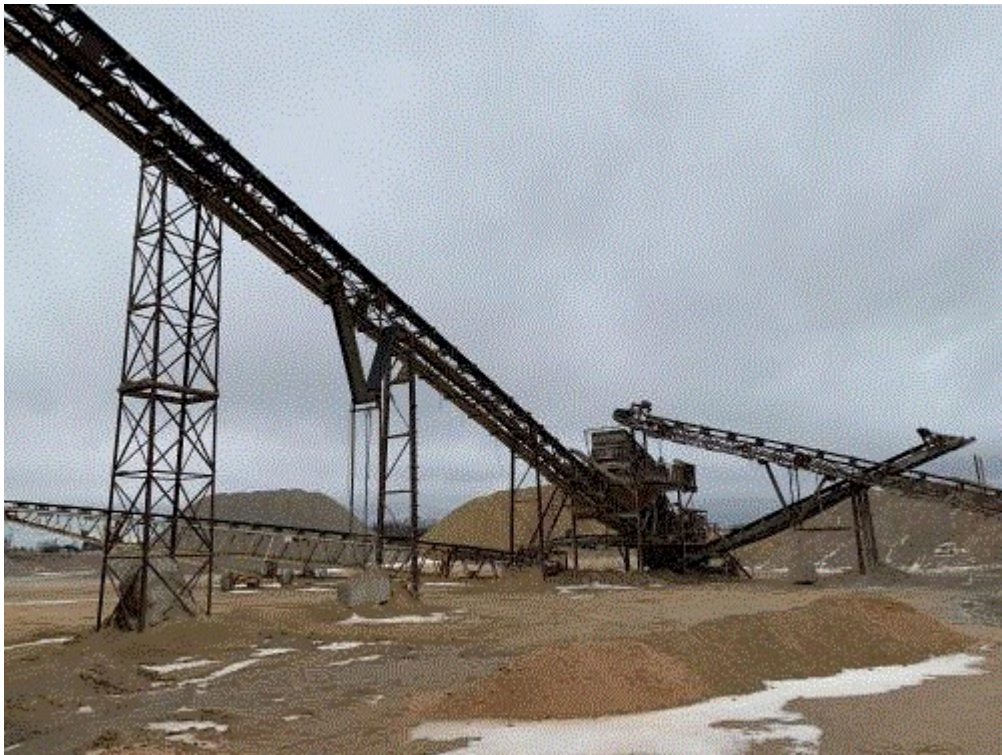
This flexible group encompasses the facility's crushing operation. During the inspection, the equipment was not in operation and was shut down for the winter season. The total throughput for 2023 was 117,974.3 tons. Upon receiving the requested records, all remaining equipment in FGCRUSHING appears to be recorded in the updated process information form and properly labeled as per SC.1.11.

Image 1(FGCRUSHING) : Remaining equipment in FGCRUSHING on-site.

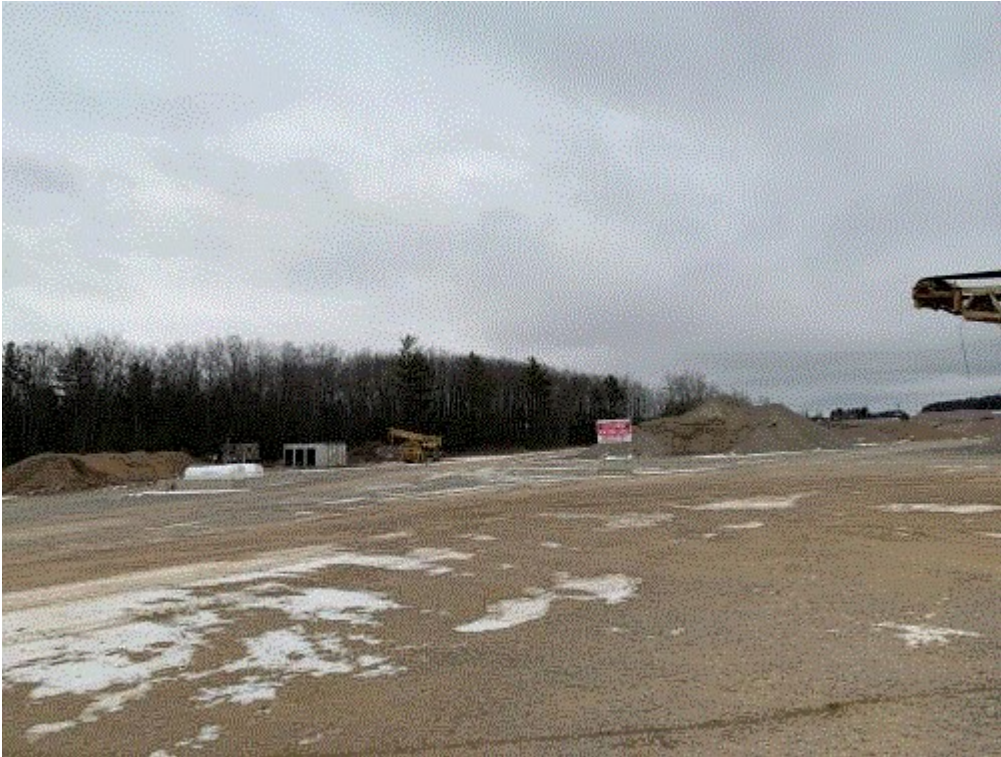
During the inspection, the facility appeared to be following all requirements of its fugitive dust plan. No visible emissions were observed on-site, and water sprays were observed on all necessary equipment. Following the inspection, a records request was sent to Cory Pangborn, president of Bichler Concrete & Gravel. The request included material processing records for the crusher and concrete batch plant, dust suppression application records, an updated process information form for FGCRUSHING, and photos showing proper labels on all equipment in FGCRUSHING.

Image 2(Facility Yard) : Yard for truck traffic.

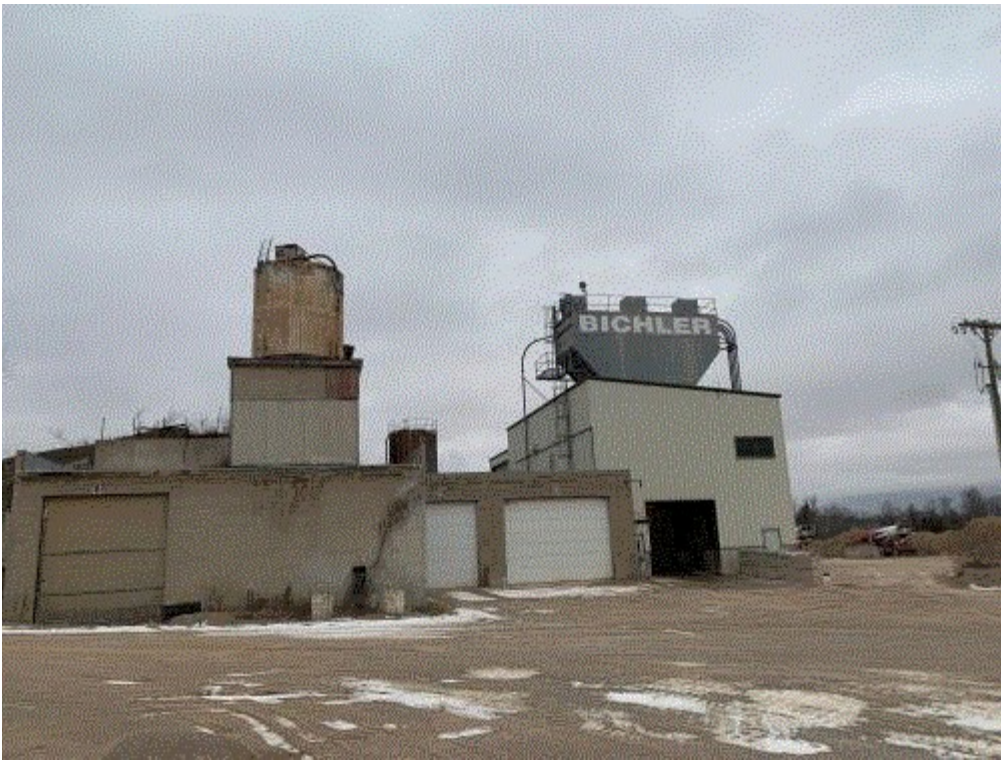
This emission unit is a ready-mix concrete batch plant and is housed in its own separate warehouse. At the time of the inspection, the unit was not in operation. This unit was previously permitted under PTI No. 349-75 but was found to be exempt from permitting under Rule 289(d). To maintain compliance under Rule 289(d), the facility keeps monthly records of the cubic yards of concrete produced and must not exceed 200,000 cubic yards of concrete produced per year. In 2023, the unit produced 15,883 cubic yards of concrete.

Image 3(Concrete Batch Plant) : Warehouse used for facility's concrete operations.

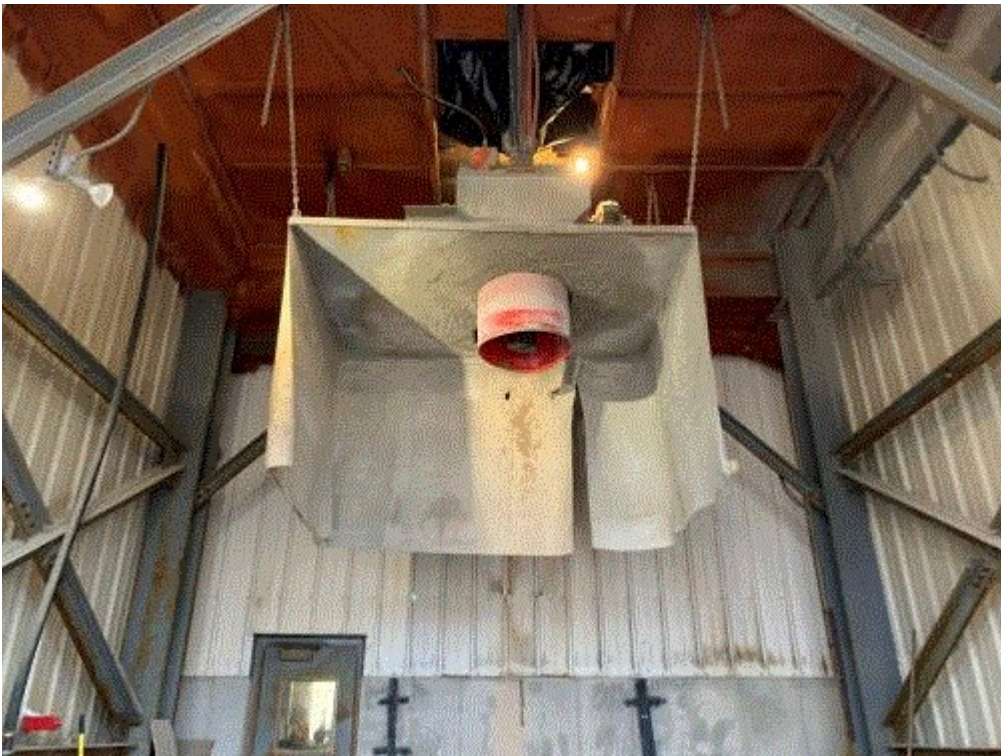
Image 4(Loading Chute) : Chute used for concrete loading.
