DEPARTMENT OF ENVIRONMENTAL QUALITY AIR QUALITY DIVISION ACTIVITY REPORT: On-site Inspection

H587768050			
FACILITY: EASTERN MI UNIVERSITY		SRN / ID: H5877	
LOCATION: 812 OAKWOOD, YPSILANTI		DISTRICT: Jackson	
CITY: YPSILANTI		COUNTY: WASHTENAW	
CONTACT: Scott Storrar, Executive Director		ACTIVITY DATE: 06/28/2023	
STAFF: Mike Kovalchick	COMPLIANCE STATUS: Non Compliance	SOURCE CLASS: SM OPT OUT	
SUBJECT: Compliance Inspection of EMU. EMU failed to conduct required NOX testing of their COGEN turbine.			
RESOLVED COMPLAINTS:

Minor Source: Opt-out Source for CO and NOx. Full Compliance Evaluation (FCE): SRN H5877

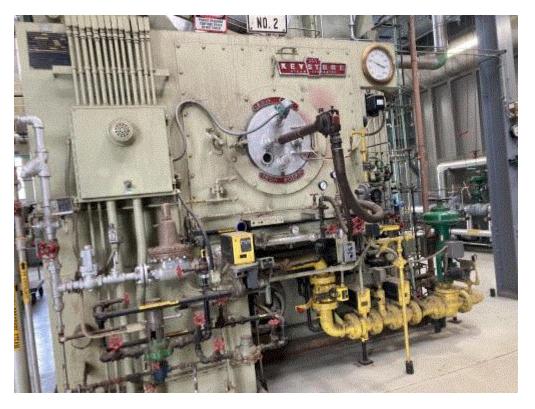
There originally were three grandfathered steam boilers that were installed prior to 8/15/1967, and therefore did not require a permit to install (PTI). EU-HP-BLR3-PT001 has been physically removed from the site. EU-HP-BLR1-PT003 and EU-BLR2-PT004 remain on site and are used in a limited fashion. They are natural gas fired with fuel oil/diesel as backup. The source has not changed fuel oil suppliers or type of fuel since the last inspection, which has a sulfur content less than the limit of 0.1%.

Image 1(Boiler 1) : Steam Boiler 1 (Grandfathered) Natural gas

We then traveled over to the Energy Center to begin the inspection. Outside, we first measured height using our range finder. It was measured to be 75 feet high which matched permit requirements. We then located at steam boilers EU-HP-BLR1-PT003 and EU-HP-BLR2-PT004. See attached photos. They were not operating and typically do not operate in the Summer and are only operated during particularly cold conditions in the Winter. Despite their age, they appeared to be well maintained.

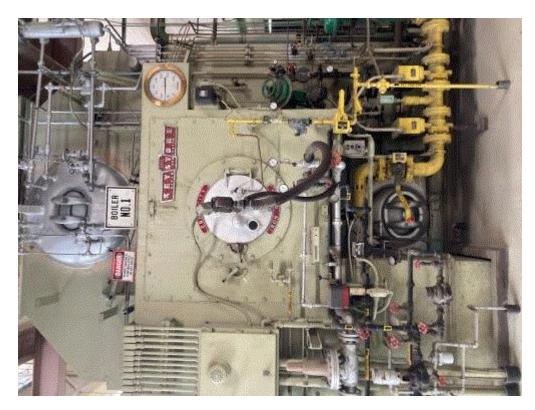
Image 2(Boiler 2) : Natural gas fired Boiler 2.

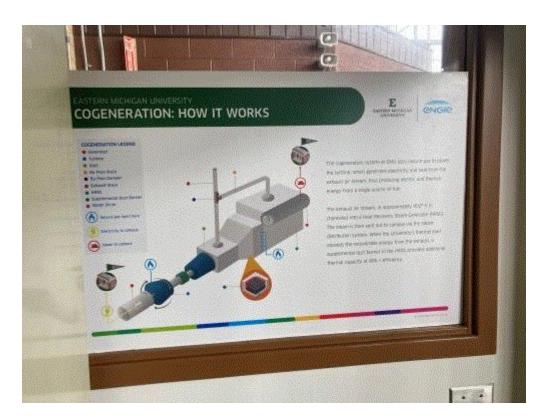
Currently, EMU operates the cogenerations system along with several other minor sources of emissions under Opt-out 39-18. The Cogen uses natural gas to power the turbine, which generates electricity and heat from the exhaust air stream, thus producing electric and thermal energy from a single source of fuel. The Solar Turbine is equipped with *SoLoNOx* burners which use lean-premixed combustion technology to ensure uniform air/fuel mixture and to prevent formation of regulated pollutants.

The exhaust air stream, at approximately 950 F is channeled into a Heat Recovery Steam Generator (HRSG). The steam is then sent out to campus via the steam distribution system. When the University's thermal load exceeds the recoverable energy from the exhaust, a supplemental duct burner in the HRSG provides additional thermal capacity at 90% + efficiency.

Image 3(COGEN Diagram) : COGEN Diagram
