**DEPARTMENT OF ENVIRONMENTAL QUALITY
AIR QUALITY DIVISION
ACTIVITY REPORT: Scheduled Inspection**

FACILITY: Jackson Metal Cleaning		SRN / ID: P0915
LOCATION: 1492 West Grand River Avenue, WILLIAMSTON		DISTRICT: Lansing
CITY: WILLIAMSTON		COUNTY: INGHAM
CONTACT: Tyler Lang , Owner		ACTIVITY DATE: 01/22/2019
STAFF: Michelle Luplow	COMPLIANCE STATUS: Non Compliance	SOURCE CLASS: MINOR
SUBJECT: Unannounced scheduled compliance inspection to determine compliance with PTI 70-18		
RESOLVED COMPLAINTS:

Conduct an unannounced scheduled compliance inspection of Jackson Metal Cleaning to determine compliance with General PTI 70-18 for for a natural gas-fired burnoff oven.

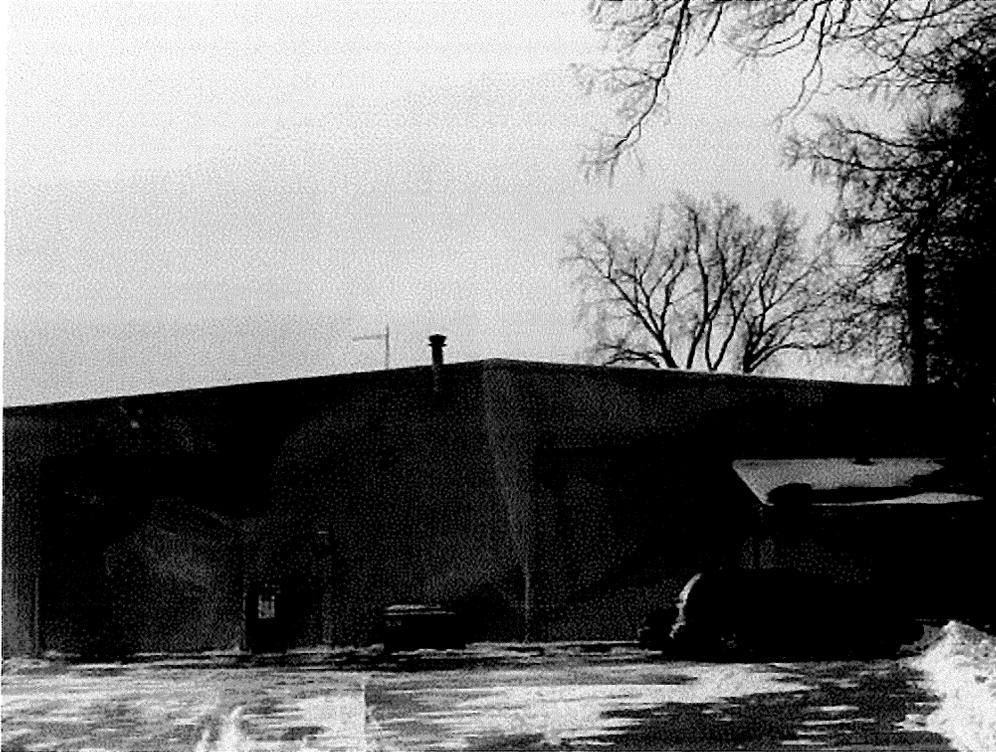
There shall be no visible emissions from EU-BURNOFF. EU-BURNOFF was operating during the inspection. S. Braman and I did not observe any visible emissions from the stack neither before, nor after the inspection. See attached photo of building with stack.

The exhaust gases from EU-BURNOFF are to be discharged unobstructed vertically upwards to the ambient air with an exit point not less than 1.5 times the building height. Attached is a photo of the building exterior with stack taken at the inspection by S. Braman and I. T. Lang provided a building design document (with associated email) stating that the height of the building, from ground level to apex, is 22'. The building height is 22'. The stack height is therefore required to be at least 33'. The stack design document shows a stack height of 36', therefore demonstrating compliance with the stack height requirement.

Image 1(Stack) : Stack is at the right edge of the building.
