DEPARTMENT OF ENVIRONMENTAL QUALITY  
AIR QUALITY DIVISION  
**ACTIVITY REPORT: On-site Inspection**

<b>FACILITY:</b> Cleanlites Recycling		<b>SRN / ID:</b> N5948
<b>LOCATION:</b> 665 HULL RD, MASON		<b>DISTRICT:</b> Lansing
<b>CITY:</b> MASON		<b>COUNTY:</b> INGHAM
<b>CONTACT:</b> Kevin Webb , Facility Manager		<b>ACTIVITY DATE:</b> 08/22/2023
<b>STAFF:</b> Michelle Luplow	<b>COMPLIANCE STATUS:</b> Compliance	<b>SOURCE CLASS:</b> MINOR
<b>SUBJECT:</b> Onsite compliance inspection to determine compliance with PTI 329-96A		
<b>RESOLVED COMPLAINTS:</b>

Conduct an unannounced, on-site compliance inspection to determine compliance with PTI 329-96A for a fluorescent lamp processing system.

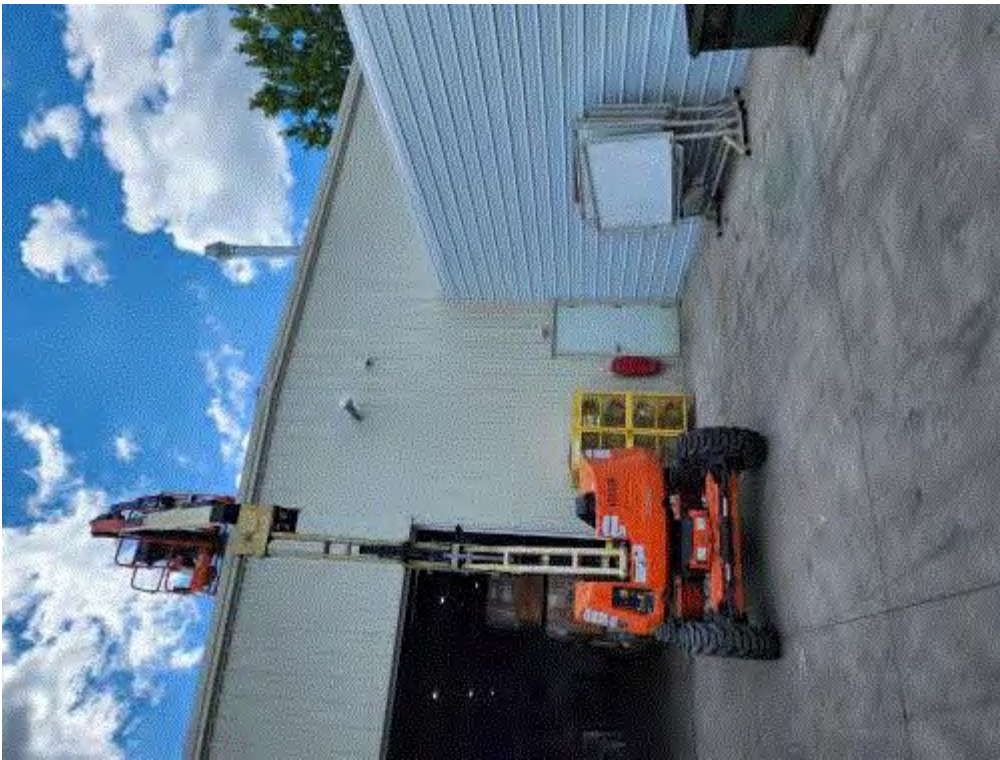
**Image 1(Pre-Install Stack)** : Photo Credit: Cleanlites. Stack height is pre-installation of extender

The EULAMPSYSTEM stack is required to be at least 38' above ground level and discharged unobstructed vertically upwards. I used AQD's Nikon Forestry Pro II Rangefinder to evaluate the stack height. There was no angle at which I could get a clear reading for the stack height. Multiple obstructions were in the way; however, I took 2 readings that measured 33.5' and 34.2'. Because of my concern about the accuracy of the readings due to the obstructions, I requested that Cleanlites conduct their own stack height measurements.

On September 18, 2023, K. Webb stated that they were unable to determine the stack height, so rather than confirm my measurements, they ordered and installed an extra 5 feet of stack. K. Webb provided photos of pre- and post- extension installation. Using the readings I took during the inspection, the stack height, with 5' of extension, ranges from 38.5' – 39.2', and would therefore meet the stack height requirement.
